Structure ID	CC-N72-001.00
Bridge Name	Duncannon Bridge
County	Cork
Grid Reference	517998, 593188
Watercourse	River Blackwater
No. of Spans	3
Dates of surveys	06.09.19, 17.06.23, 09.06.24
Species Recorded	Maternity roost of Daubenton's bats. Colony of Sand martins
Bat Grade	3
Recommendations	Repointing works in vicinity of marked crevices to be supervised by ecologist. All bore holes to be left open for sand martins Derogation licence required from NPWS

Duncannon Bridge is a large three arch masonry bridge spanning the River Blackwater in County Cork. The bridge dates from c. 1810. Duncannon Bridge stands within the Blackwater River (Cork/Waterford) SAC. The bridge has been surveyed at least three times between 2019 and 2024. Numerous crevices were marked under the arches for retention for bats. Five crevices were marked under the westernmost arch. One crevice, behind the downstream facing stones of the westernmost arch, contained a nursery colony of approximately 12 Daubenton's bats *Myotis daubentonii*. The bats move between the different crevices and it is imperative that all the marked crevices are retained.

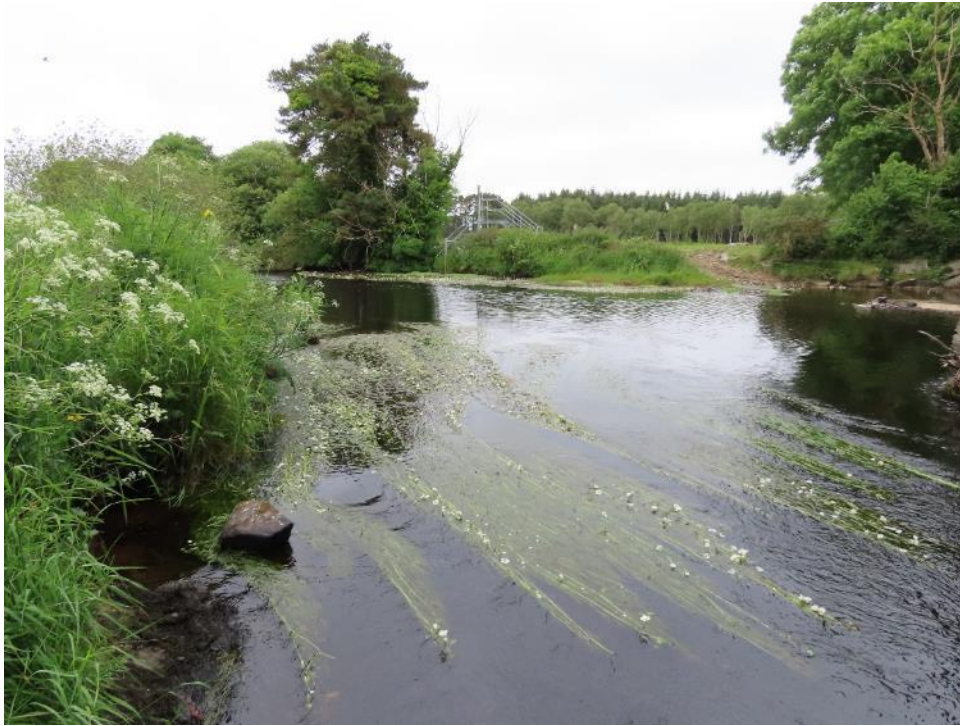
There is floating river vegetation upstream of the bridge.

Duncannon Bridge – floating river vegetation upstream

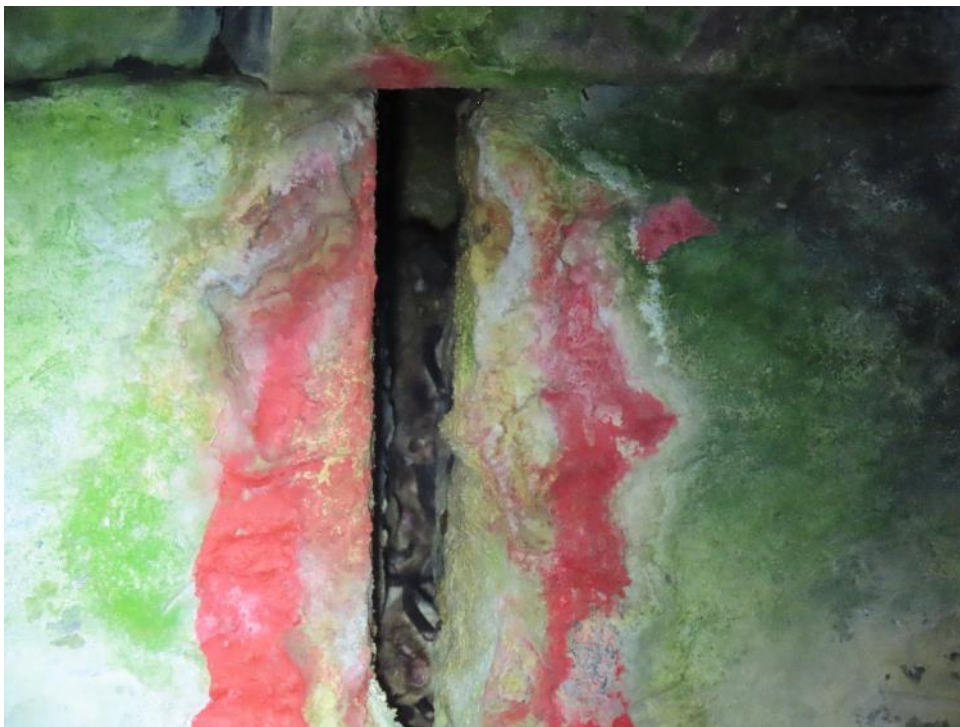
Duncannon Bridge – nursery roost of Daubenton's bats in void under westernmost arch

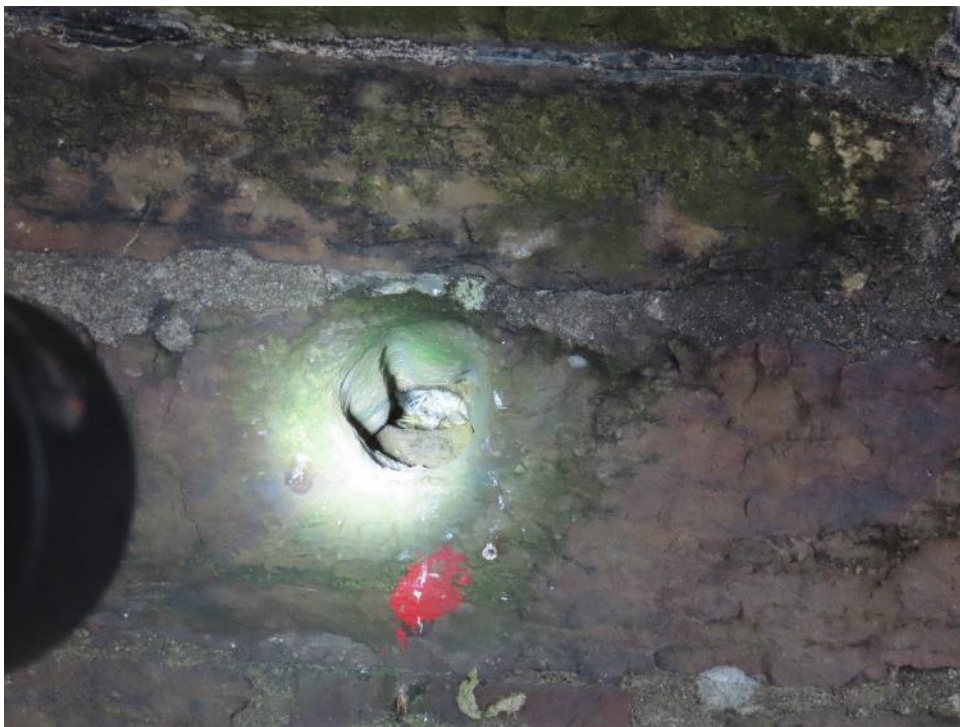
Duncannon Bridge – Sand martin nest in bore hole

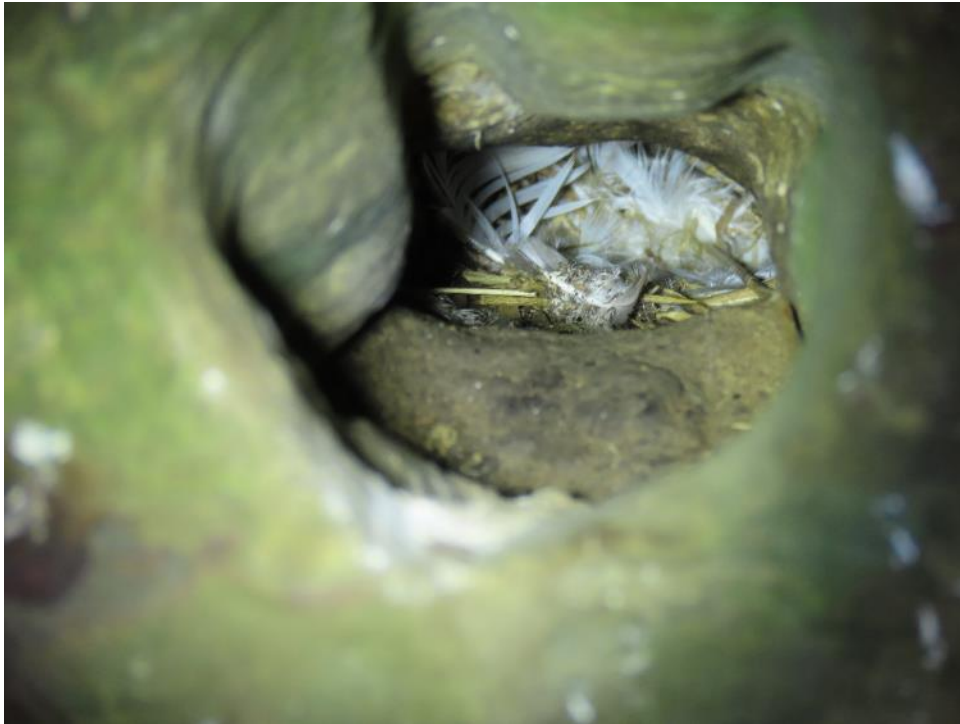
There are bore holes in the abutment walls of the bridge. Many of these bore holes contain Sand martin nests which were active on the date of the surveys in 2023 and 2024 (eggs and nestlings).

Duncannon Bridge – sand martin nest in borehole in abutment

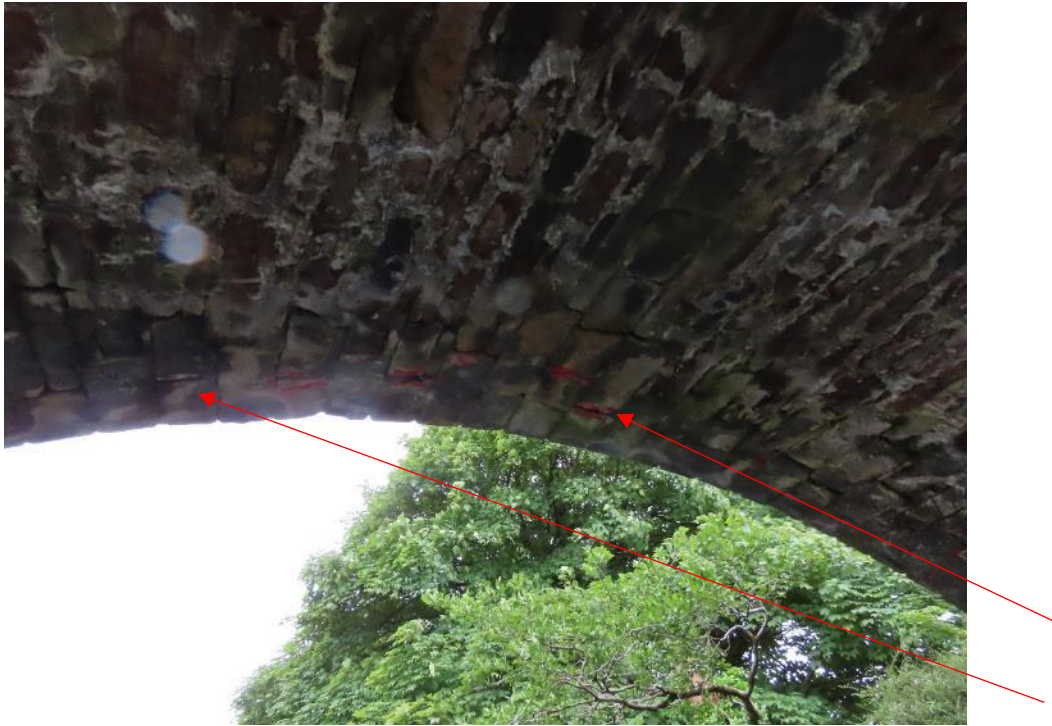
Duncannon Bridge – five crevices marked all behind downstream facing stones of westernmost arch

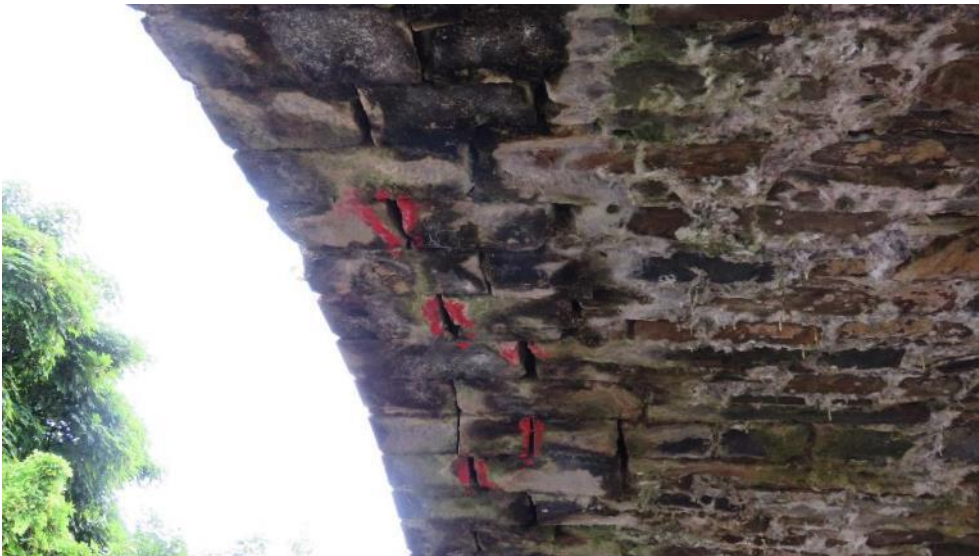
Crevices were previously marked under the arches for retention for bats. Of the five crevices marked under the westernmost arch, three contained colonies of Daubenton's bats – 7 bats, 5 bats, 5 bats. Young bats were present indicating that this is a maternity roost.

Five previously marked crevice behind the downstream facing stones of the western arch. A total of 17 Daubenton's bats were recorded in these crevices

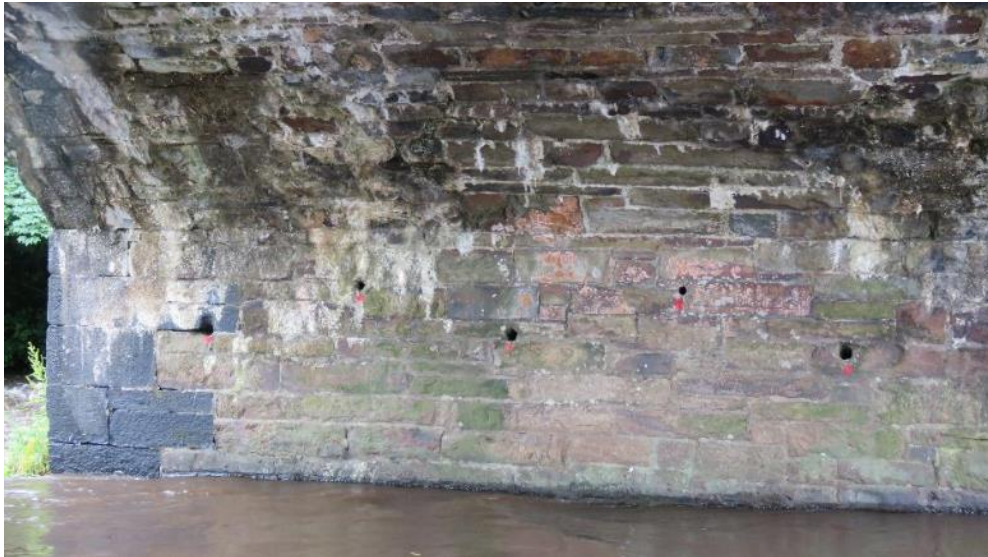
Sand martins were recorded nesting in almost every drainage hole/bore hole under the arches – mainly under the western and centre arch. One nesting hole was recorded under the eastern arch. Inspection of the nest sites revealed young bird at the full range of developmental stages – eggs, recently hatched nestlings, fledglings almost ready to fly. It is estimated that approximately 20 holes were occupied.

Series of 5 bore holes under the western arch – all occupied by nesting sand martins

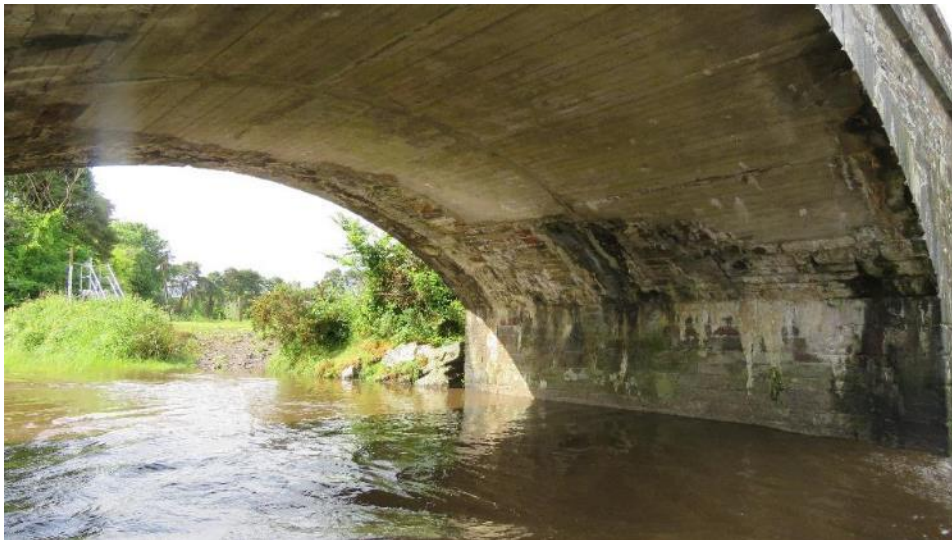
Easternmost arch – shutter cement applied to arch apex

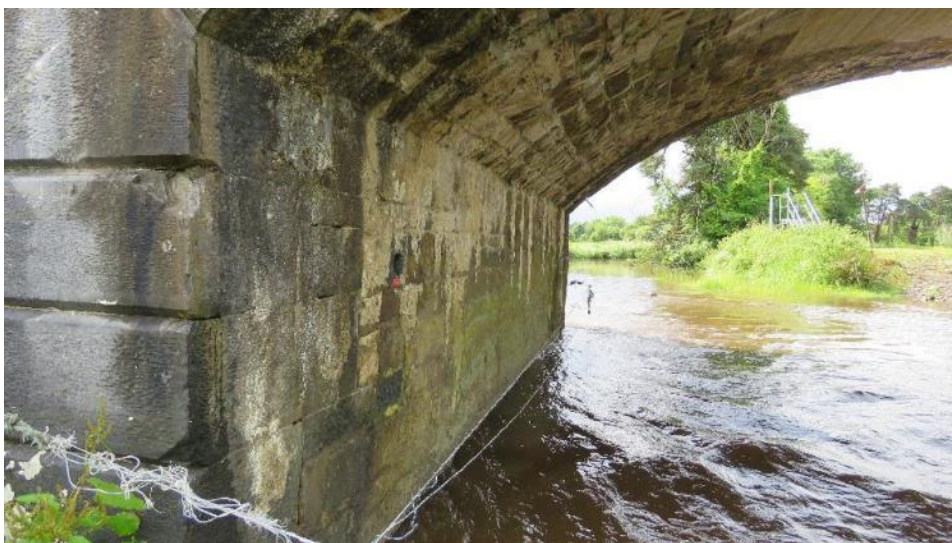
Sand martin nest in bore hole under eastern arch

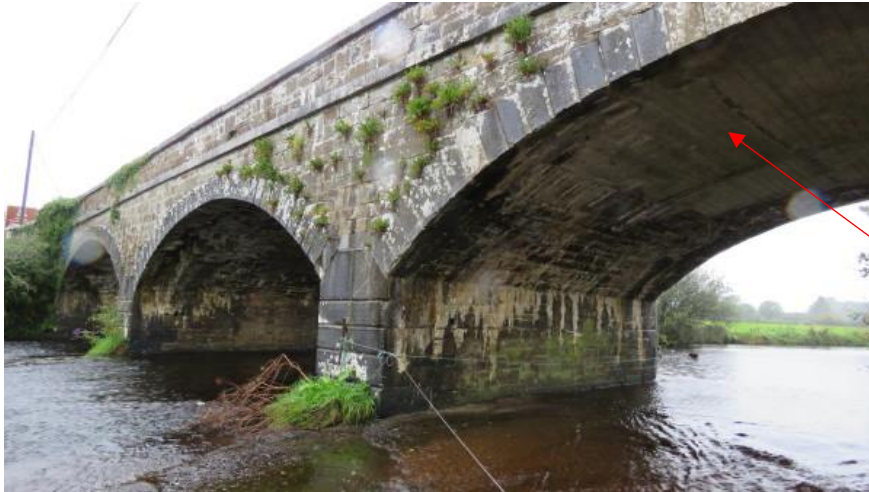
Photo 2 – Duncannon Bridge – showing some shuttered grouting under eastern arch

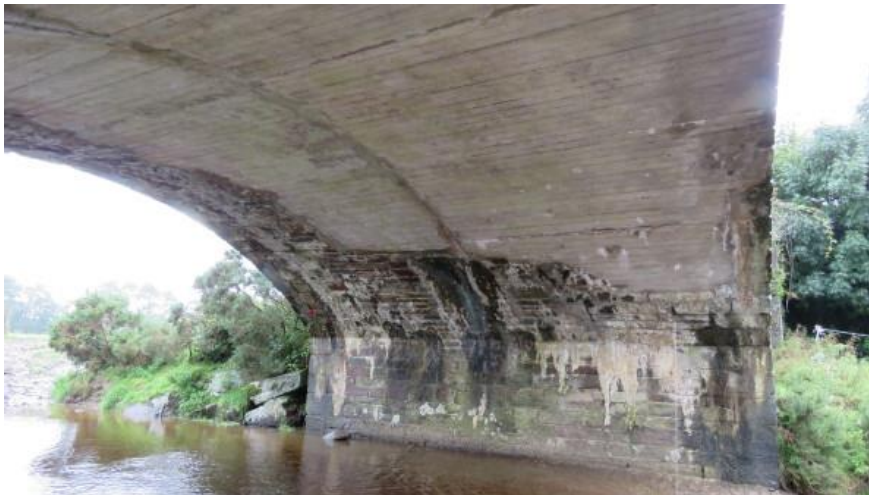
Photo 3 – Duncannon Bridge – close-up of shuttered grouting under eastern arch

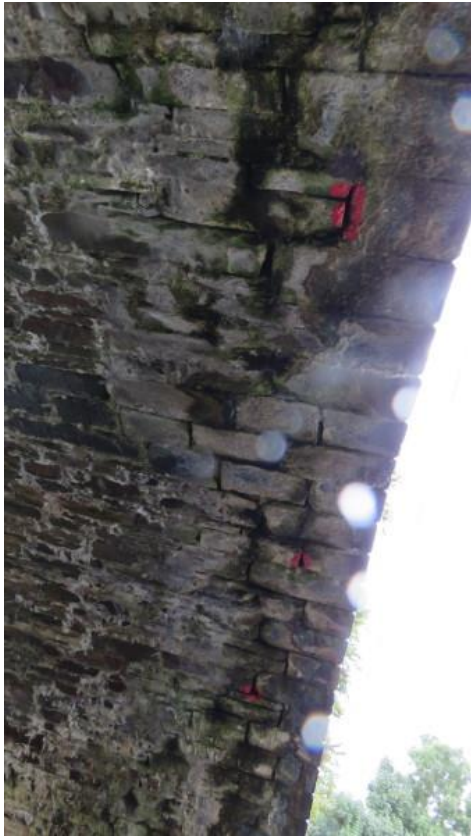
Photo 4 – Duncannon Bridge – 3 crevices marked behind facing stones

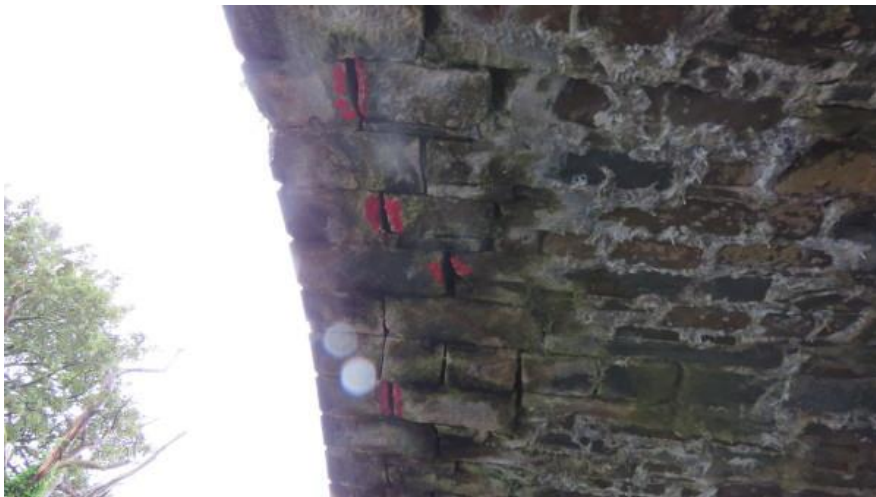
Photo 5 – Duncannon Bridge – 4 crevices marked for retention behind facing stones

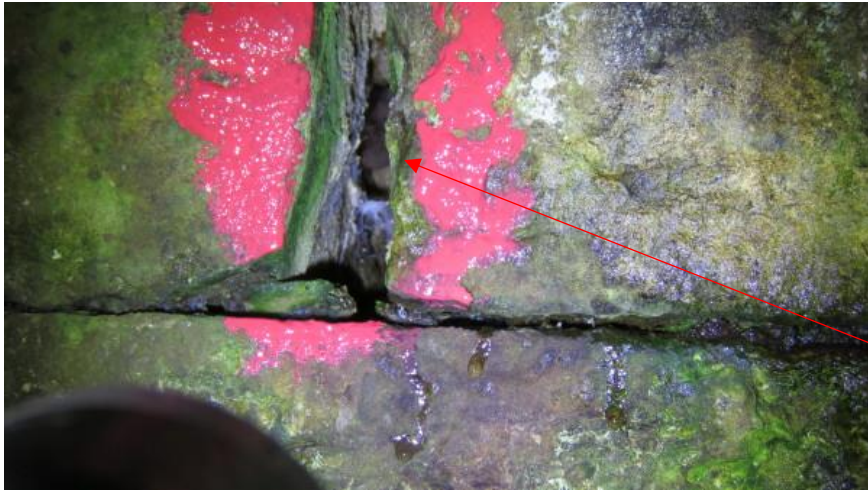
Photo 6 – Duncannon Bridge – Daubenton’s bat in marked crevice
