Existing Condition Photos – Grove Street, Roscrea, Co. Tipperary

Supplementary photographic information to explain how this application qualifies under; Regulation 54(2) of the European Communities (Birds and Natural Habitats) Regulations:

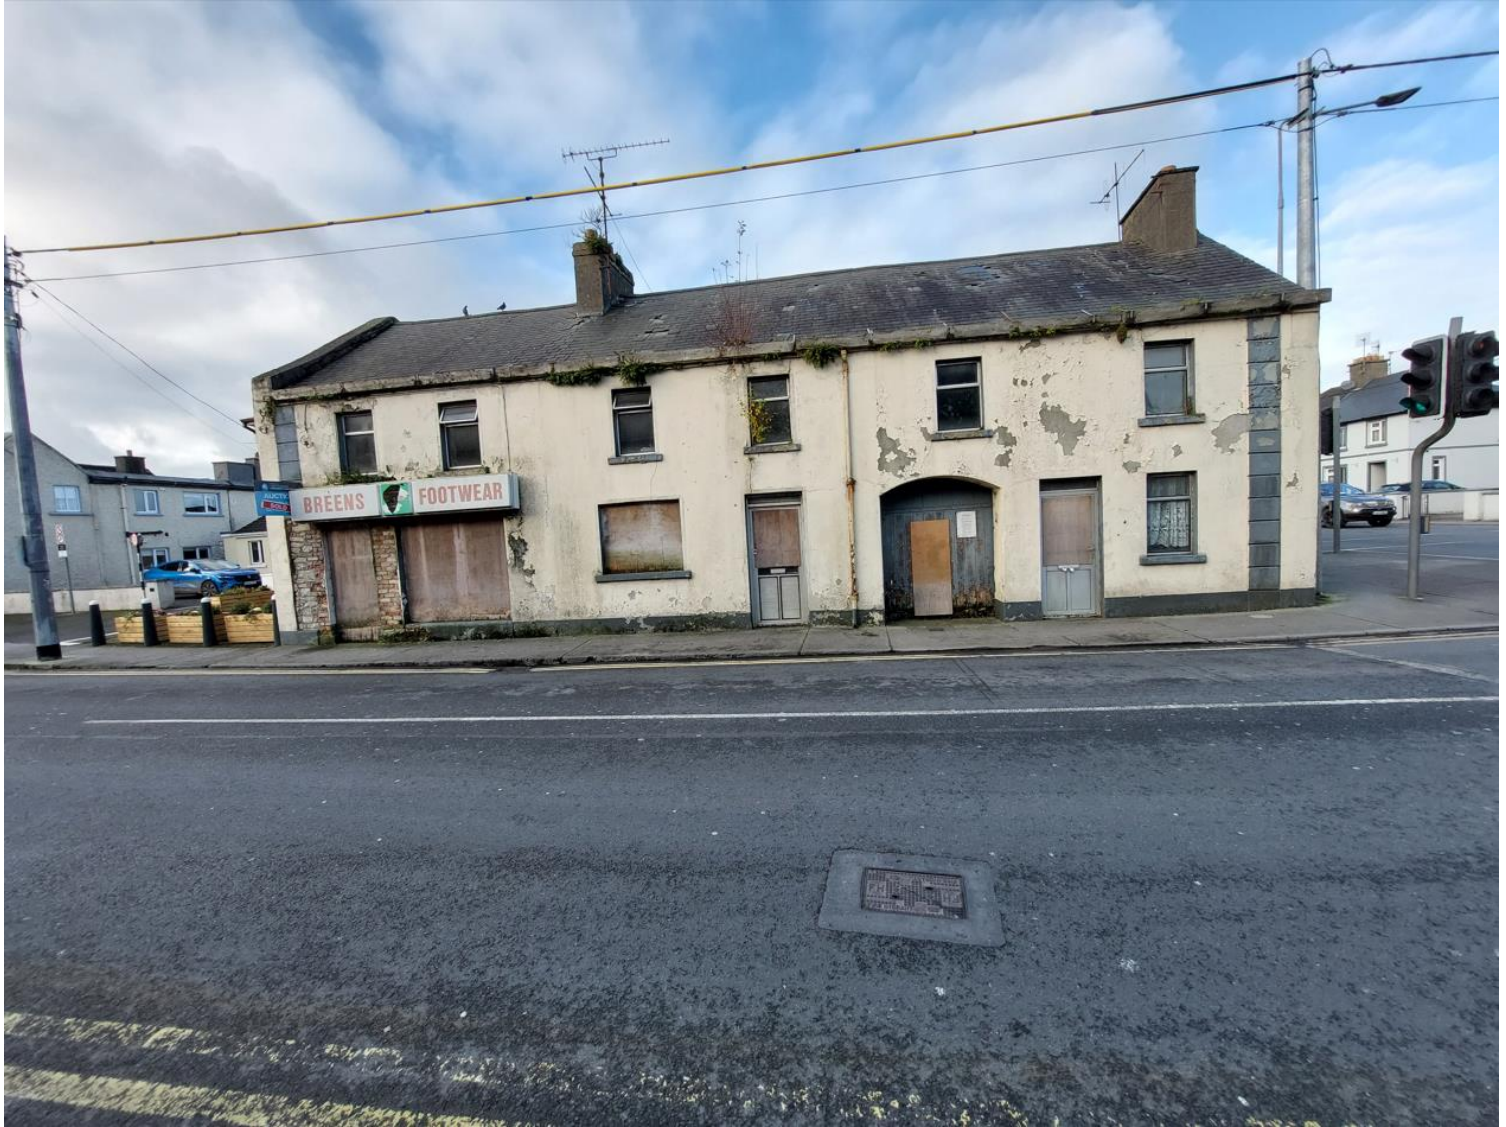
Photo 1: Front view (public footpath directly underneath, roof sagging, roof tiles slipping, vegetation growing within soffit, gutters removed previously for safety)

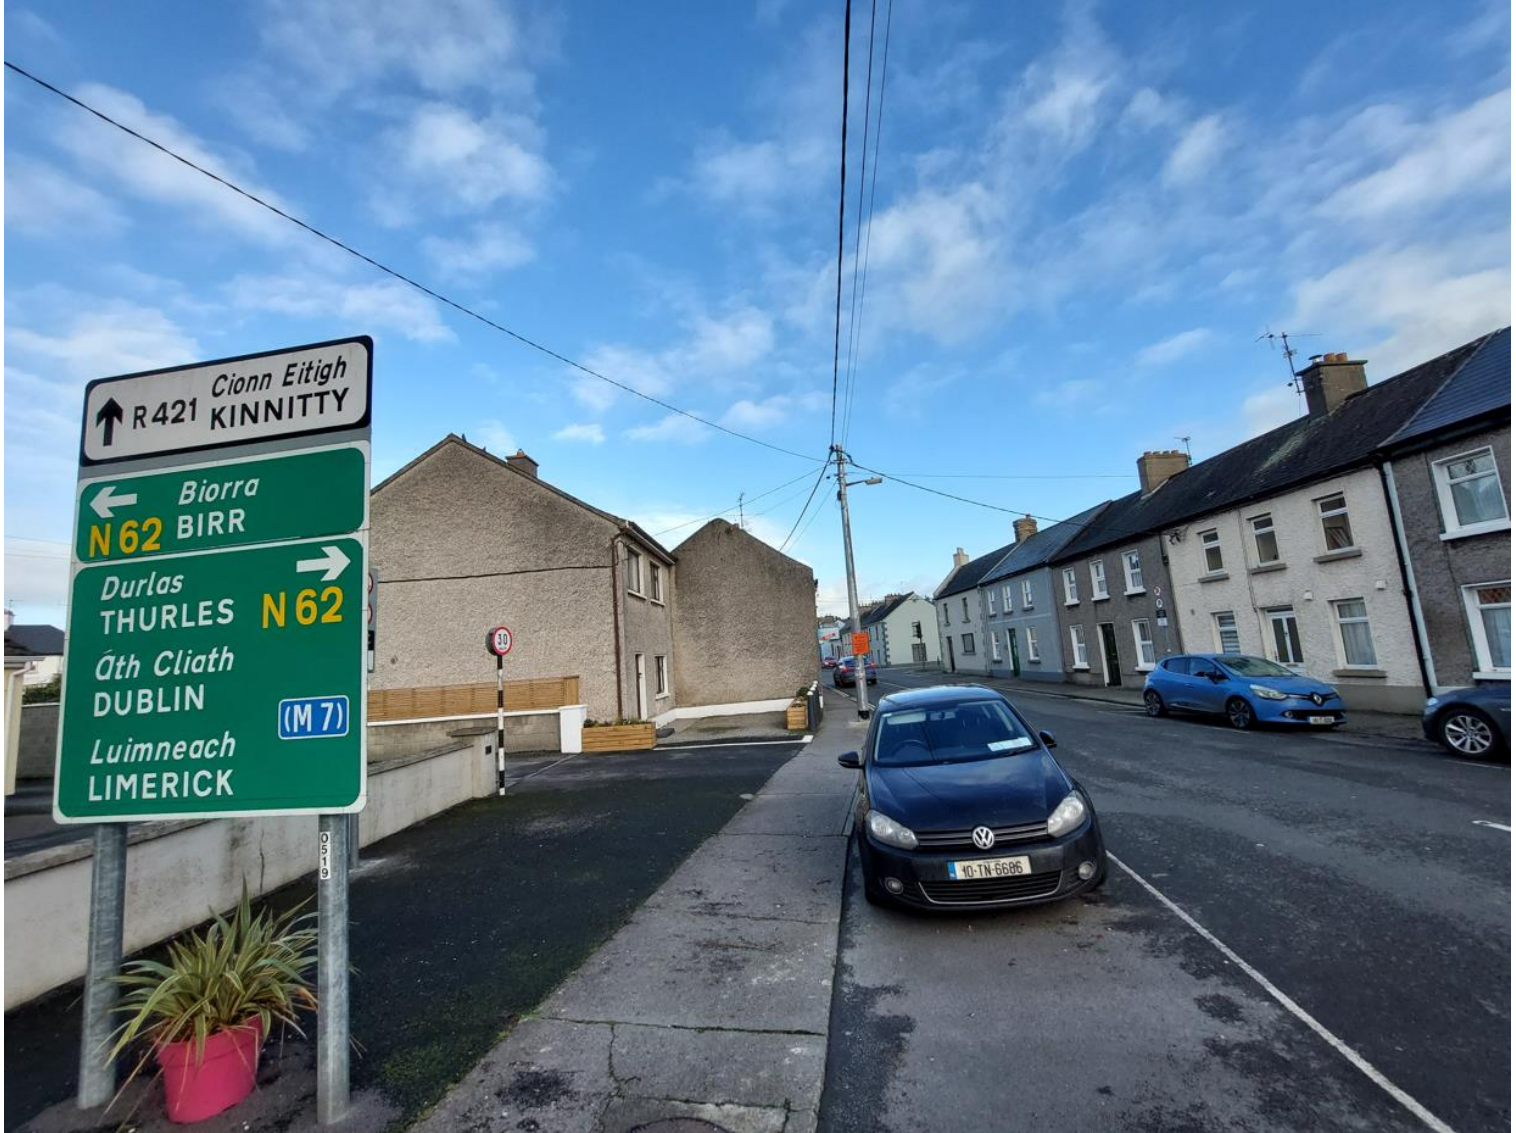
Photos 2: Side view (development is at a main junction along the N62. New build to be separated from neighbouring house, to be offset further back from the public footpath which will provide a safety buffer between the public road and footpath and better visibility at the traffic junction). New building will be further away from existing overhead ESB cables).

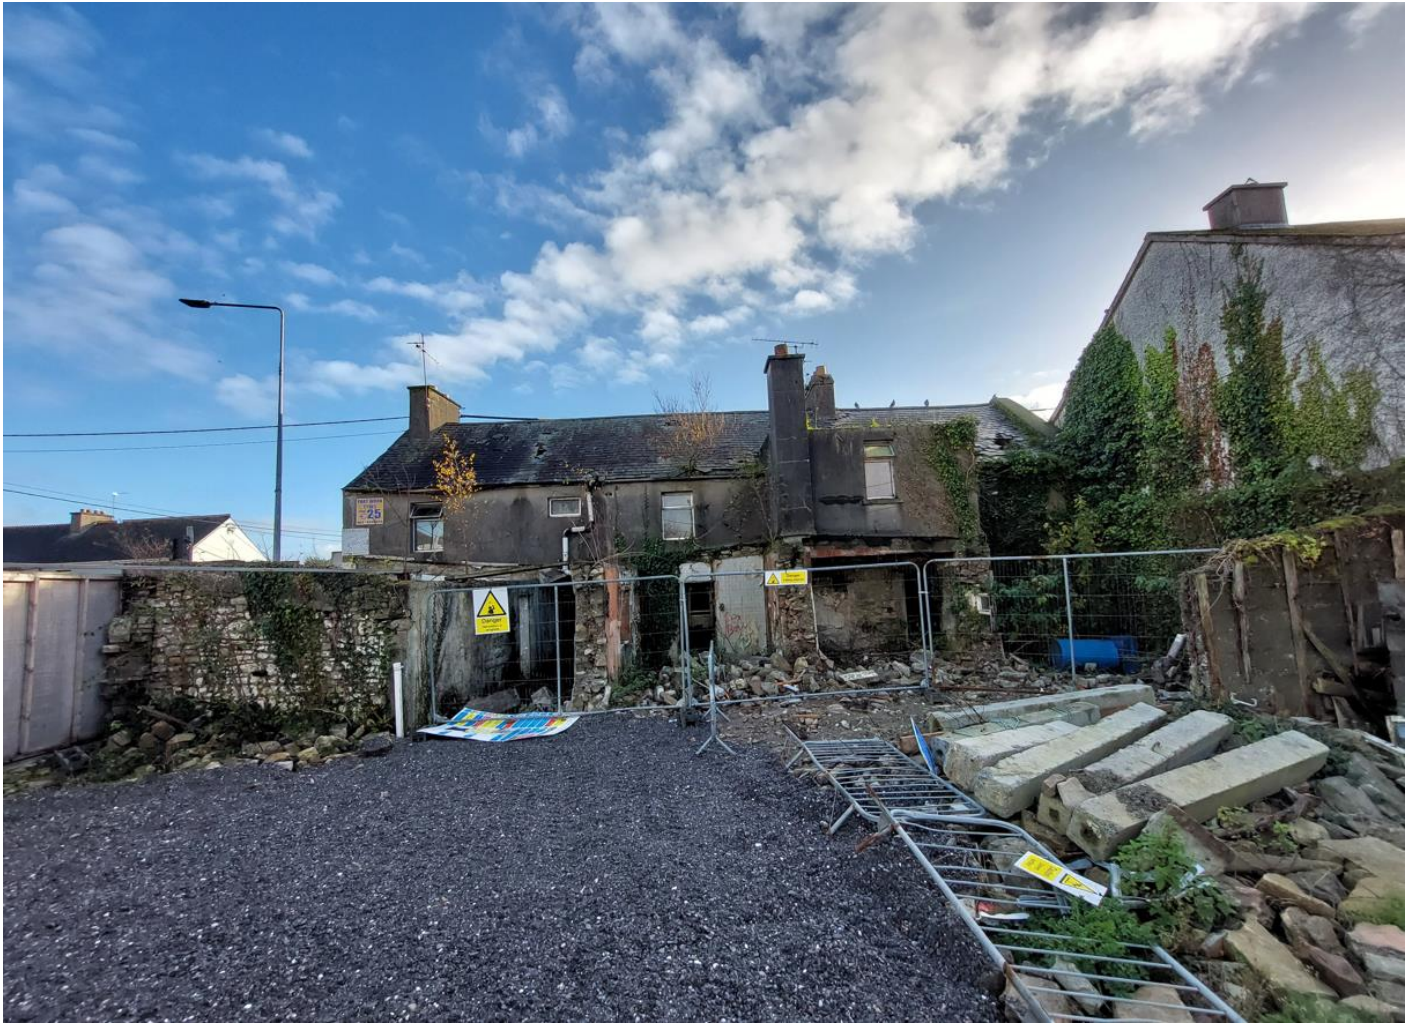
Photo 3: Rear view (roof is sagging, rotting and will eventually collapse. Roof tiles currently slipping off roof. This structure is joined with an inhabited private house which will be affected the more this building deteriorates over time).

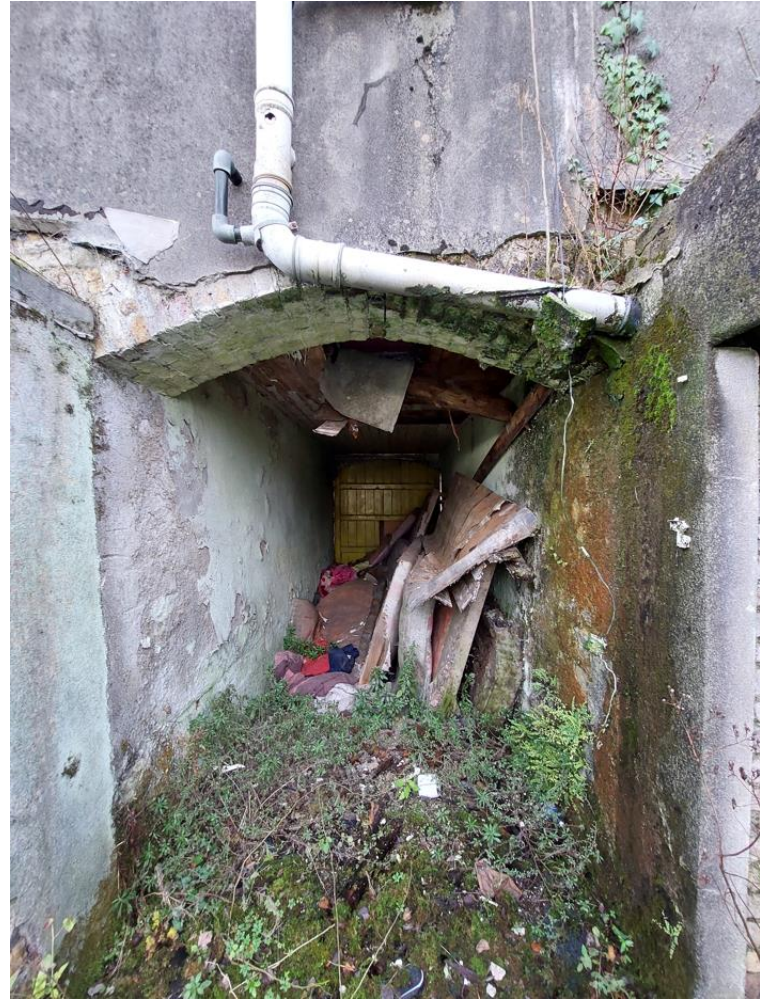
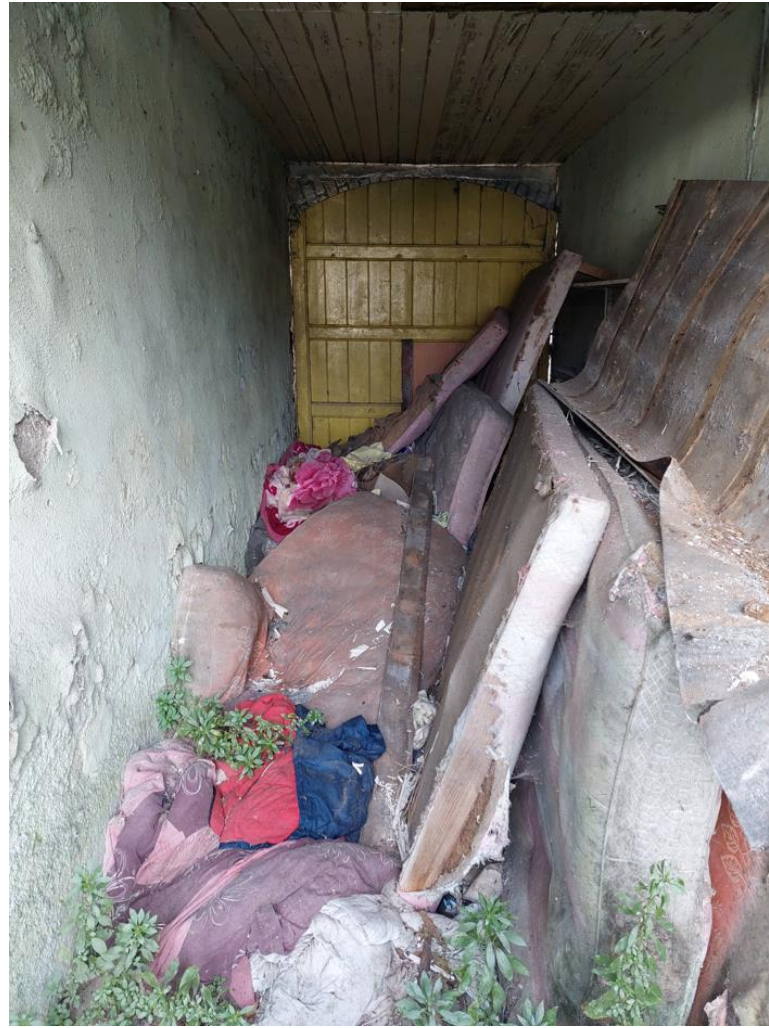
Photo's 4: Parts of this building has been used by squatters, rough sleepers and is an area known for anti-social behaviour, drug and drink taking.

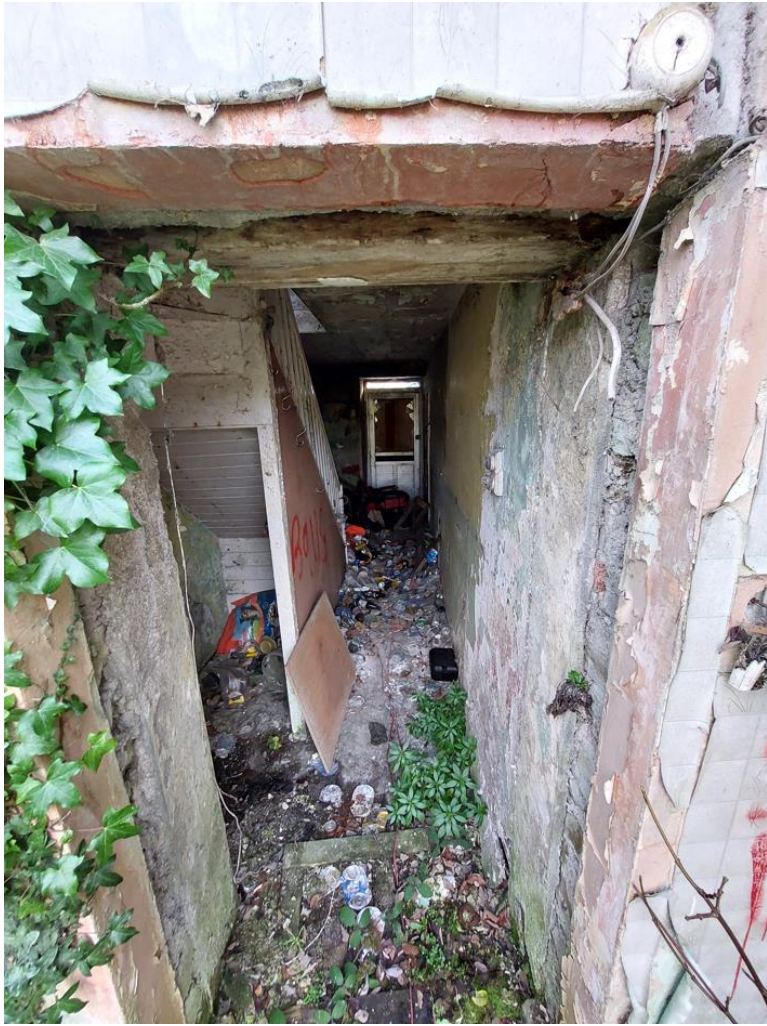
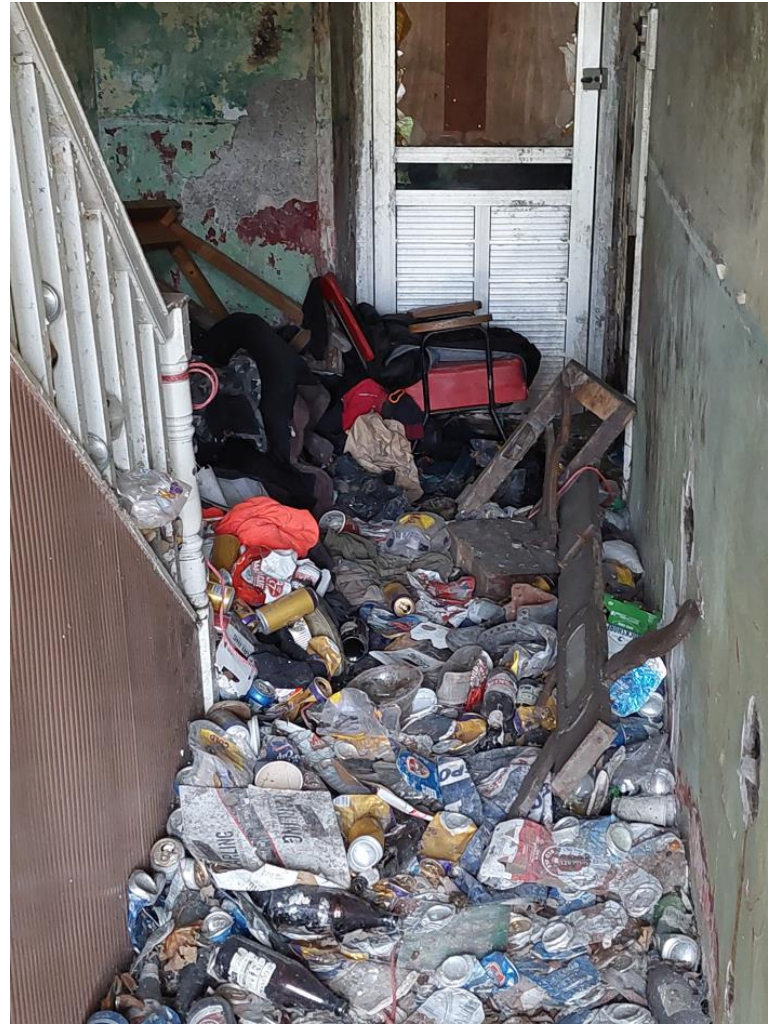
Photo's 5: Building known for anti-social behaviour, drug and drink use.

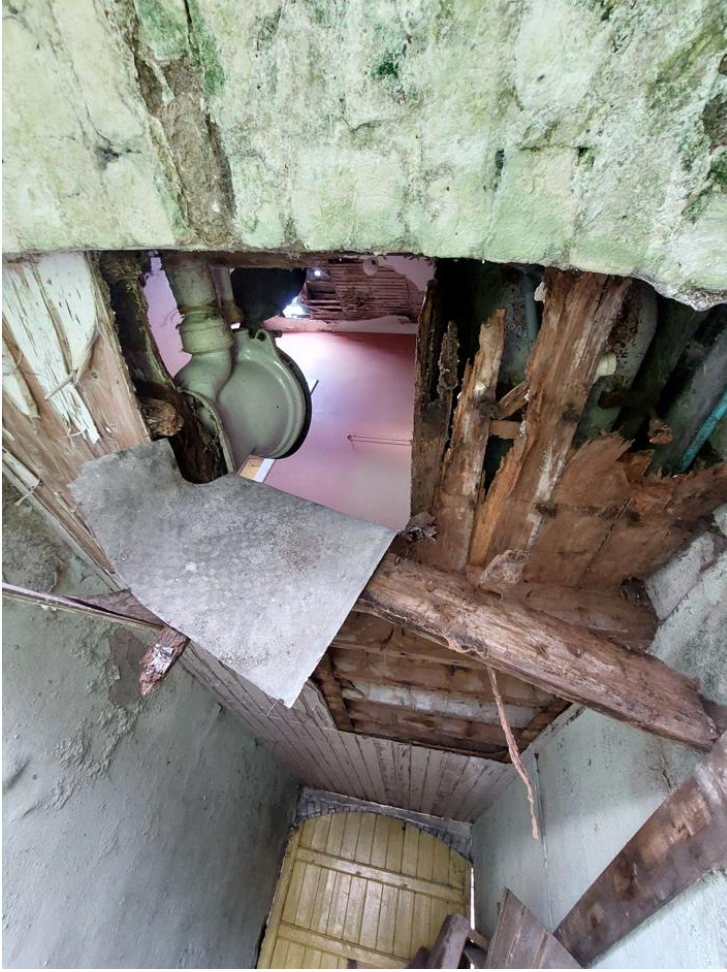
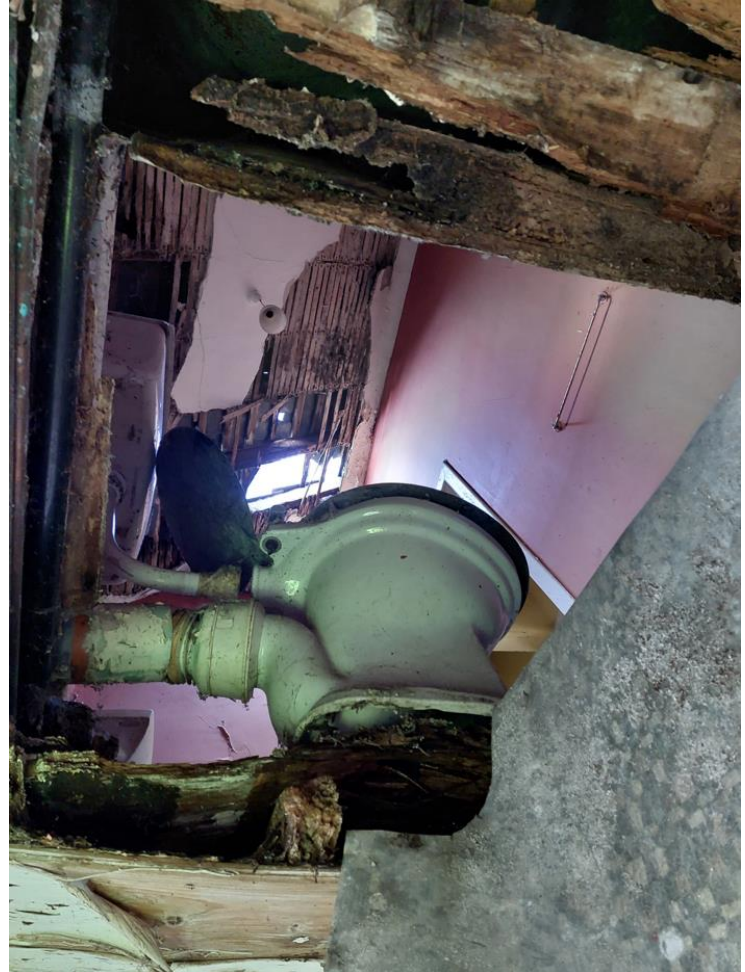
Photo's 6: View looking from ground floor up to first floor and roof (first floor joists and floors have rotten through and collapsed, roof structure rotting and collapsing in places. Not possible to safely access the first floor).

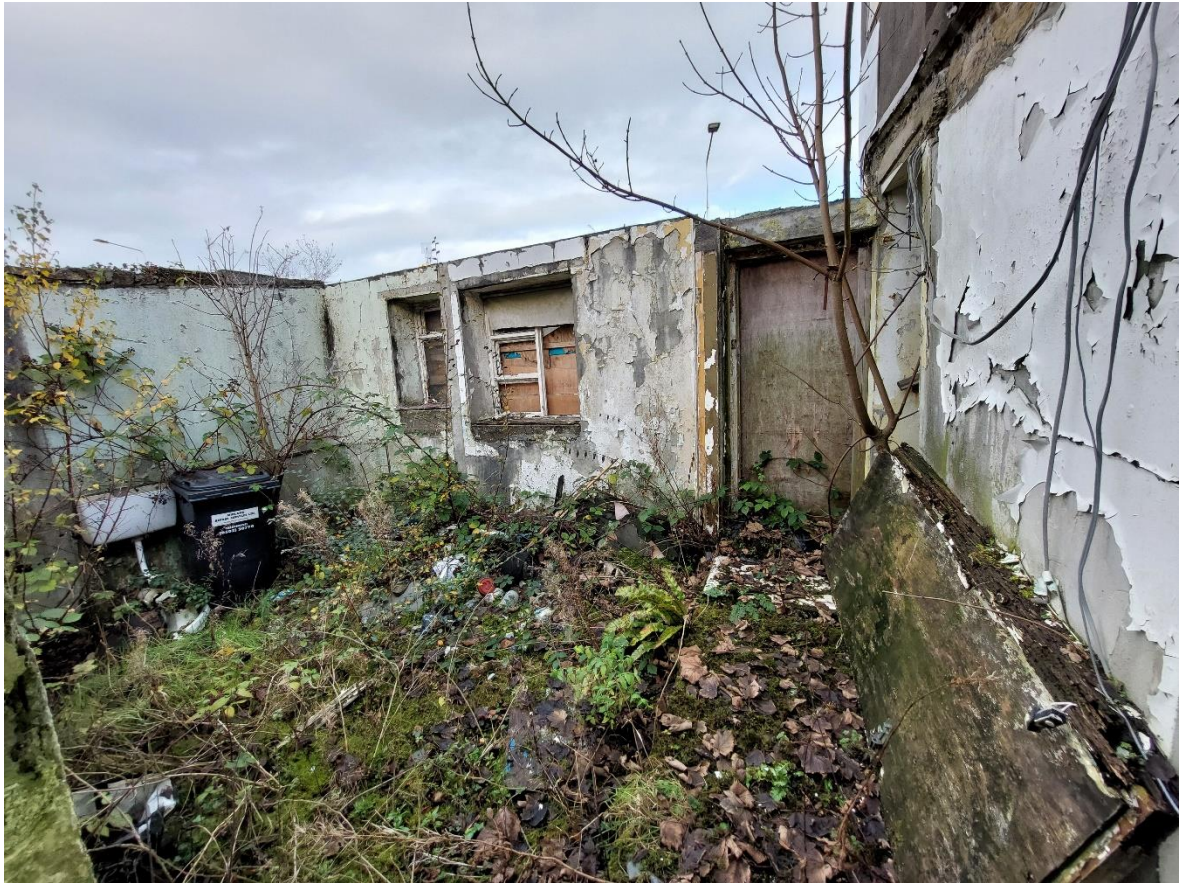
Photo 6: View of rear room (vegetation taken over, roof collapsed, rubbish thrown into area)

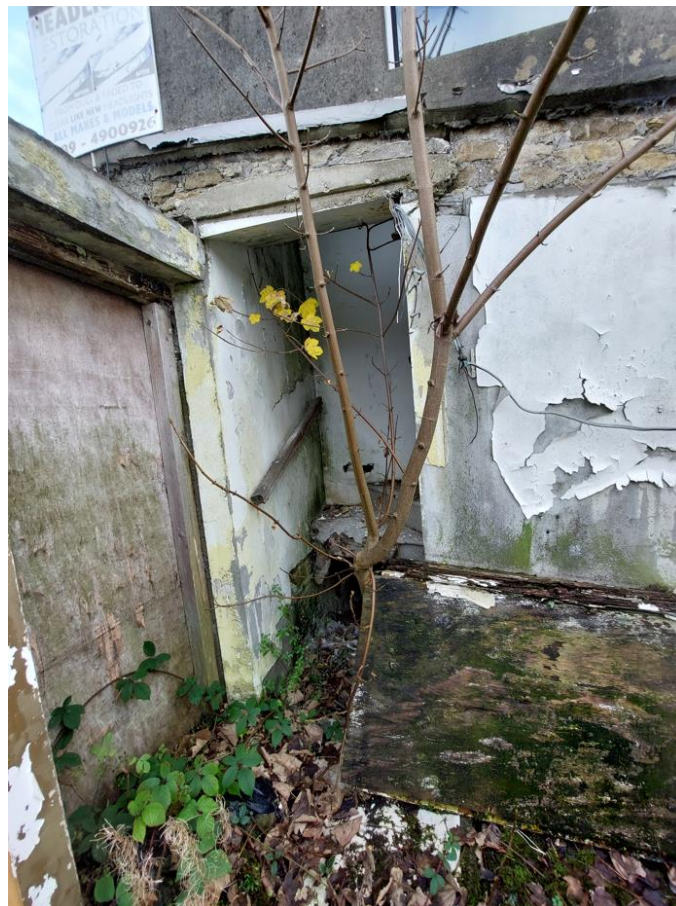
Photo 7: Stair access to first floor (steps rotten and collapsed)

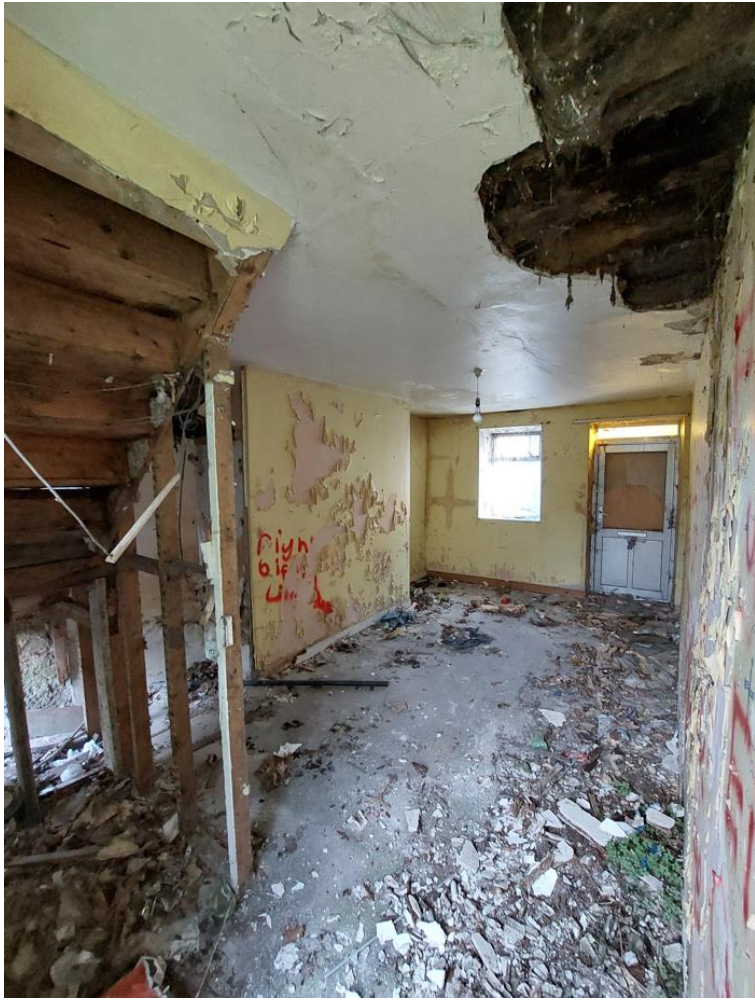
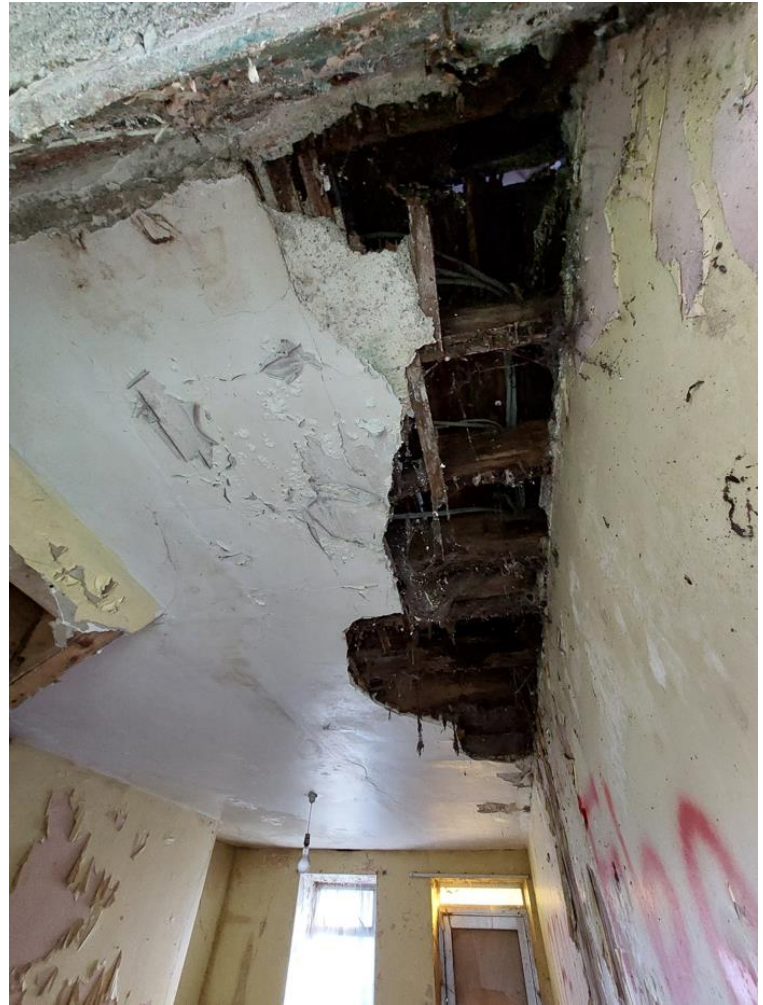
Photo 8: View from ground floor looking up (ceiling collapsing, first floor joists rotting)

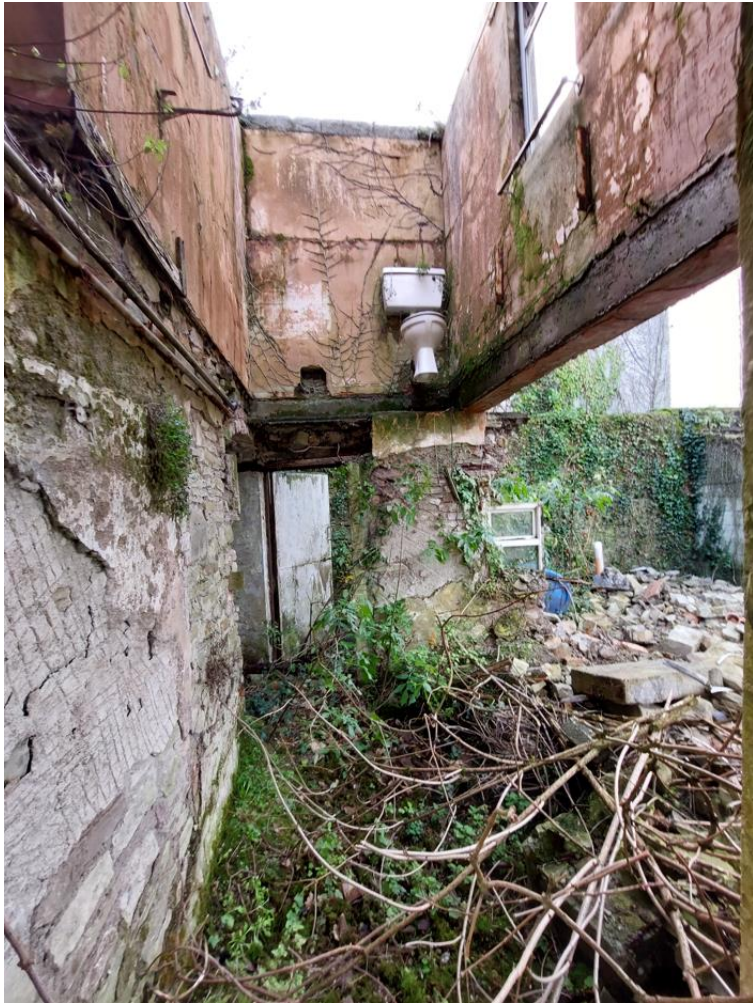
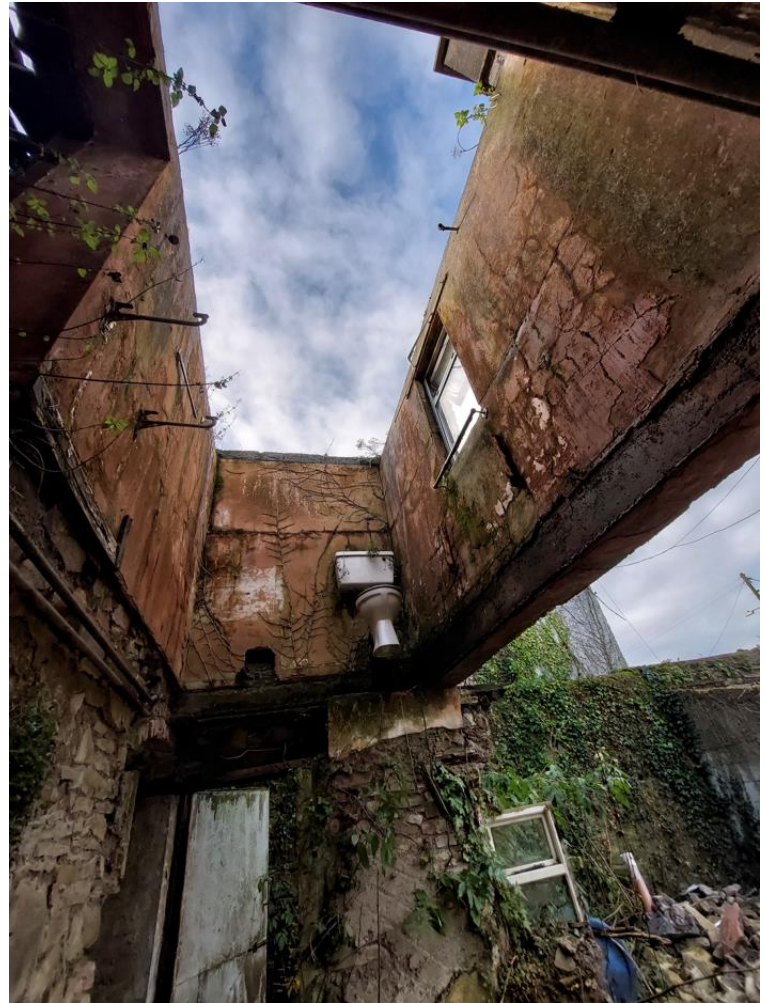
Photo 9: View of rear rooms (roof and first floor joists previously collapsed and removed).

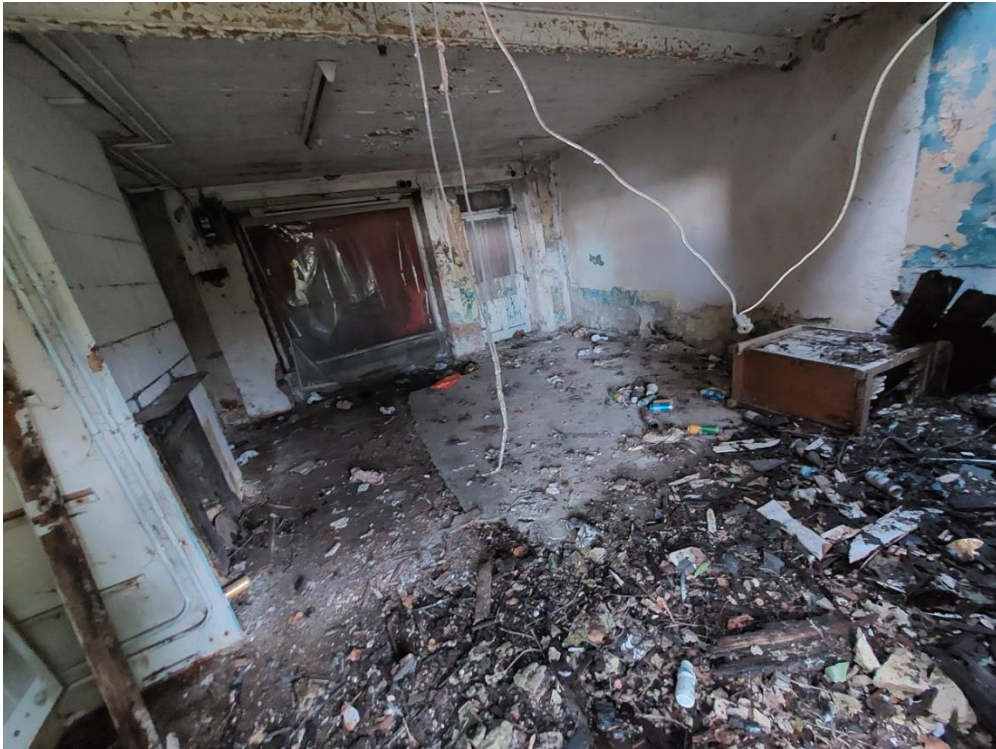
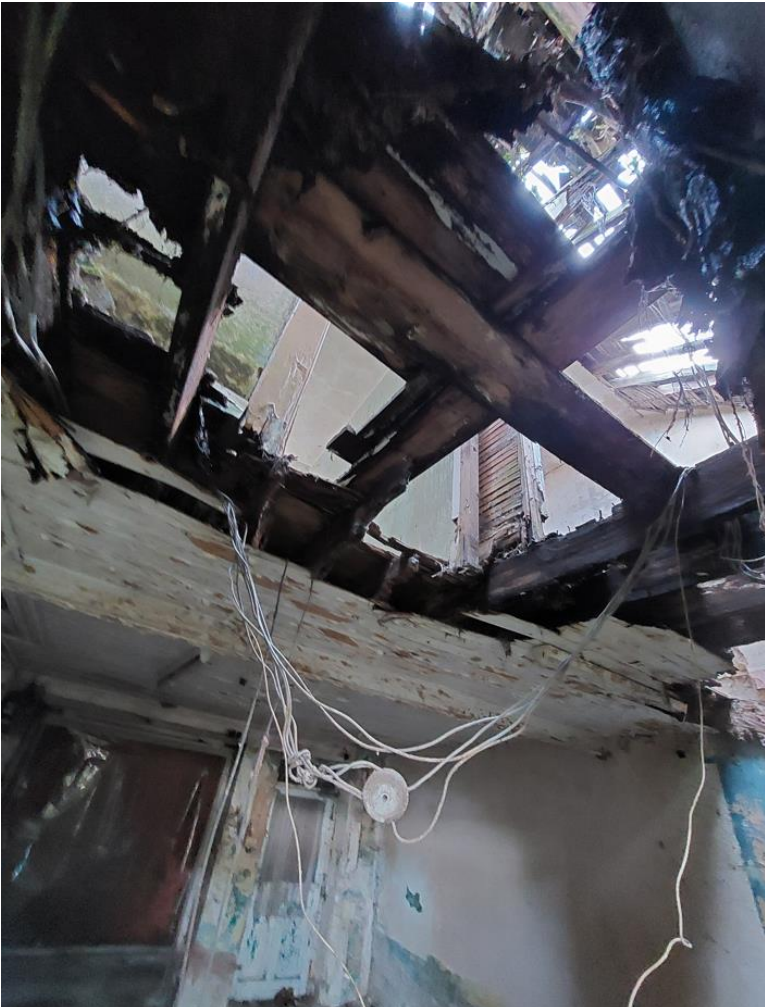
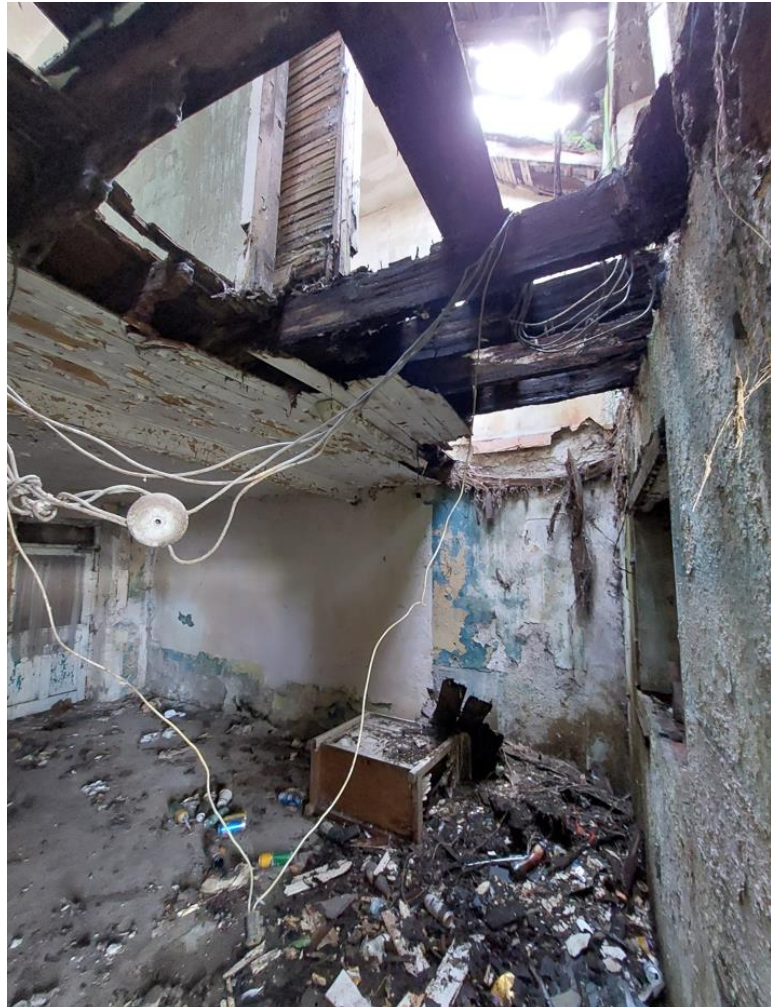
Photo 10: View from Ground floor looking up (first floor joists rotting and collapsed, roof structure rotting and collapsed in places. Not safe to access first floor. Area used for anti-social activity).
