SURVEY AT: Old Dwelling, The Spa, Tralee

FOR: Cathal de Lacy/Katherine Reidy

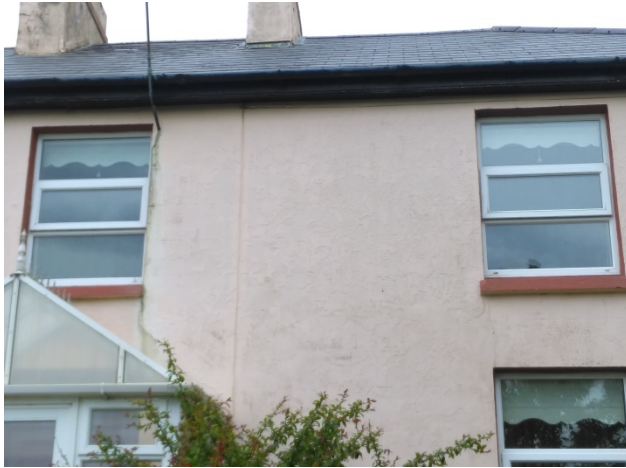
Photo 1: Front of house with uPVC windows, cracking in wall plaster and rotting fascia/soffit

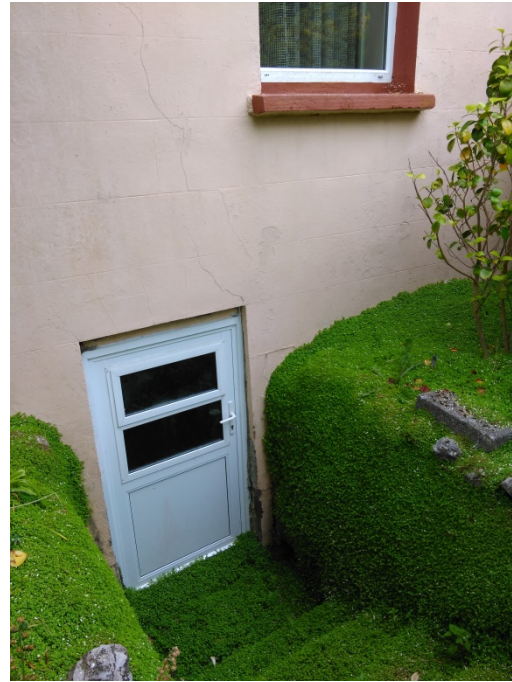
Photo 2: Basement entrance with significant cracking on wall and growth of mosses

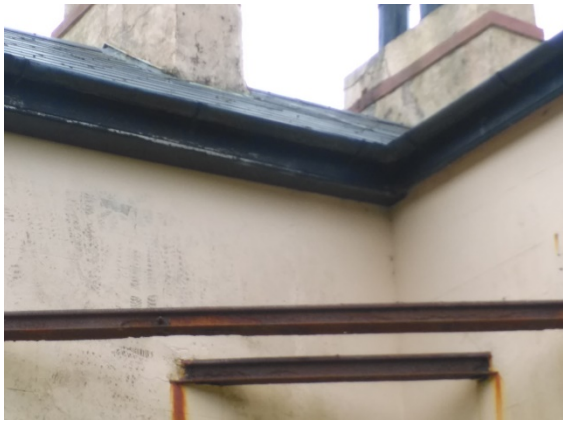
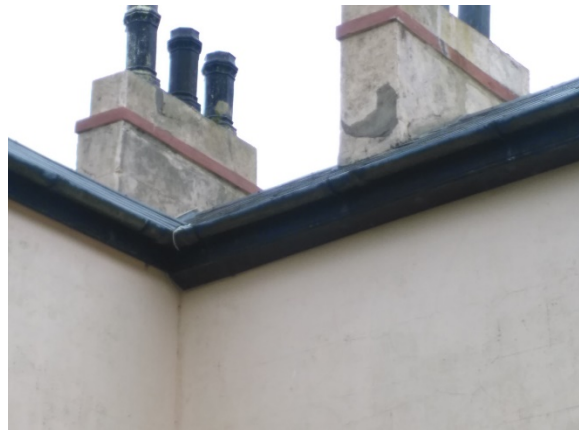
Photos 3 & 4: Rotting Fascia/Soffit, cracks in chimney and bars where water tank was previously

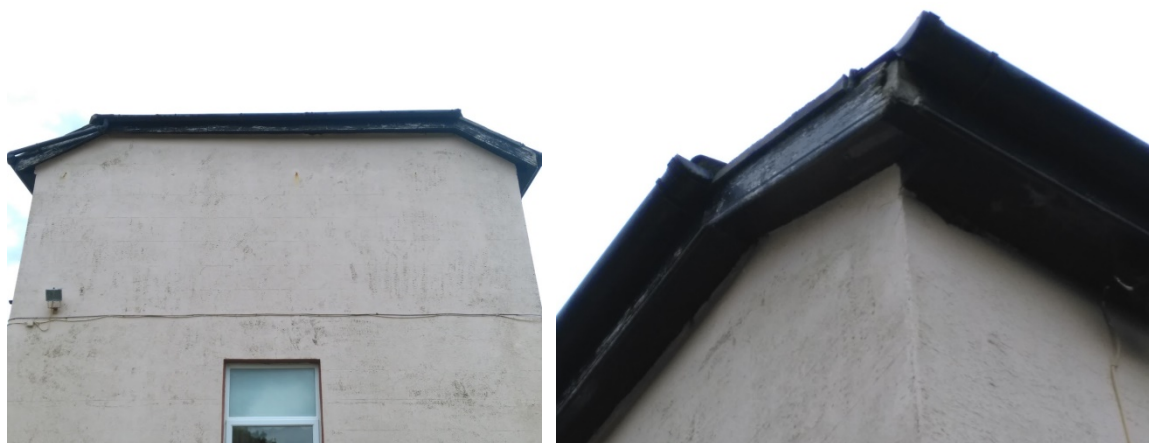
Photos 5 & 6: Side of house with significant plaster cracking and rotting fascia/soffit

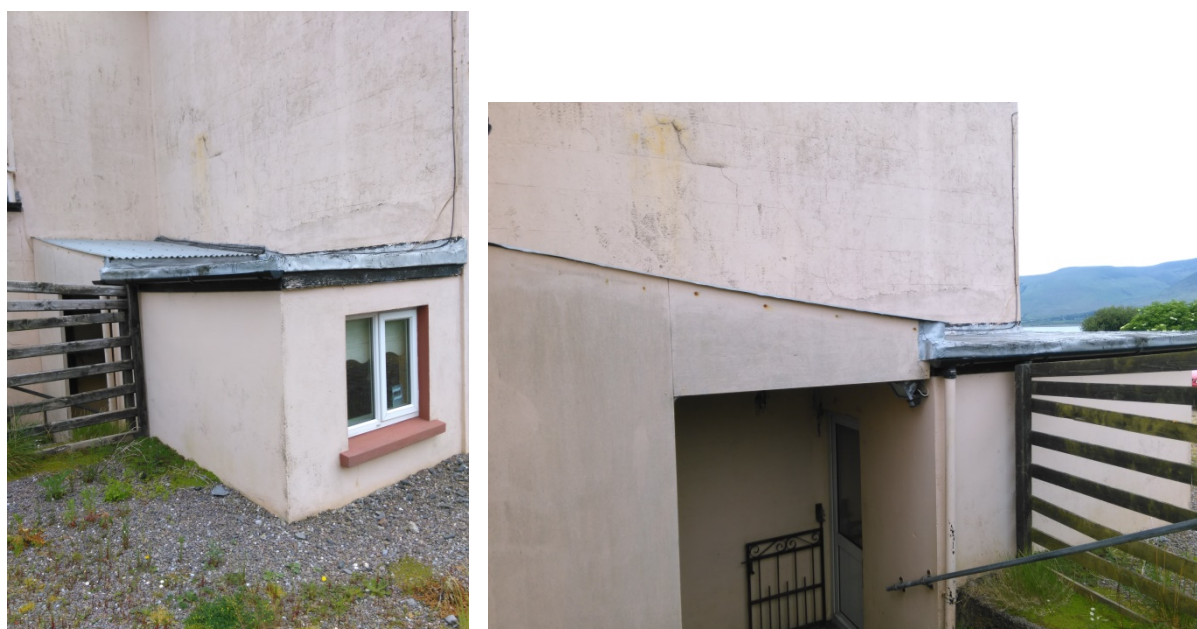
Photos 7 & 8: Poor quality extension and significant crack on wall

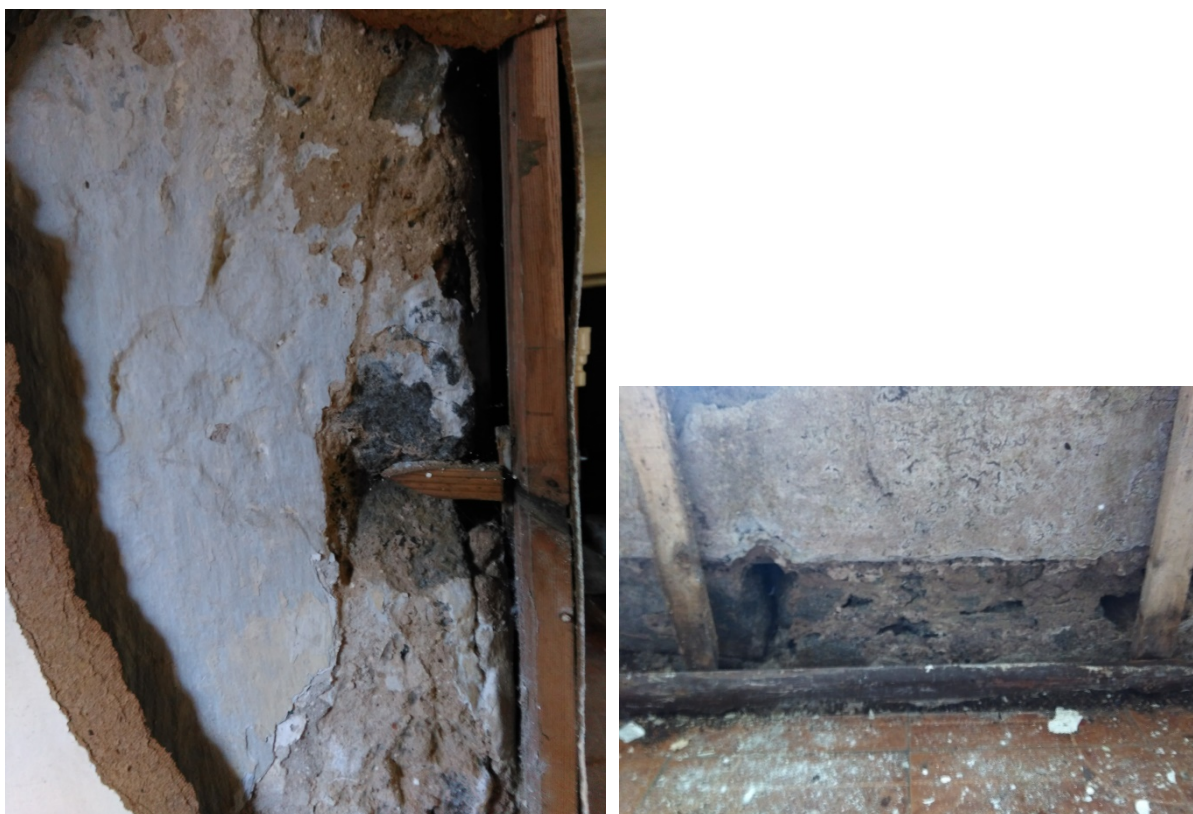
Photos 13 & 14: Evidence of sea gravel used in mortar, spalling and deterioration in the mortar

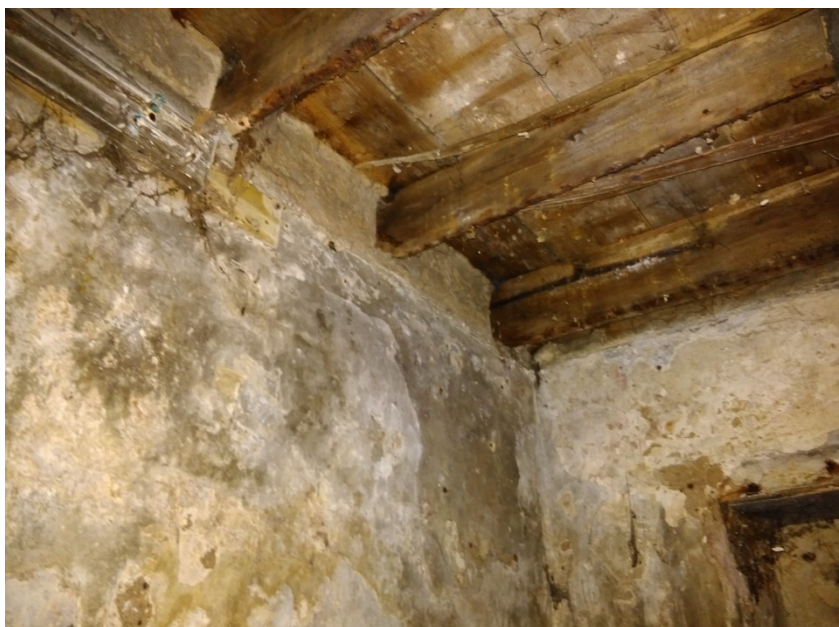
Photo 15: Rotting timber trusses and further evidence of deterioration in the walls

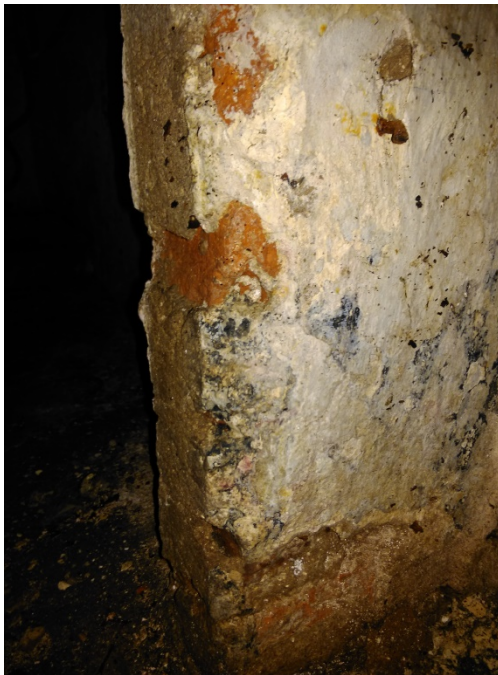
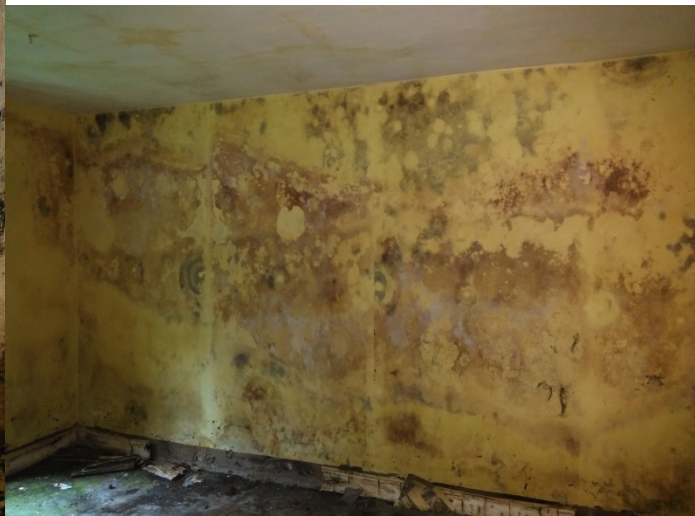
Photos 18 & 19: Further photos of the basement showing spalling, rising damp and rotten skirting

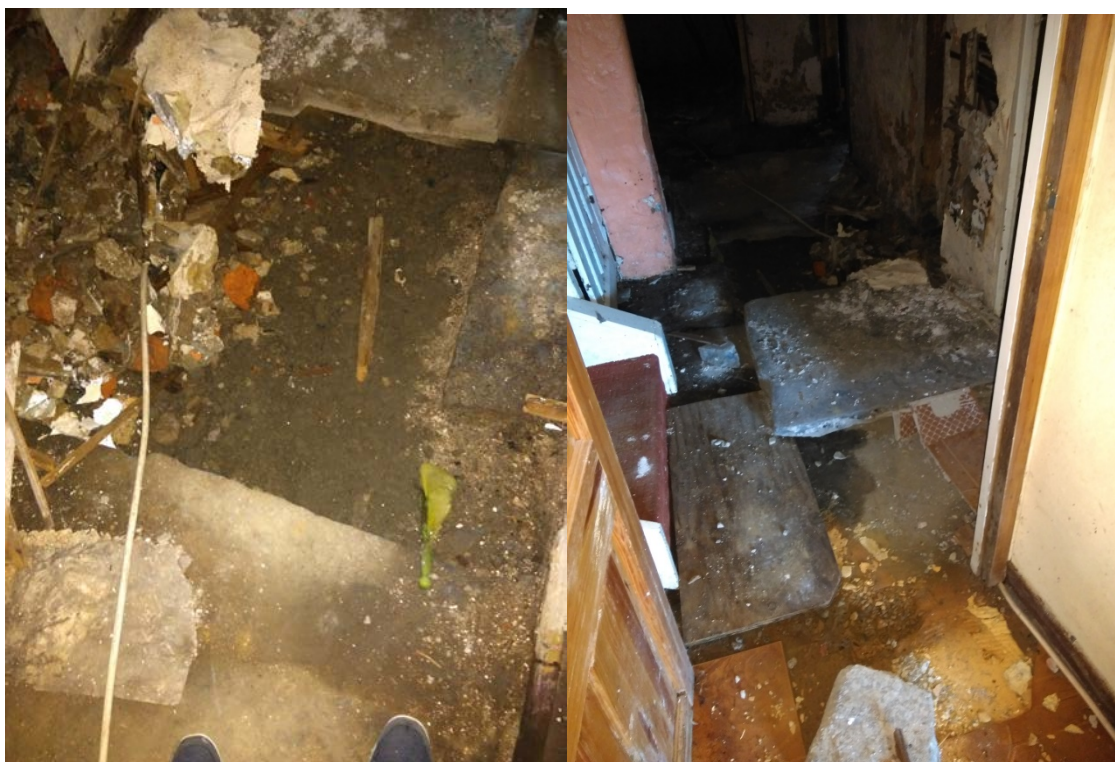
Photos 20 & 21: Excavation of floor to show earth foundation and evidence of flooding damage

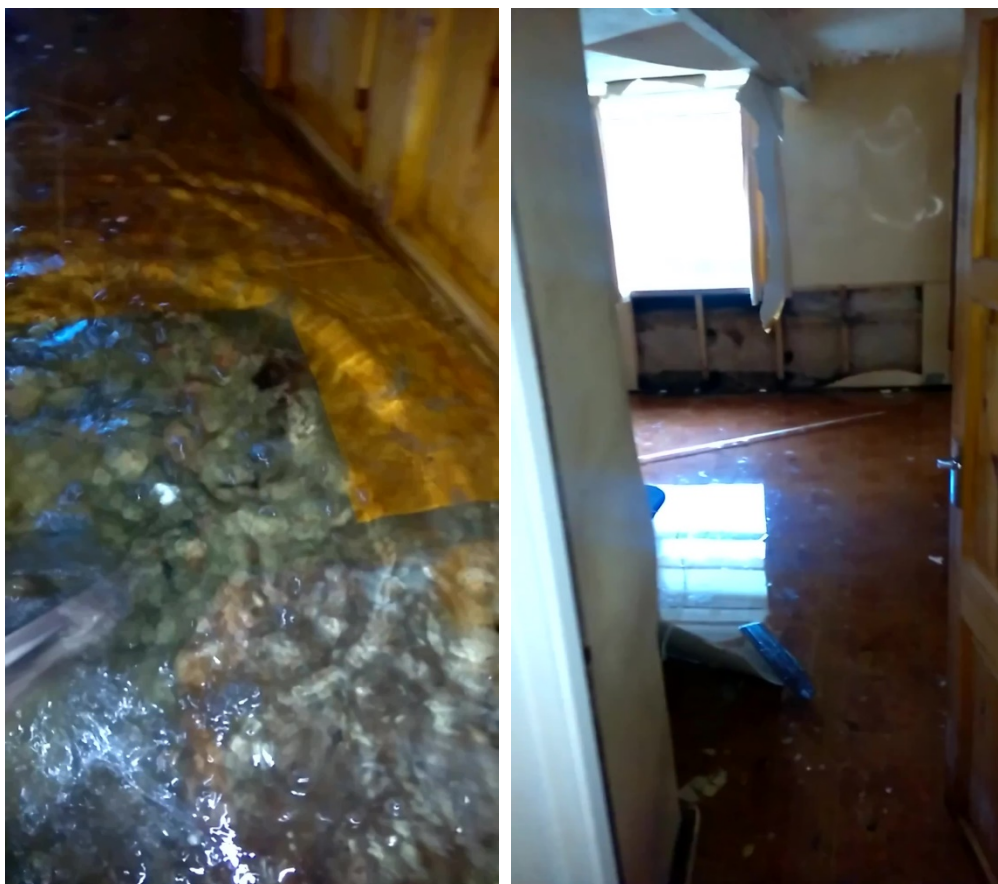
Photos 22 & 23: Stills taken from video recorded after flooding in December 2015

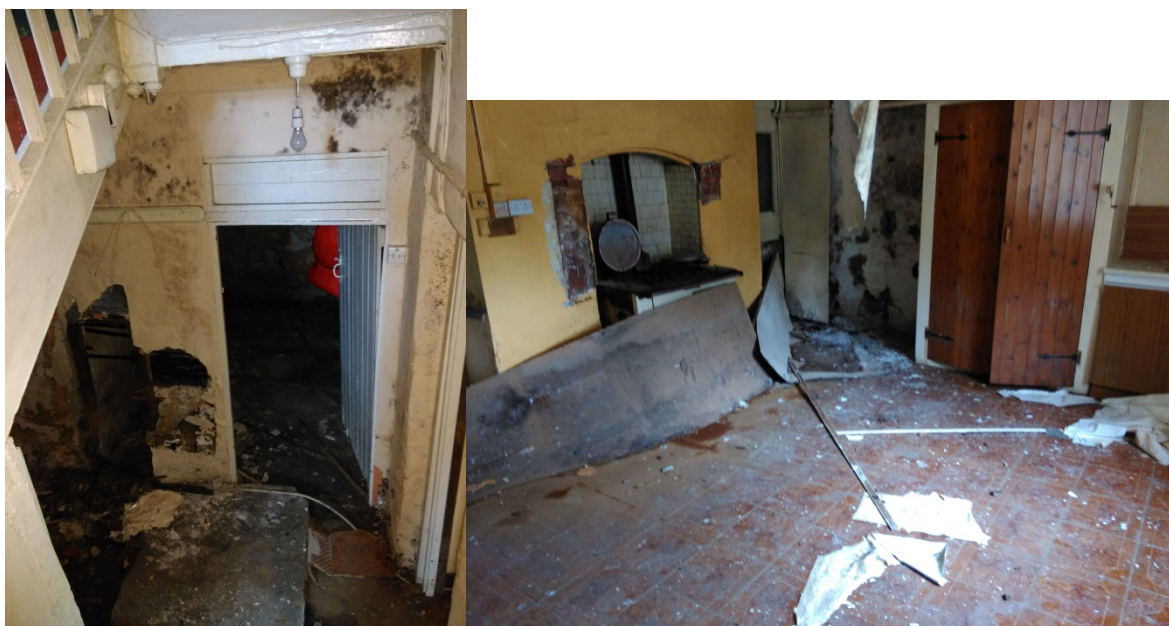
Photos 28 & 29: Basement with significant mould, dampness and water damage

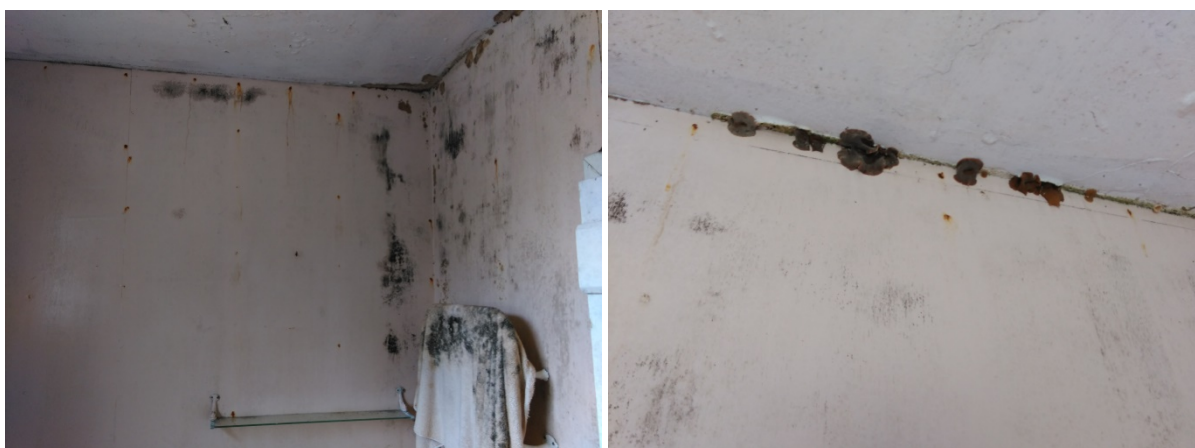
Photos 30 & 31: Further damp and mould in bathroom with growth of fungus

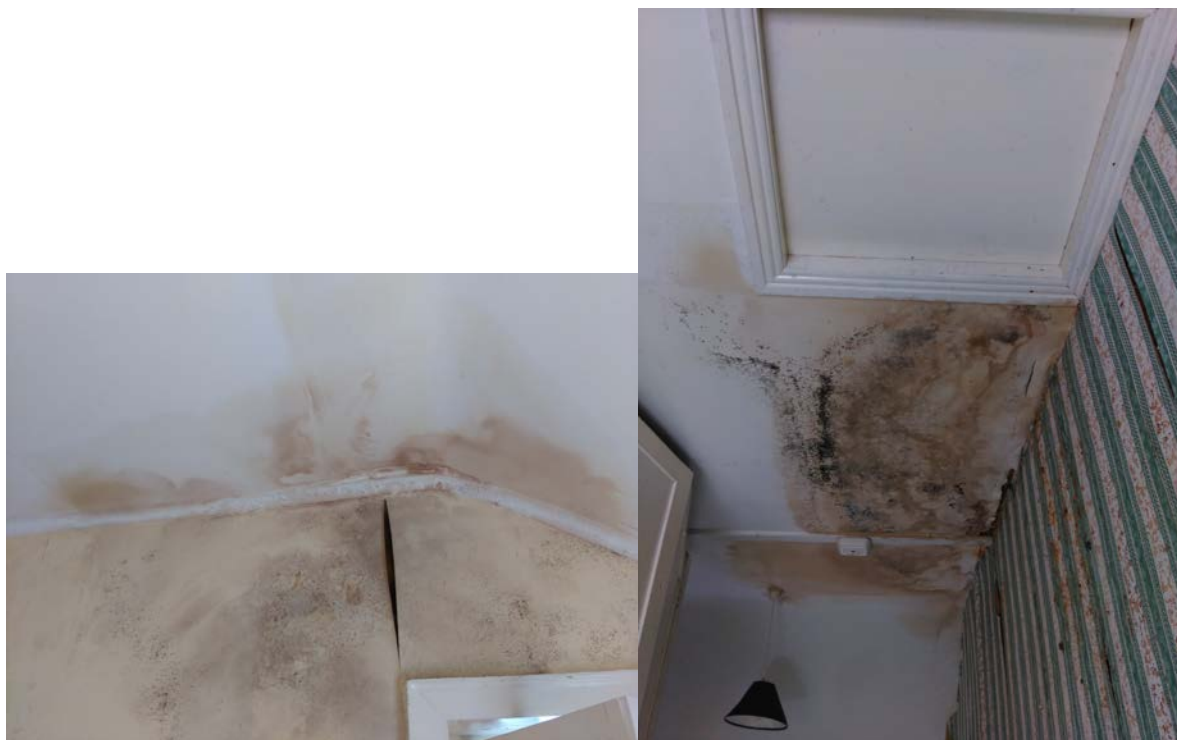
Photos 34 & 35: Evidence of water ingress and damage through the roof/ceiling

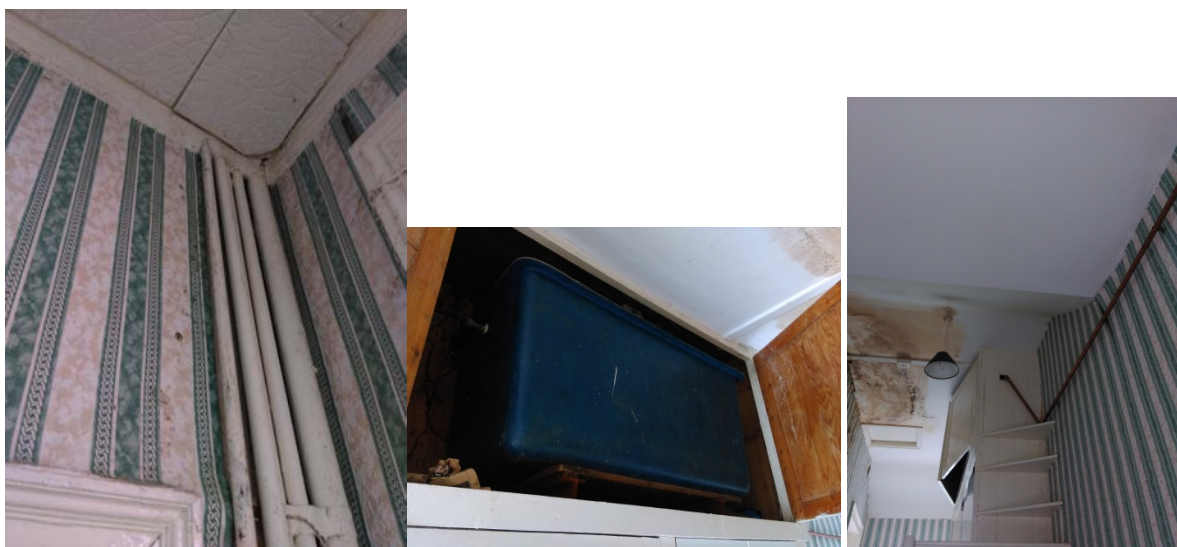
Photos 36, 37 & 38: Exposed plumbing and water tank in a press at top of stairs
