Bridge Name: Kingstown Bridge

Watercourse: Kingstown River (1.53 km upstream of Newvillage Bridge)

Date of Survey: 30.05.23 and 18.05.24

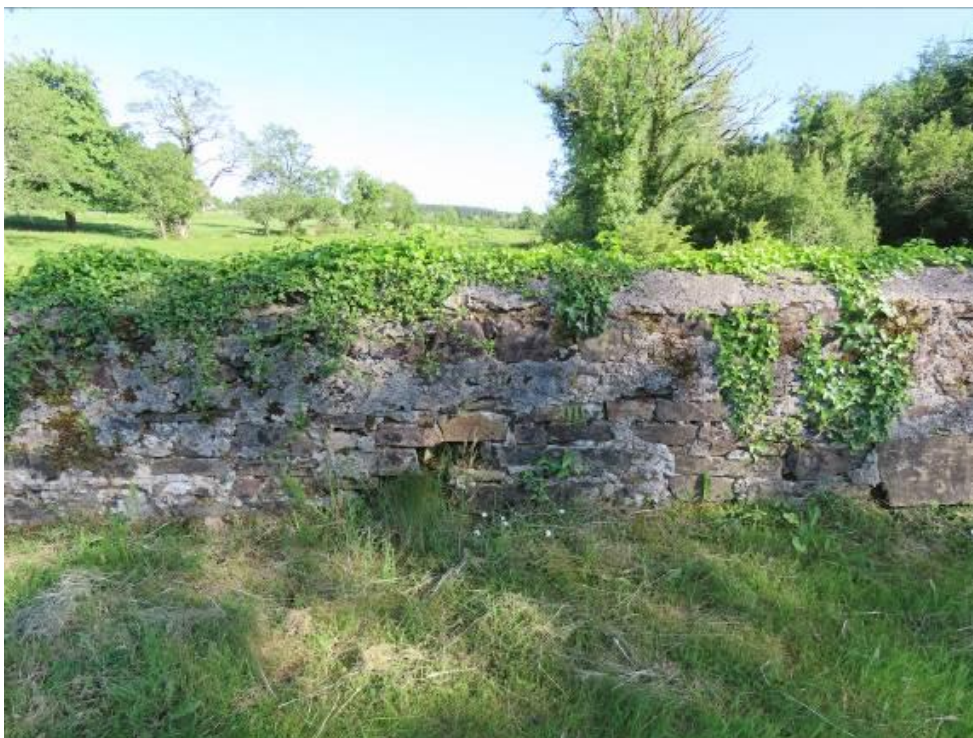
Photo 40 – damaged parapet wall

Proposed Works: Remove vegetation from bridge, repair and repoint masonry

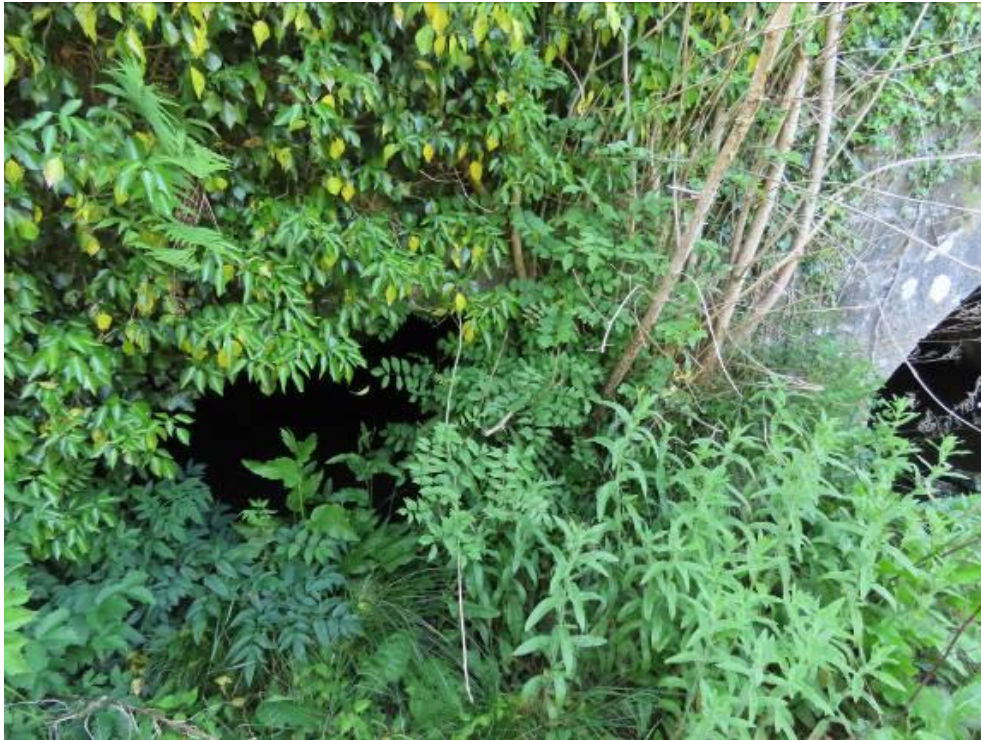
Description: Kingstown Bridge is a fine 5-arch masonry structure spanning the Kingstown River. It is situated to the south of the entrance to Kentstown House. The bridge walls are heavily overgrown with ivy. There is an Ash tree growing out of the bridge wall on southern side of bridge.

Photo 41 – westernmost arch obscured by vegetation

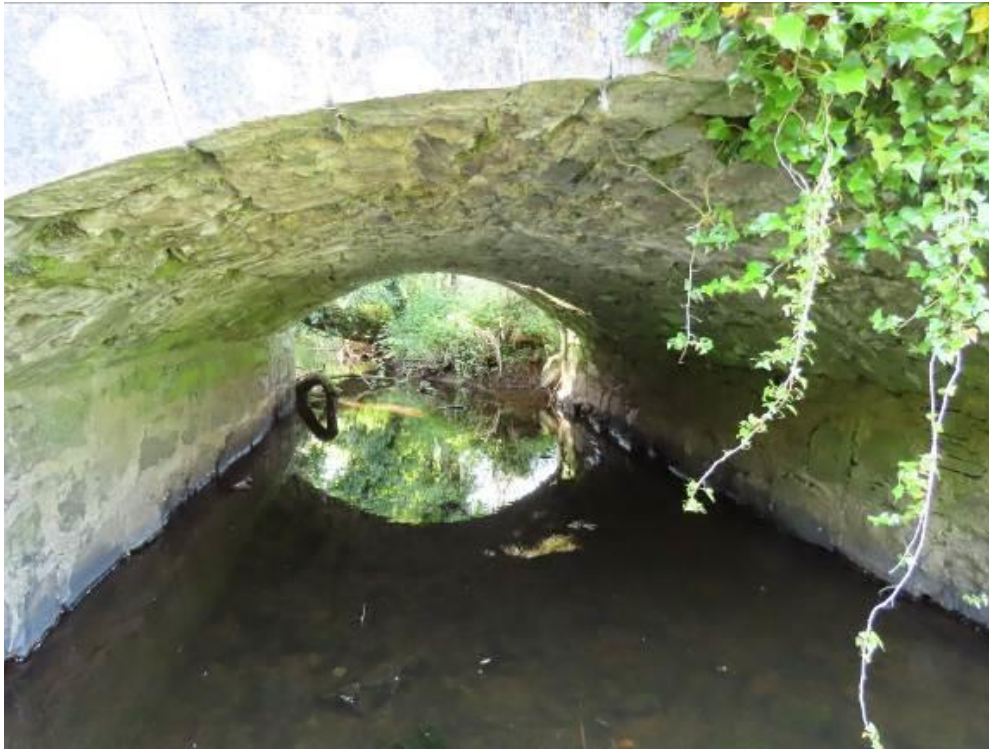
A single crevice was marked for bats under Arch 1. Otter prints were recorded in mud under the arch.

Photo 43 – view under arch 1

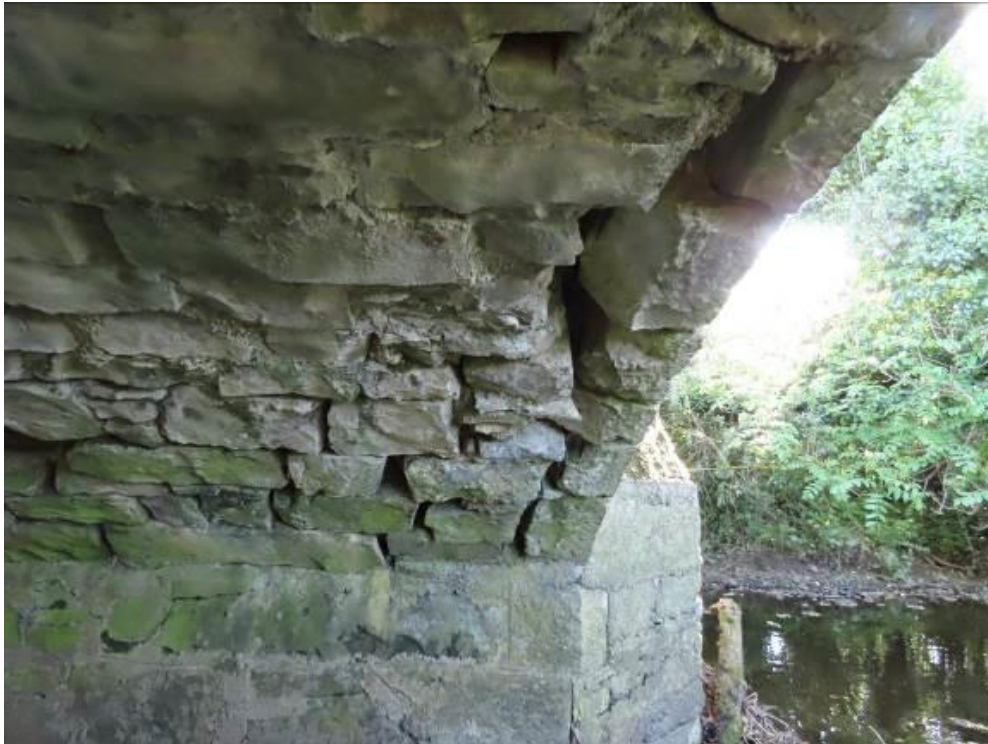
Arch 2 – Single Daubenton's bat in previously marked crevice midway under the arch. A second Daubenton's bat in a new crevice which was marked for retention. A third crevice was also marked for retention for bats. There is a severe crack behind the upstream facing stones.

Photo 45 – crack behind facing stones of Arch 2

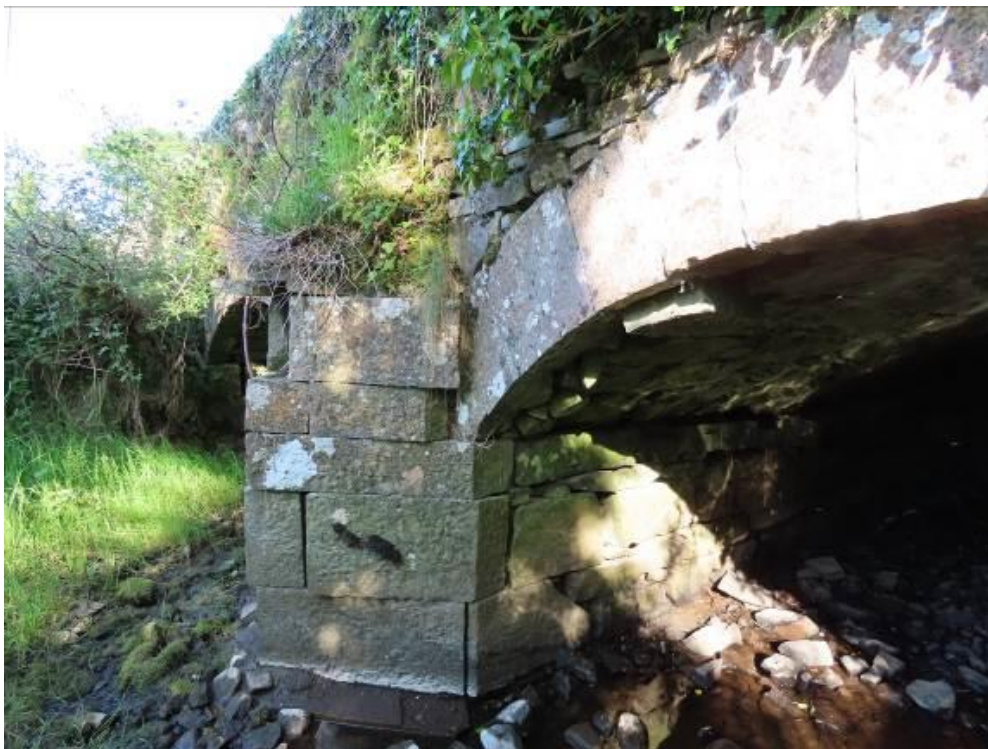
Photo 46 – damaged pier

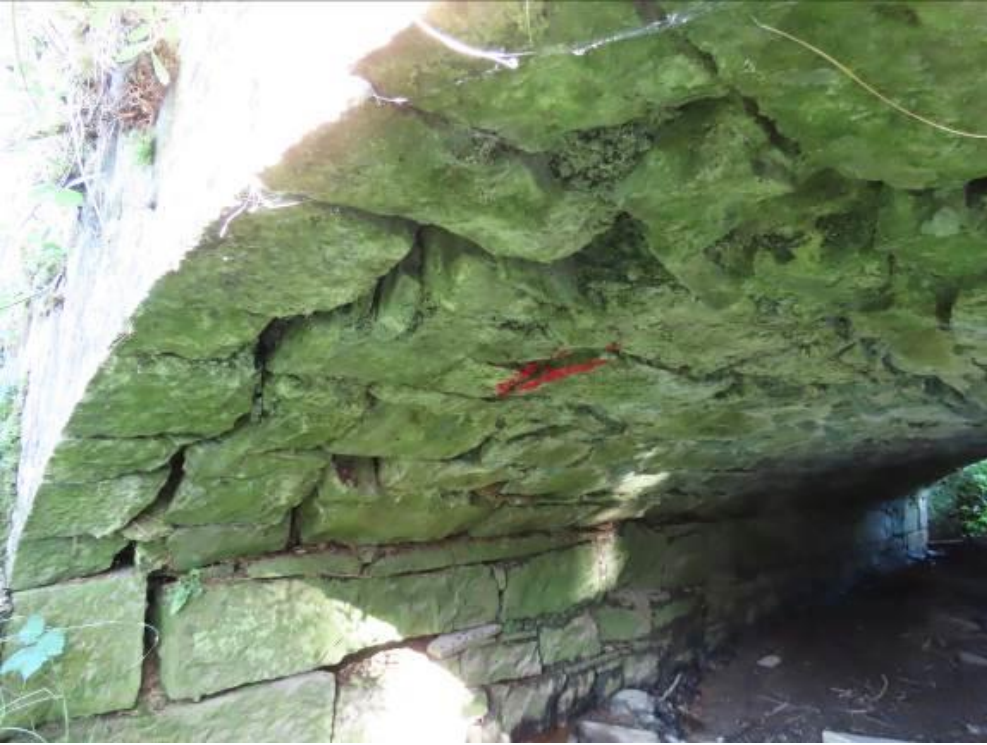
Photo 47 – crevice marked for retention

Recommendations: The proposed works to Kingstown Bridge will require a derogation licence from NPWS. No works will be permitted until mid-September 2024. Bridge to be re-surveyed immediately prior to works commencing. Works to be supervised by licenced ecologist. All marked crevices to be retained for bats.

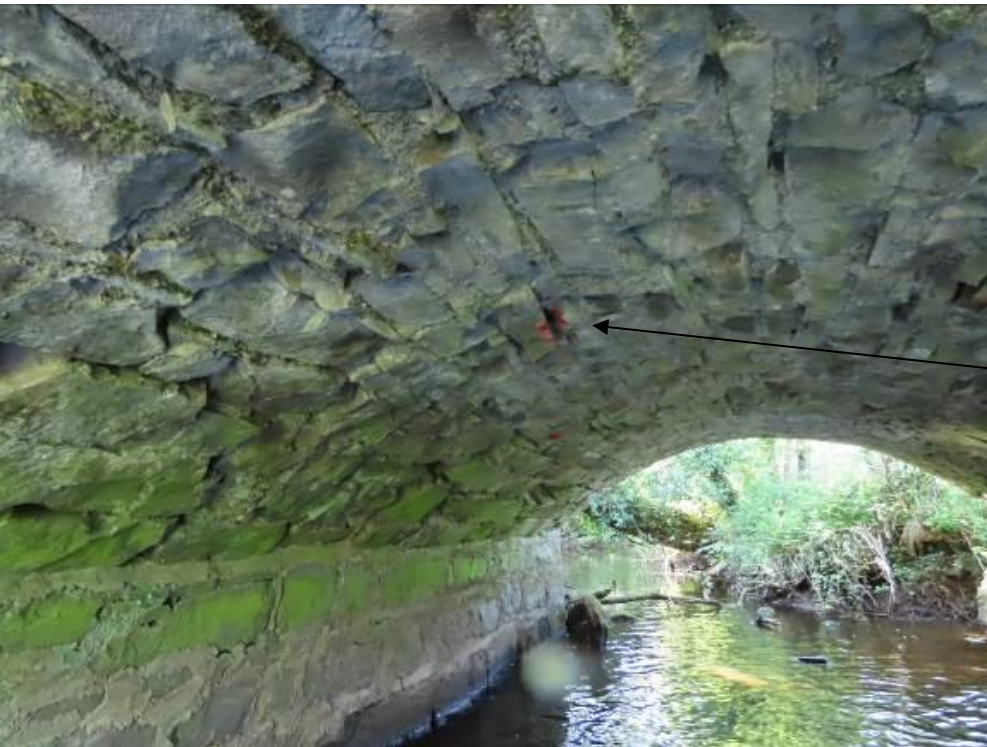
Arch 4 - Six crevices were marked for retention for bats under Arch 4. One of these crevices contained a single Daubenton's bat in 2023.

Photo 48 – crevice containing single Daubenton's bat under Arch 4

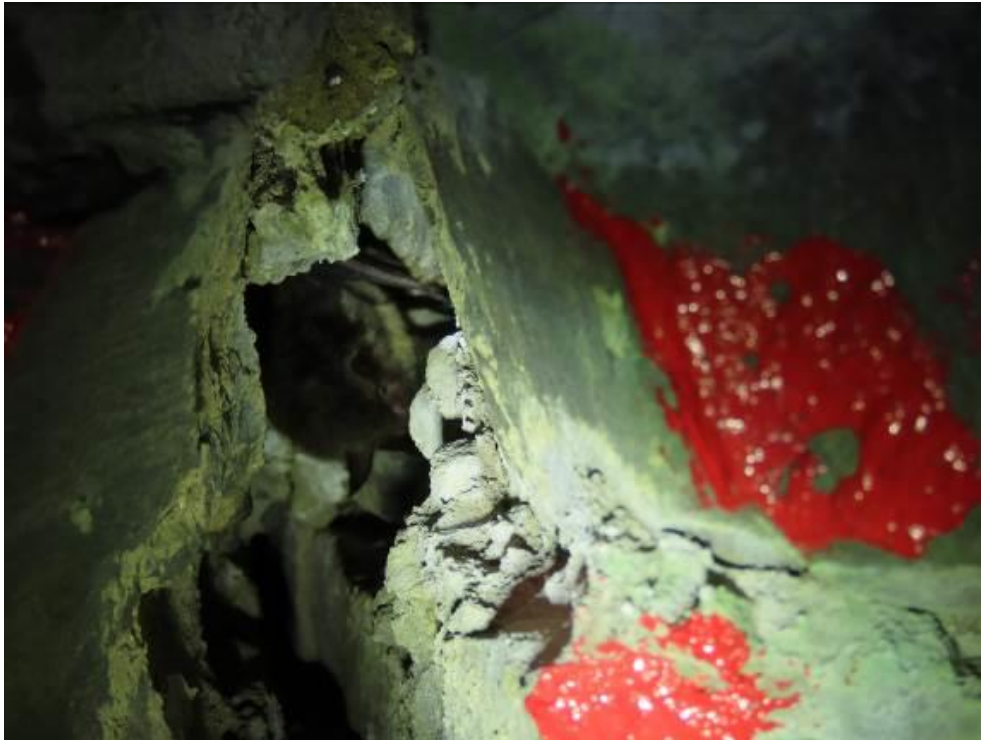
Photo 49 – Daubenton's bat in crevice under Arch 4

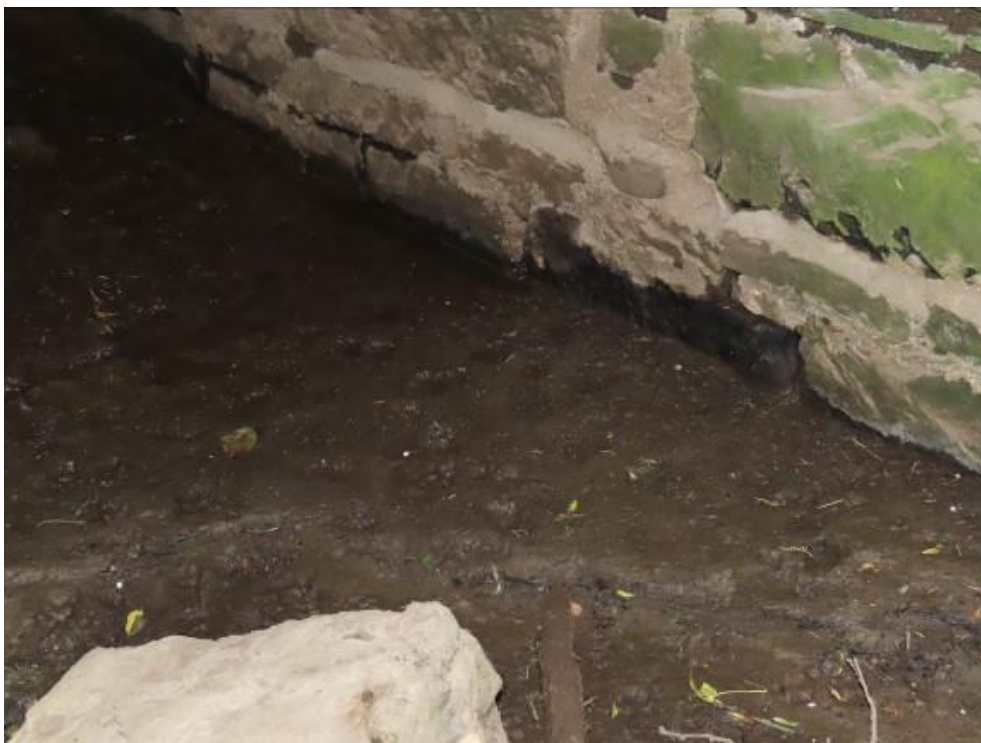
Photo 50 – Otter pints in mud under arch
