SECTION THROUGH THE TOP WINDOW

SOUTH ELEVATION EXTERNAL

Drawing Stage: Drawn By: Checked By: Approved By: Date: LE LE 25/01/2024 Information RK Project Details: Menlough Castle Project Name: Scale: Project Number: Menlough Menlough Castle, Galway Site Address: **Castle Galway Phase 4** NTS 20612 Galway City Council Drawing Title: Summary of Proposed Works Originator: Client: 11 Issued for Information 25/01/2024 RK Project: Zone: To The External South Elevation - Sheet 1 Architect: 7L Architects REV. No. REVISION DESCRIPTION DATE ISSUED BY CORA

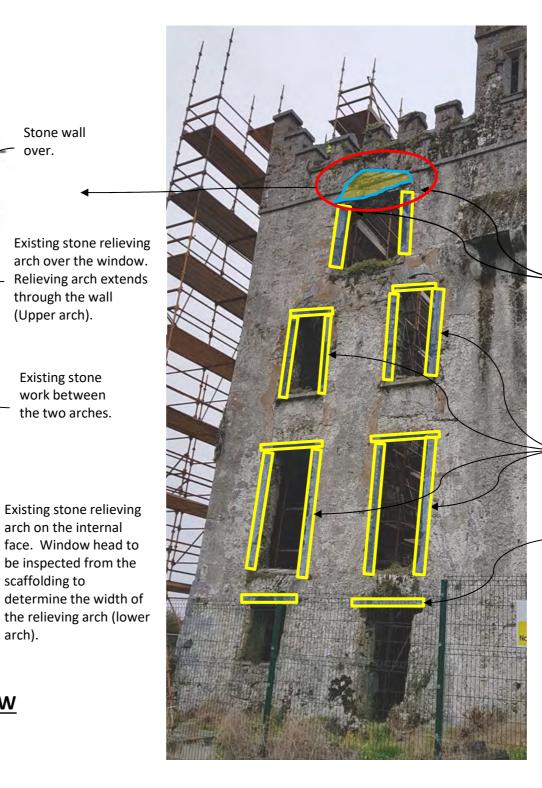
Existing stone work over the window is loose. Allow for fully recording all the stone in this area and carefully dismantle the stone work and store it on site. Consolidate and repair the underside of the upper arch when the stone is removed. Note deep repointing maybe required. Once the repair work to the lintel is complete, rebuild the section of wall exactly as is was, dry pack between the rebuilt section and the underside of the arch. Repoint the wall, refer to specification.

Stone wall over. Existing stone relieving arch over the window. Relieving arch extends through the wall (Upper arch). Existing stone work between the two arches. Existing stone relieving arch on the internal face. Window head to be inspected from the scaffolding to

100mm x 200mm (high) x 12mm (thick) stainless steel angle to support the stone work over. Stainless steel angle to be fixed to the precast lintels with 2 No. M12 stainless steel chemical anchors at 400mm centres, 65mm edge distance. Minimum embedment depth of 150mm. Fischer FIS V chemical resin.

215mm x 215mm precast concrete lintels over the window opening. Allow for two number precast lintels with the rough side facing up. Number of lintels to be confirmed on site. Note lintel weighs approx. 300kg each.

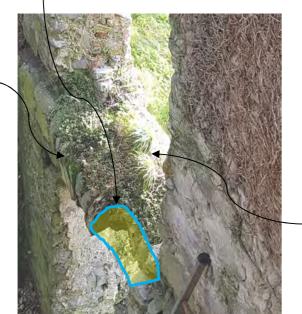
Vegetation to be carefully removed from the window cill and the stone work to be consolidated. The base of the windows to be flaunched to allow water to self drain. Note small stone may be required to reduce the width of the mortar joint. Note some of the existing cill stone may be cracked. Allow to 3 number crack repairs with M6 stainless steel dowels stitching across the cracks.

Missing voussoirs to be replaced with new stone to match the existing. Assumed sequence of works.

Temporary props to be installed to support the wall over. Temporary works to contractors design.

Timber formwork to be installed to support the arch.

Existing voussoirs to be number and record.

Damage voussoirs to be carefully removed.

New stone to match the existing, bedding on sand and packed with hot mix placed hot.

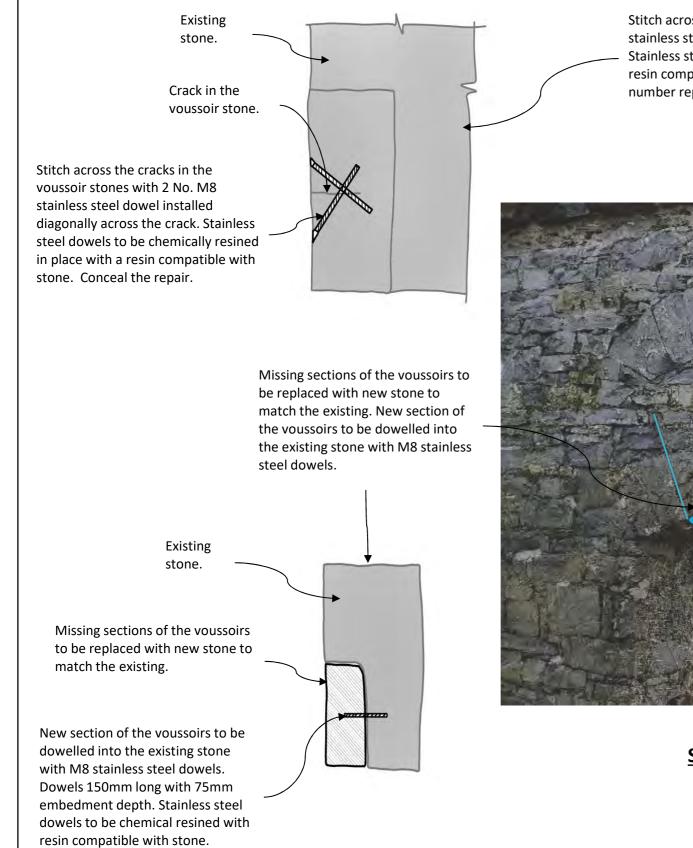
SOUTH ELEVATION INTERNAL

Allow for consolidation of the underside of the stone arch. Note deep repointing may be required with pieces of slate.

> Existing lintel to be inspected on site. Allow for four number 215mm x 65mm precast lintels with one number 100mm x 100mm limestone lintel on either side, number of lintels per opening. Dry pack between the new lintels and the existing stone. Wall over to be temporary propped during the works. Repair the wall over once the temporary works have been removed.

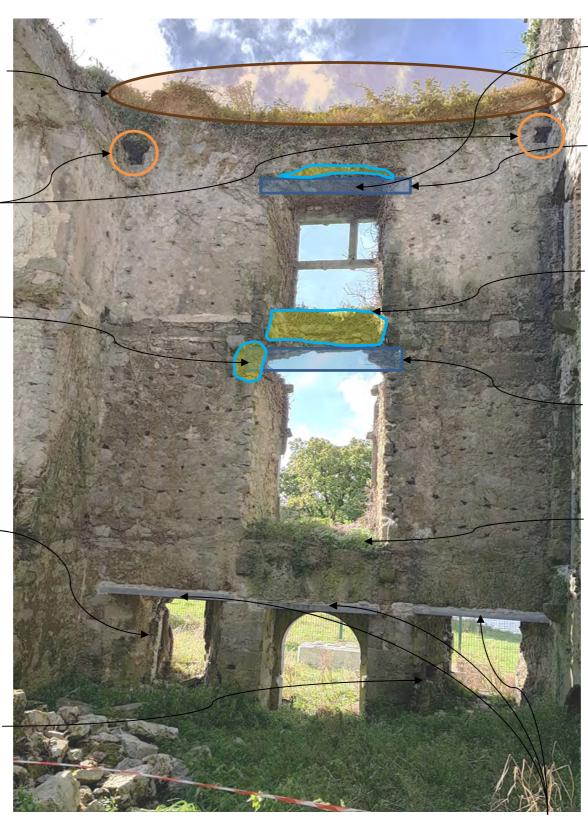
SOUTH ELEVATION EXTERNAL

Existing lintel missing. Allow for five number 215mm x 215mm precast lintels or 215mm x 215mm cast insitu lintels (4H16 with H10 links at 100mm centres per lintel) with one number 200mm x 100mm limestone lintel on one side. Dry pack between the new lintels and the existing stone. Wall over to be temporary propped during the works. Repair the wall over once the temporary works have been removed.

Vegetation to be removed from the base of the window and the stone work consolidated. The wall below the cill is to be inspected once the scaffolding is erected. Allow for new stone work to match the existing to be keyed into the existing wall. The base of the window is to be flaunched to allow water to self drain. Note small stone may be required to reduce the width of the mortar joint.

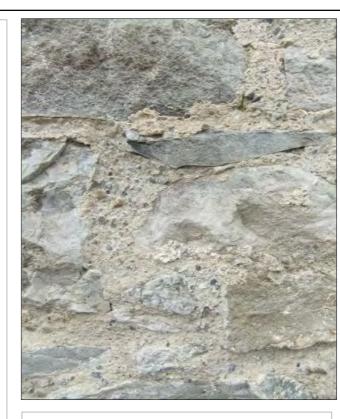
Example of flush pointing in stonework beaten back to expose aggregate
