Summary of findings from the **Survey of Potential Turloughs 2015**

Report for:
NPWS, 7 Ely Place, Dublin 2

Volume I: Main Report

October 2015

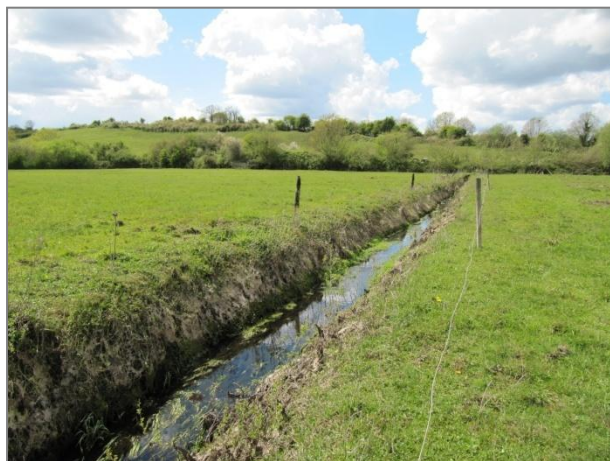
NTSV14_Photo_022_17_FON_01a.jpg
17 Drains

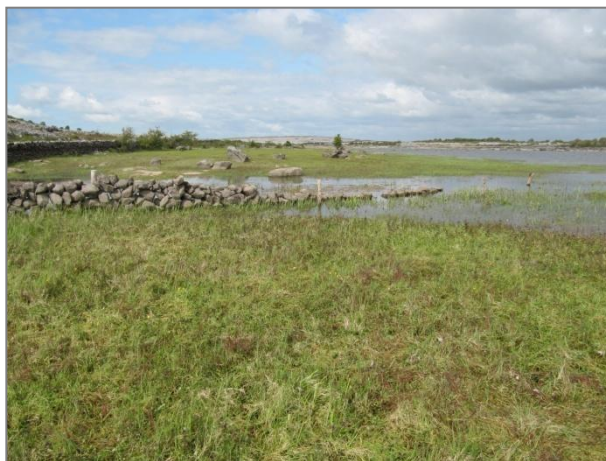
NTSV14_Photo_019_18_FON_01a.jpg
18 Discontinued hedges/walls

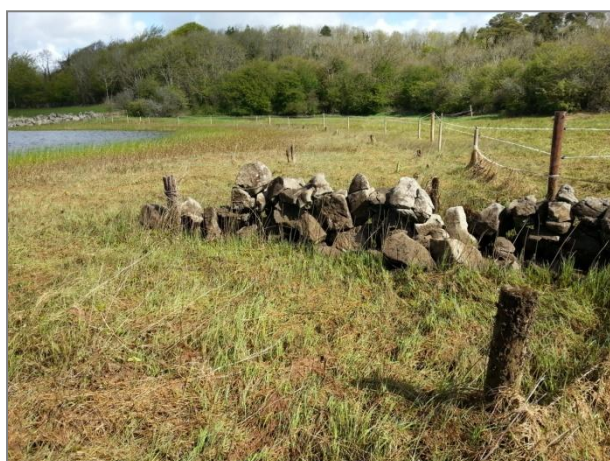
NTSV14_Photo_040_18_JM_01a.jpg
18 Discontinued hedges/walls

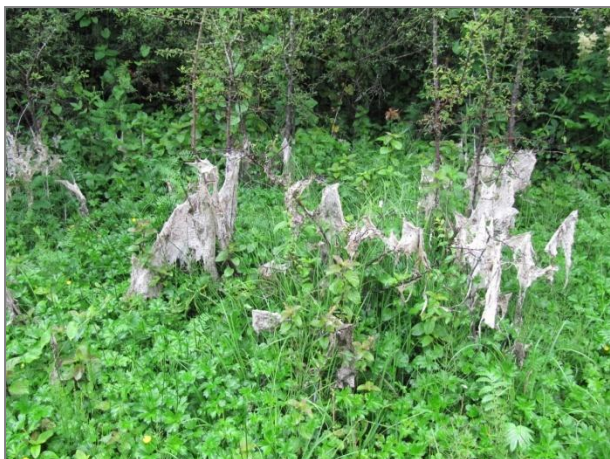
NTSV14_Photo_560_20_FON_01a.jpg
20 Algal paper

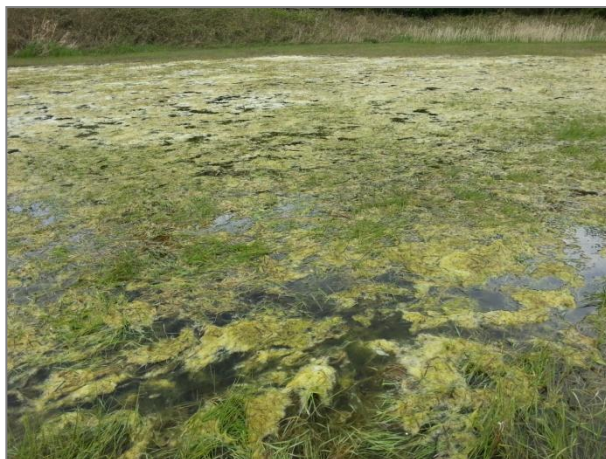
NTSV14_Photo_531_21_JM_01a.jpg
21 Evidence of nutrient enrichment

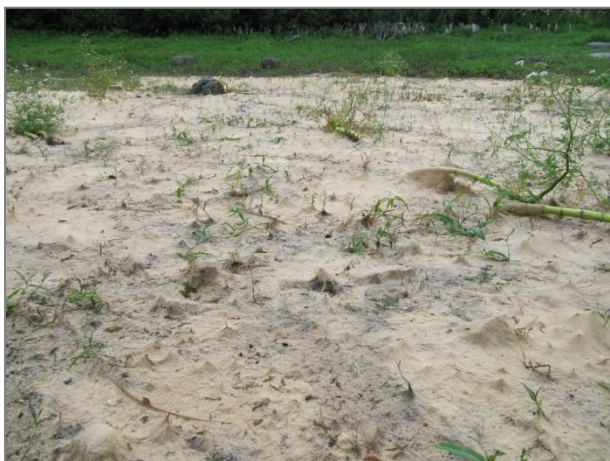
NTSV14_Photo_560_21_FON_01a.jpg
21 Evidence of nutrient enrichment

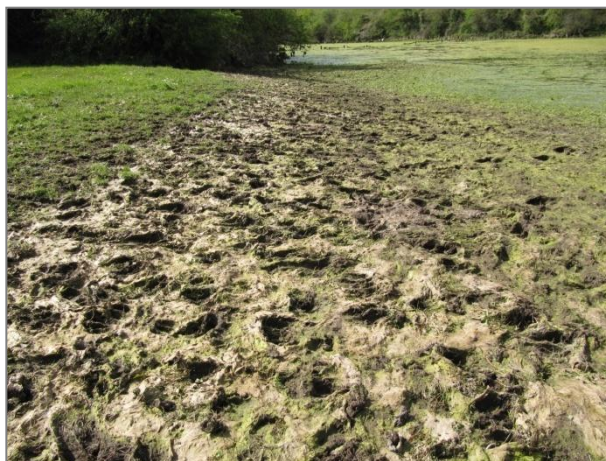
NTSV14_Photo_021_22_FON_01a.jpg
22 Evidence of ecologically unsuitable grazing

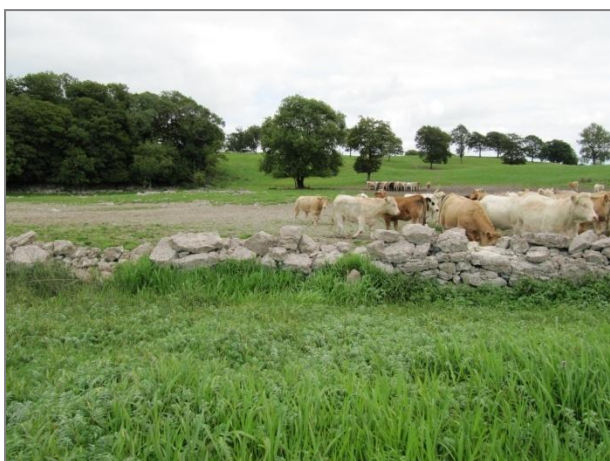
NTSV14_Photo_469_22b_FON_01a.jpg

22 Evidence of ecologically unsuitable grazing
