Memorandum

Project Title	Markievicz Bridge Repair Works	From	Kevin O'Riordan
Project No	224138	То	Sligo County Council c/o Michael Ryan
Subject	Scope Extents	Сс	n/a
Doc. No.	224138-PUNCH-XX-XX-FN-CS-0001 S4.P01	Date	07/03/2024

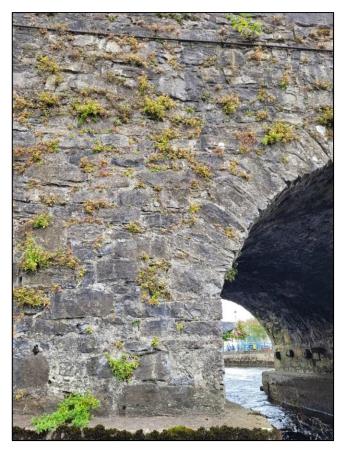
During detailed inspection, the vegetation on both elevations of the bridge was determined to be minor in nature and not affecting structural condition of any bridge component. As such it was not classified as damage, and consequently there is no associated proposed repair. Refer Figure 2 below of typical vegetation to bridge elevations.

Figure 2. Typical minor growth vegetation to bridge elevation

This option would see all vegetation removed and effected mortar joints repointed locally. It is conservatively assumed that this work, were it to be done at a later date outside of the current project, would be screened in for AA owing to the use of lime mortar directly above a receiving water within an SAC.
