CUNNANE STRATTON REYNOLDS

## TREE SURVEY

Wildlands,  
Moycullen,  
Co Galway.

June 2024

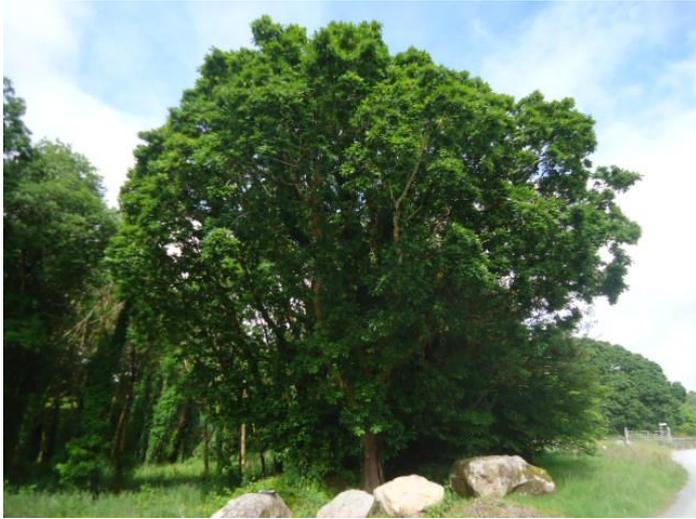
T18

2.3 There are three individual high quality mature Oak trees located within the site area, (T18/T19/T23). Between these there are a number of tree groups which vary in quality and species. Three groups (TG2, TG3 & TG5) are composed almost exclusively of young native Ash trees which have regenerated on the infilled land, but are now unfortunately dying due to Ash Dieback disease. Two groups of native Hazel (TG1 & TG6) hug the existing access road to the east while a group (TG4) composed primarily of native Silver Birch with occasional Ash and Goat Willow hugs the stream along the western boundary. At the northern end of the site a group of Goat Willow. Finally a mixed group (TG7) located at the northern end of the site is composed primarily of Goat Willow but also with some Rowan and Wild Cherry present.

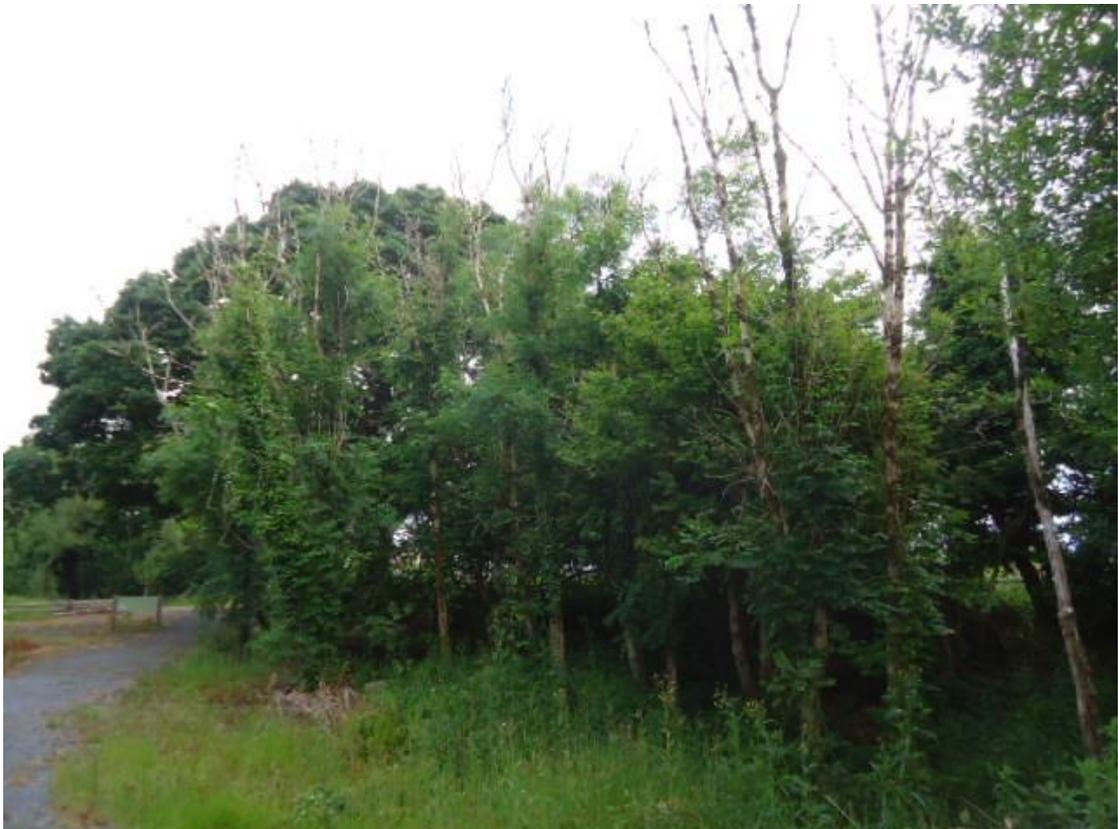
TG2

3.2 Category 'U' trees are recommended for immediate removal, (fell or monolith to safe height), on general management grounds, irrespective of site development – three tree groups (TG2/TG3/TG5)) were identified as such during this survey due to advanced Ash Dieback.
