# **Traditional Farm Building Scheme: St. Mura's, Fahan, Buncrana, Co. Donegal**

**Bat survey and assessment**

Site:	Lamberton Farm, St. Mura's, Fahan, Buncrana, Co. Donegal
Structure:	Byre
Project reference:	TF1662
Grid reference:	NV 52103 89007
Bat species present:	None
Roost location:	N/A
Bat access:	N/A
Proposed work:	Roof replacement
Impact on bats:	Bat roost disturbance
Bat survey by:	Aengus Kennedy

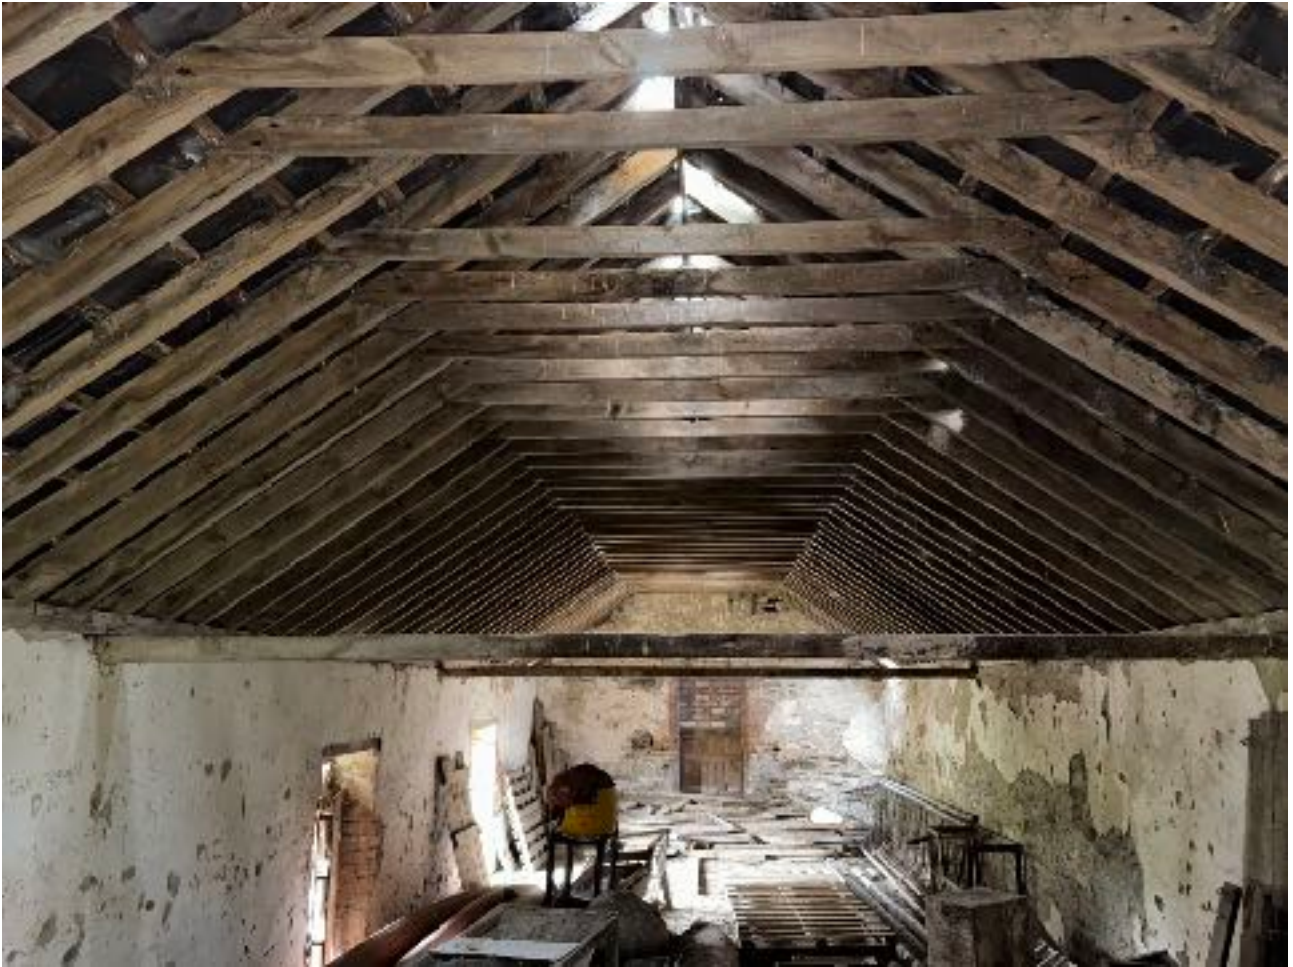
Inside upstairs of Lamberton's barn looking towards southern gable end and leisler roost. Note the lack of cobwebs.

- Bat boxes are recommended for the south side of the building when construction is completed. These will provide some alternative to the many cracks in between the bricks that are currently present. The south gable presents an opportunity for large bat boxes that could be used by the current leisler bat roost.

- Two bat access bricks should be built into the wall on the south gable end. One should be close to the apex, the second 1 metre below on the south eastern edge of the building.

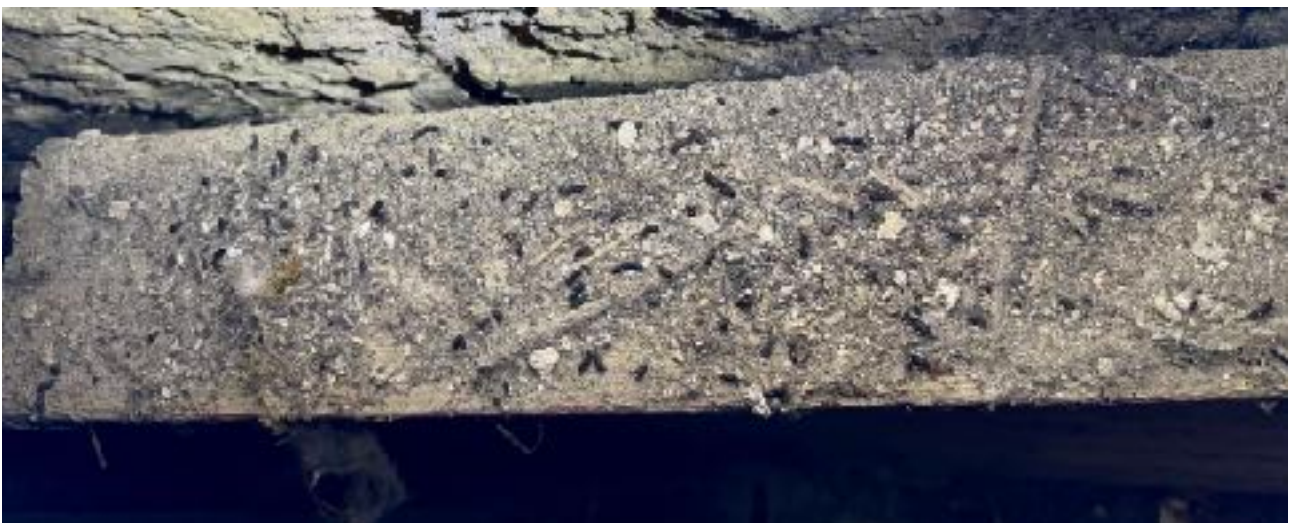
A small number of bat droppings were found scattered through the barn. A concentration of large bat droppings were found in one small area under a gap between rafter and wall that was clear of cobwebs. A small number of insect wings were observed near these droppings at the north end of the building. The rafters were clear of cobwebs. All of these signs indicated possible bat presence.

Bat droppings under potential single brown long-eared bat roost

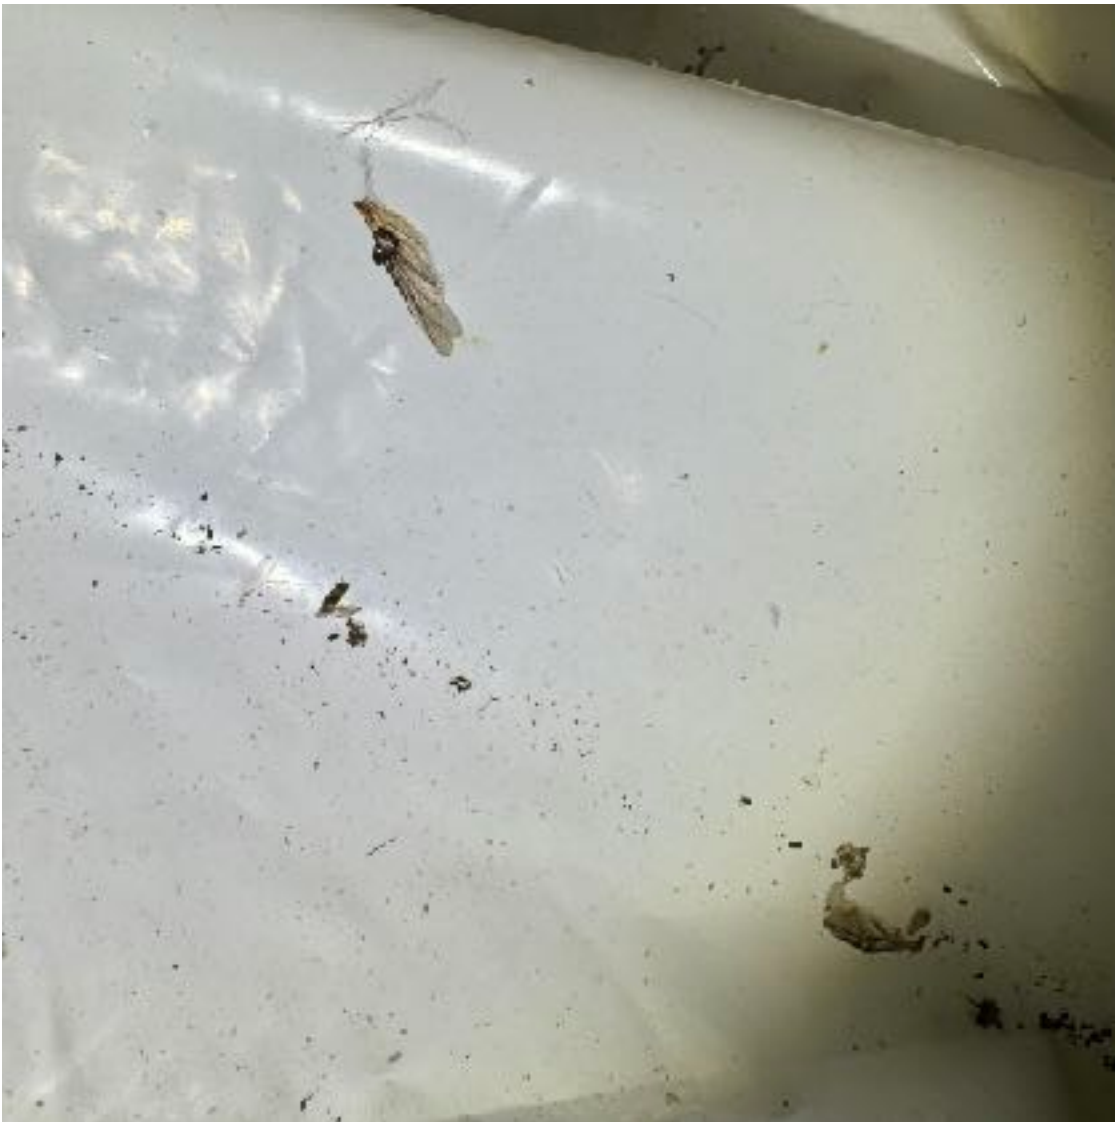
Insect wings as potential evidence of bat use in the upstairs floor of the building

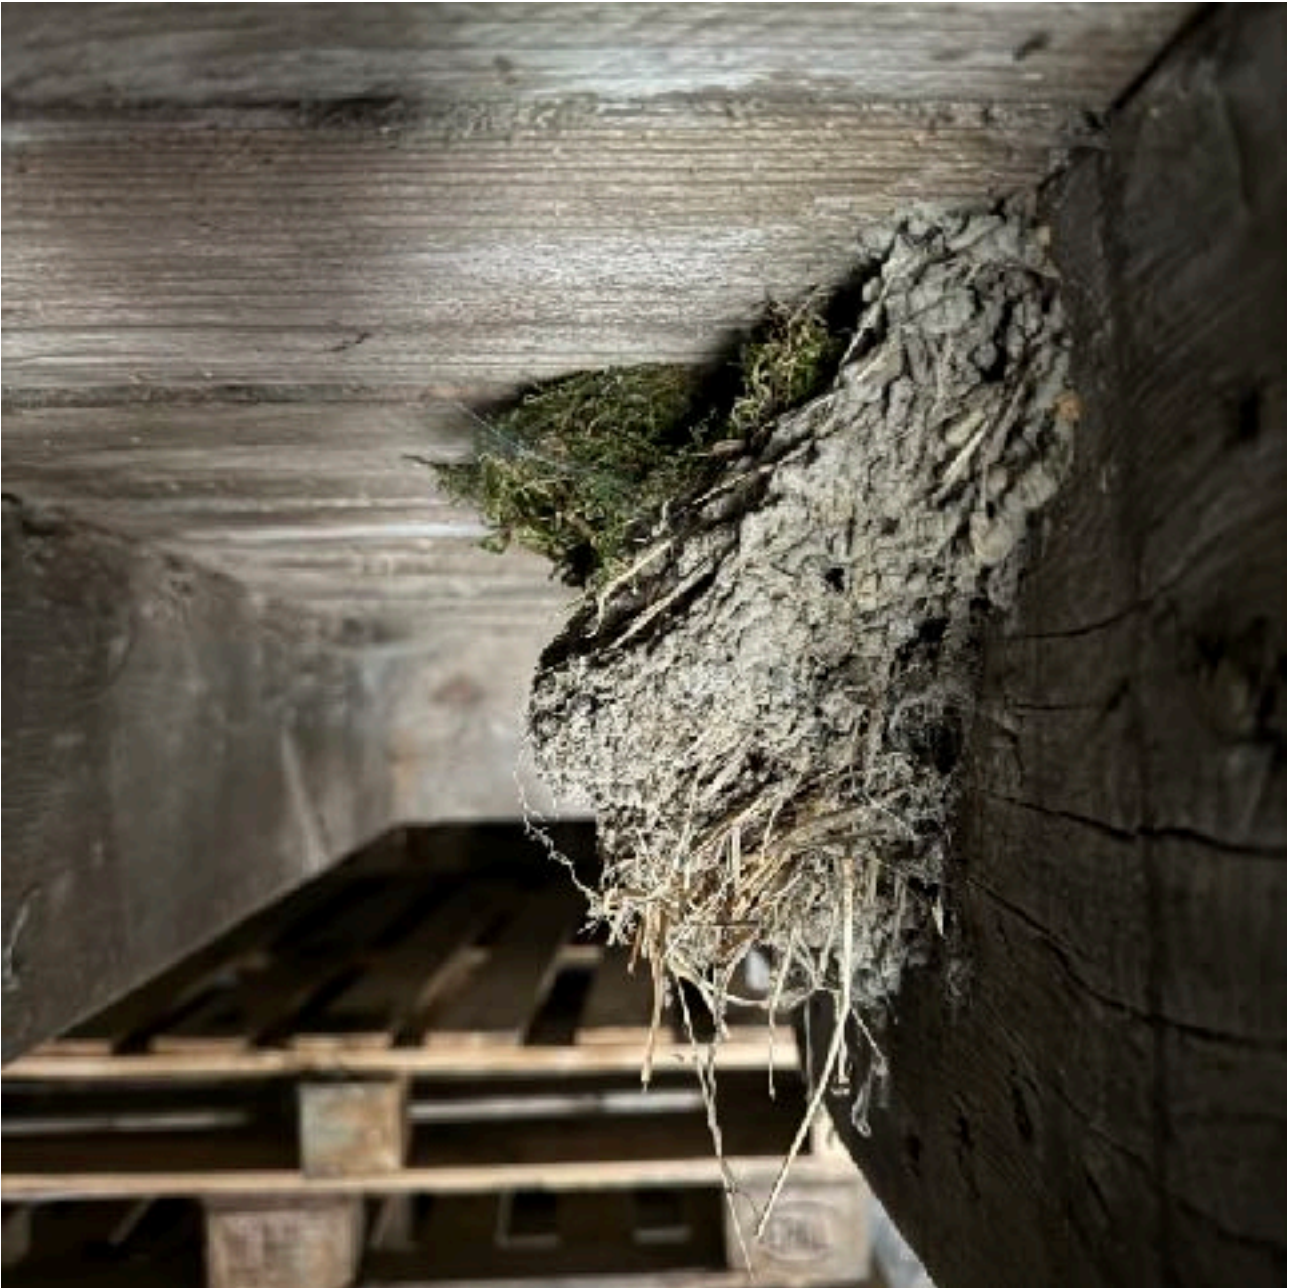
Fresh (2024) wrens nest built on old swallows nest

- Bird boxes, both large open fronted and regular small holed are recommended for the north side of the construction and on some of the surrounding trees when works are completed.
