Draft response to Clondegad

We acknowledge receipt of your Section 54 derogation licence application for a dwelling at Clondegad, Ballynacally, Co. Clare. The Department is of the opinion that the report accompanying the application does not adequately address the conservation concerns and mitigation requirements for the annex II species Lesser Horseshoe Bat.

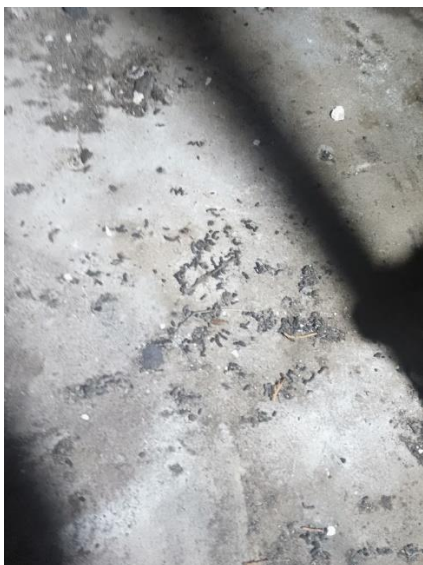
There was evidence of this species utilising the sheds during survey, this was further verified by the presence of bat droppings found in the loft and adjoining sheds. The further information request asked for a survey of the house, which was provided. The landscape is a rich bat landscape and activity was recorded, especially by Lesser horseshoe bats in this courtyard, behind the house and in the sheds. Historically, according to local people bats were always associated with these sheds.

Bat droppings in the loft of the shed (November 2024)

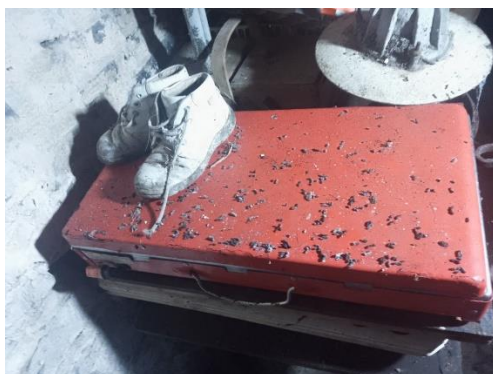
bat dropping in the shed which the loft opens out to (November 2024)

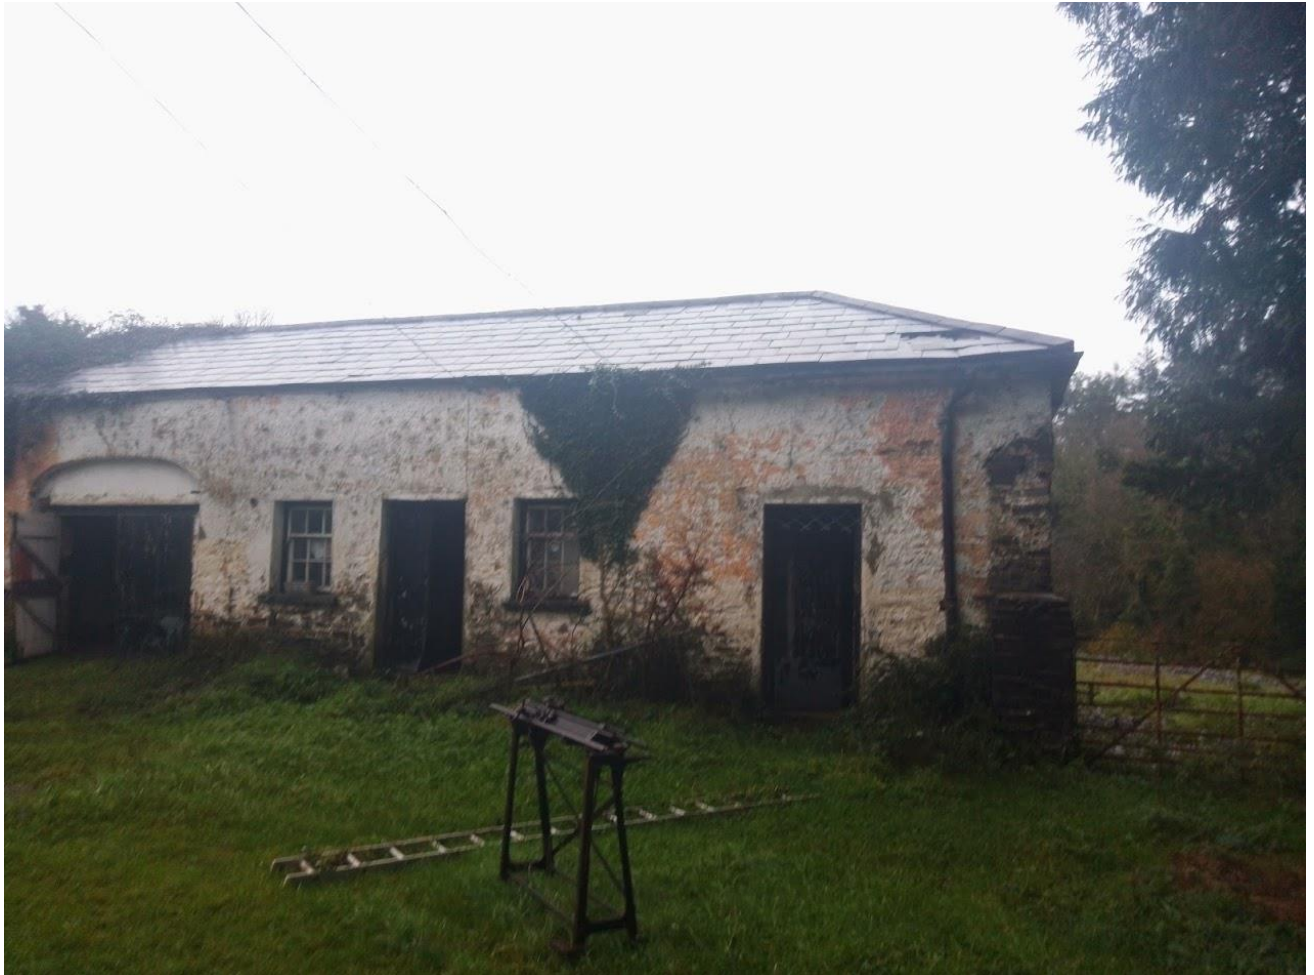
Sheds from the front, (Facing south) from the right is the cart house which the loft opens out to.

In the middle section with two windows is the space below the loft.

To the left is a cow byre which is closest to the Owenslieve River as seen it is adjacent to treelines and riparian vegetation.

Access will be improved by leaving windows open and cutting sections from existing doors.

Some maintenance is required with the floor of the loft requiring strengthening and missing slates replaced.

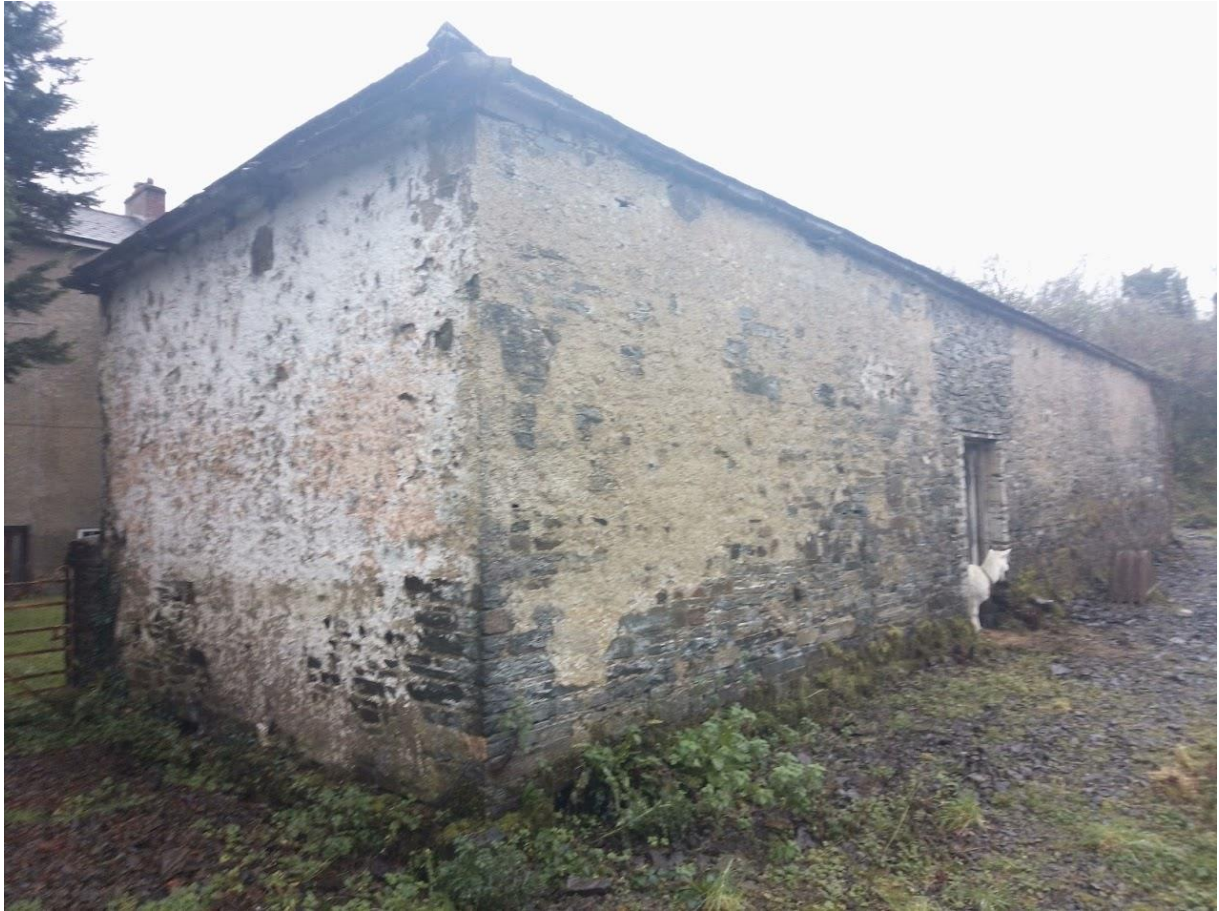
The back of the sheds (Facing North) showing the access to the area below the loft. (where goat is). This area is to be enhanced with shrubs and standards planted from the doorway towards the near corner, as this would connect the roost with the Owenslieve River.

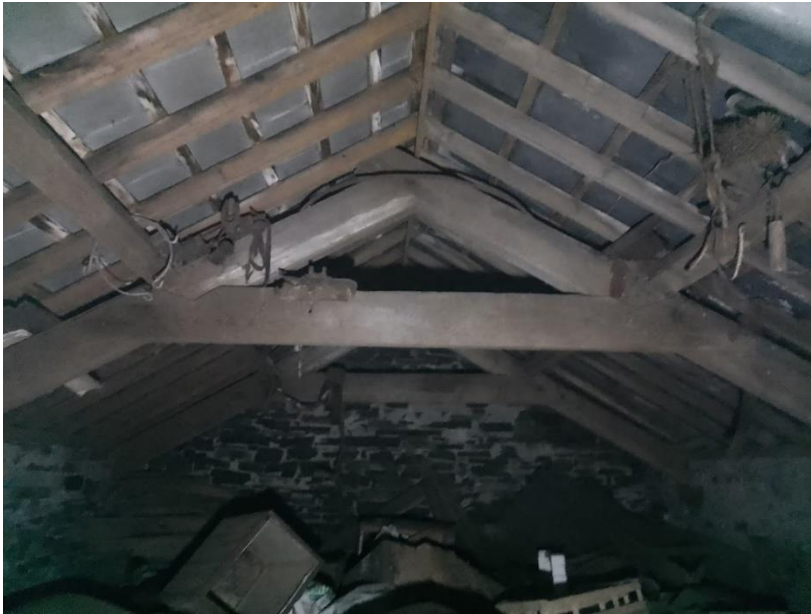
Internal view of the loft space, showing the roof in good condition with good roosting areas.

4. **The floors of the loft are in a poor condition and unsafe.** Strengthening and supporting the floor from below would be the safest and most efficient method of achieving this.

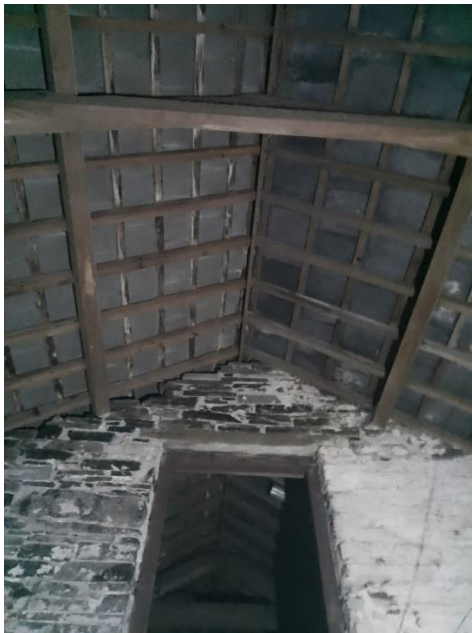
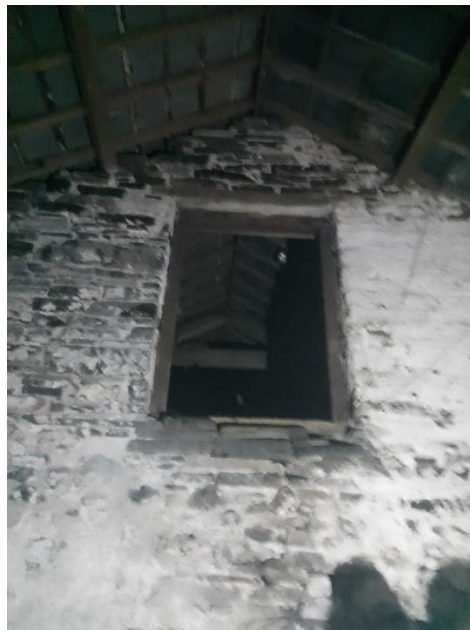
The loft door from the loft to the cart shed giving good secure access for Lesser horseshoe bats. Externally windows and doors have spaces that accommodate this species flying to roost.
