**Bat survey and building inspection,
Main Street, Kiltyclogher, Co. Leitrim**

For: dhb Architects, Waterford

October 2023

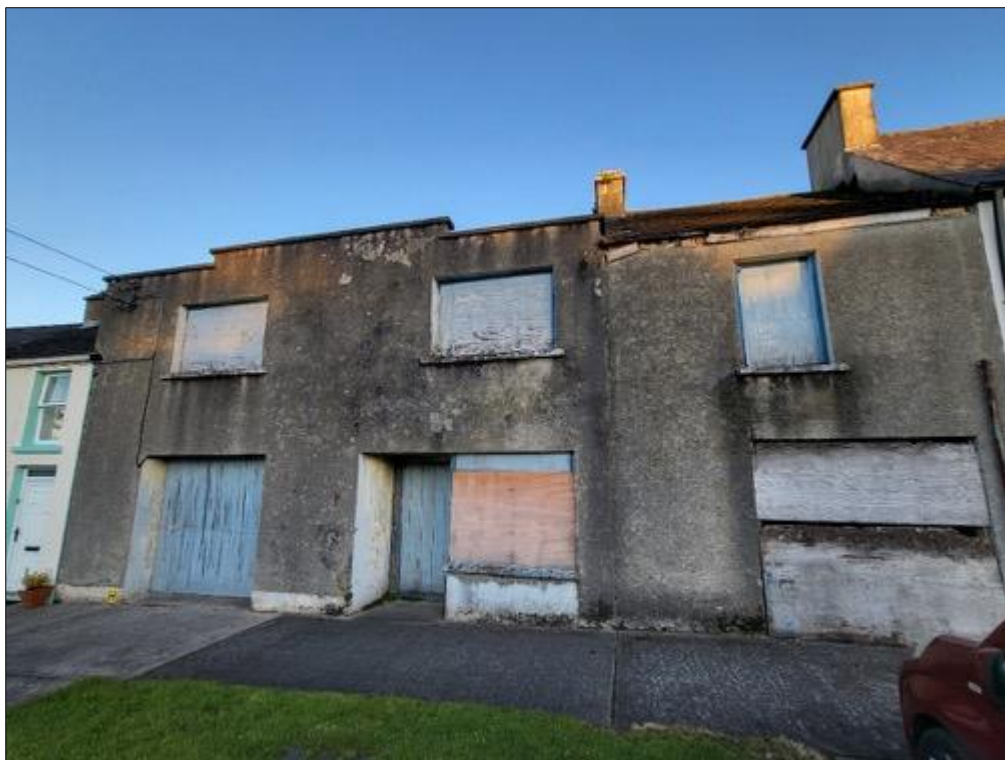
Figure 2. *View of the front of the site, taken from Main Street.*

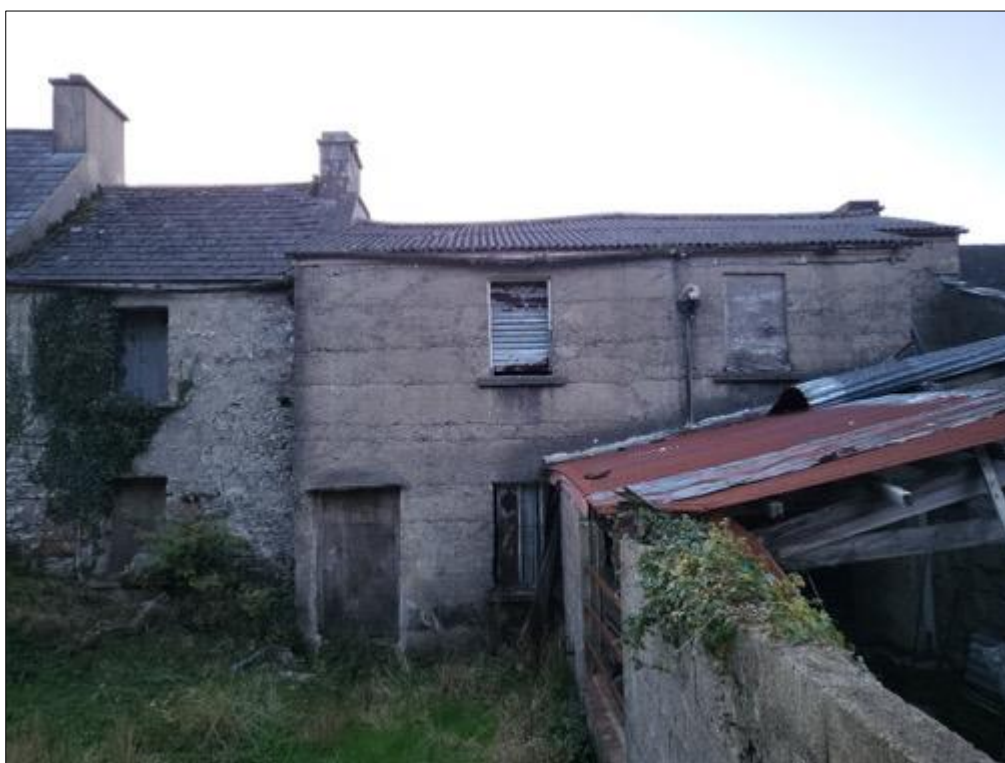
Figure 3. *View of the rear of the site, taken from the back garden.*

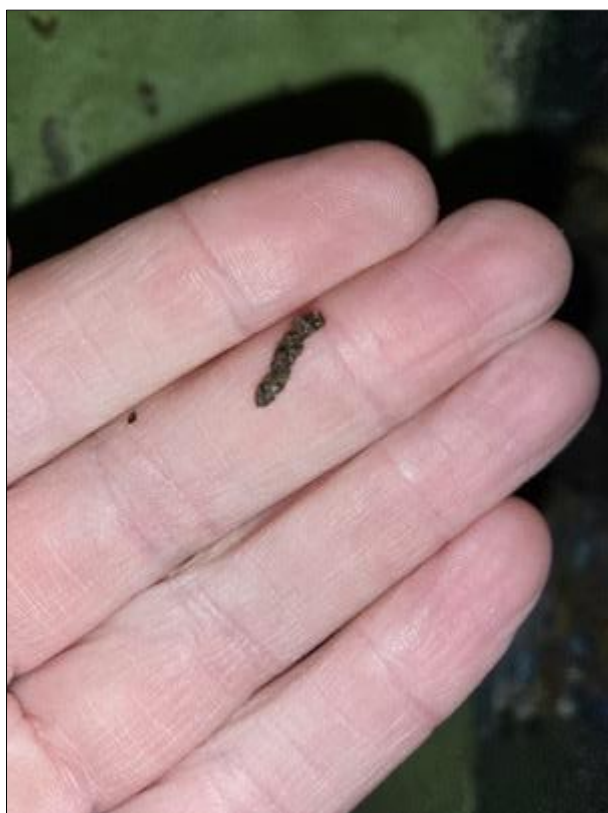
Usage of the building by bats was confirmed by the presence of scattered bat droppings on both the ground floor and the stairs. The droppings were both old and fresh with most of them belonging to brown long-eared bat *Plecotus auritus*, *Figure 4*. Discarded moth and butterfly wings were noted in piles inside the building, indicating a feeding perch by this species, *Figure 5*. Additionally, smaller droppings, characteristic of pipistrelle species, were also noted scattered around the stairs and on the accessible section of the wooden second storey floor. A live bat was noted roosting in a crease of hanging roof felt, directly over the stairs, *Figure 6*, prompting the surveyor to immediately withdraw from the building to avoid creating any disturbance. The species of this bat is unknown.

Figure 4. *Brown long-eared bat dropping.*

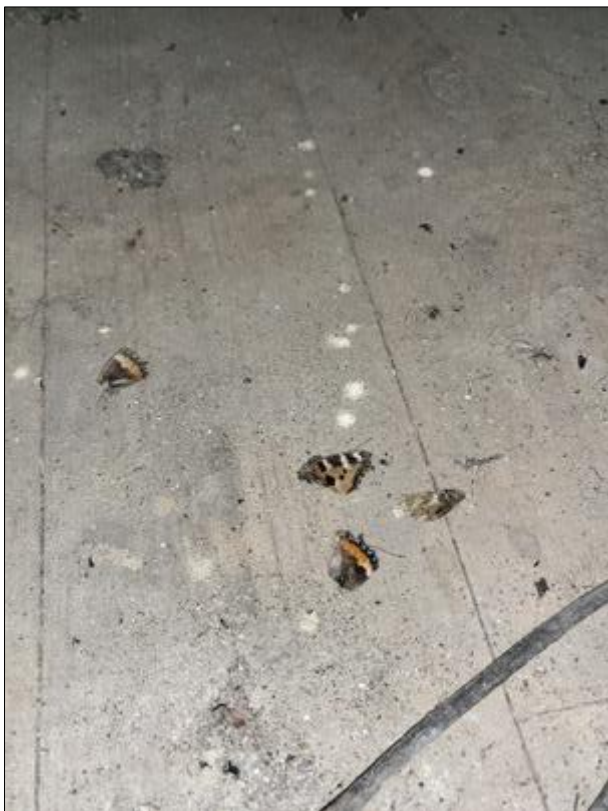
Figure 5. Discarded butterfly and moth wings on second storey floor. Indicative of a brown long-eared bat's feeding perch.

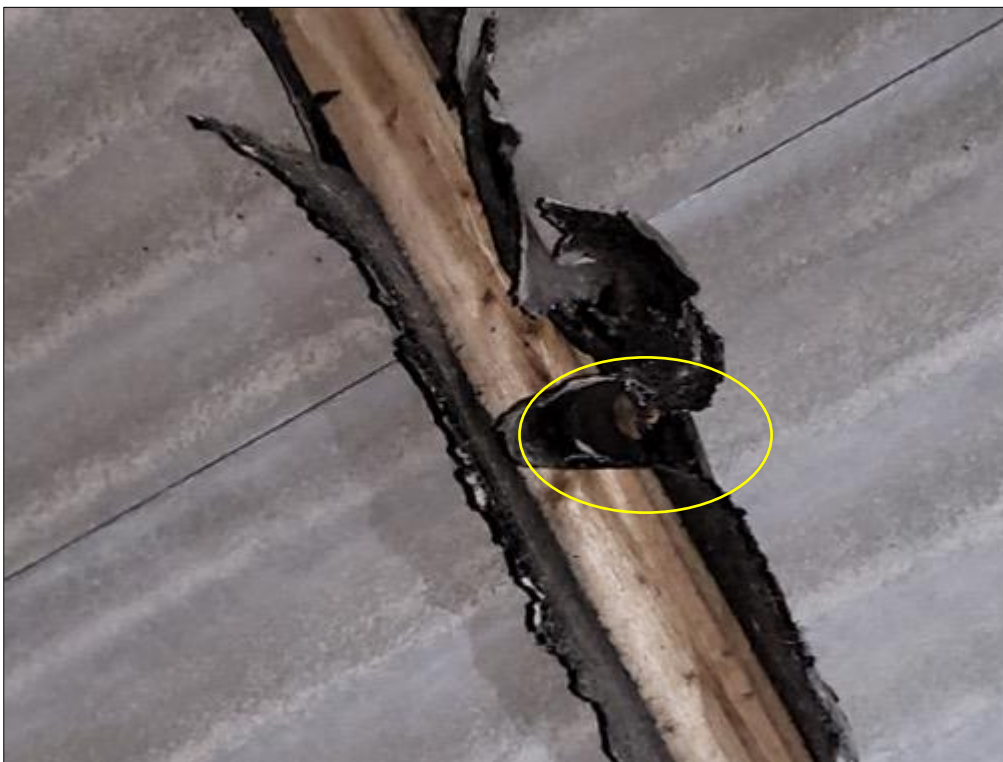
Figure 6. Bat species observed roosting in felt hanging over the stairway.

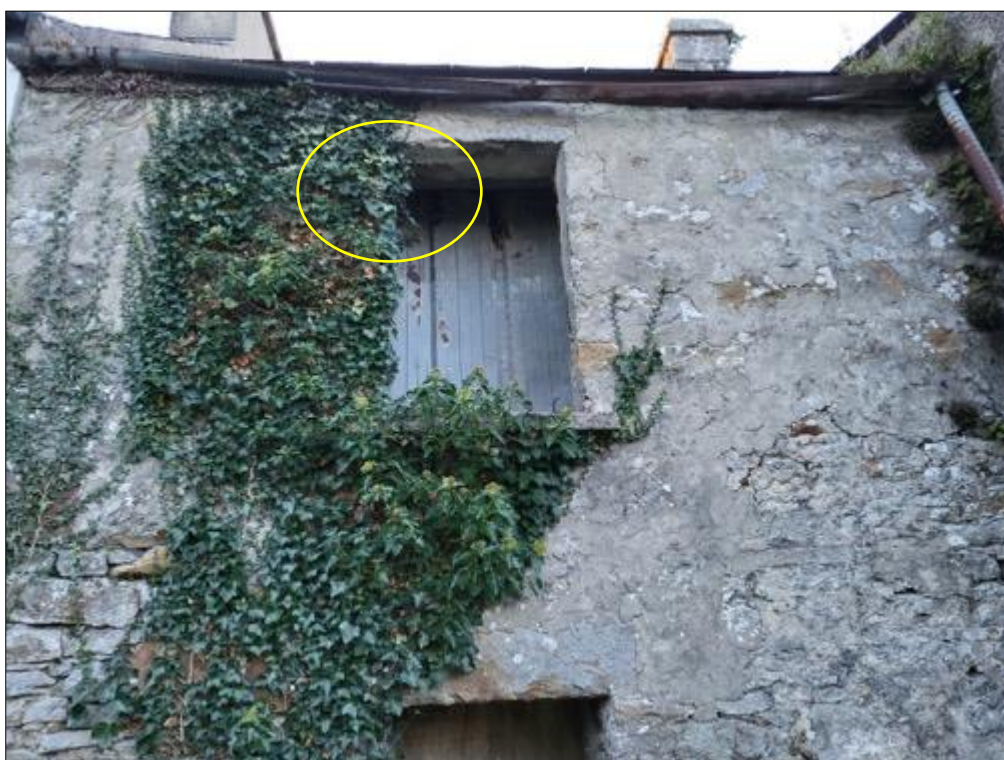
The emergence watch of the rear of the building commenced at 18:25. A single soprano pipistrelle emerged from an upstairs window at 19:06, *Figure 7*, and flew across the garden towards the southeast. At 19:34 a brown long-eared bat was noted flying in a circular pattern over the ground floor in the section of the building with no ceiling. This area provides sufficient height and width for this pre-emergence behaviour which is characteristic of brown long-eared bats. No further bats were noted emerging. At 19.41, a Leisler's bat *Nyctalus leisleri* was detected passing over the garden but was not confirmed as having emerged from the building.

Figure 7. Second storey rear window from which a single soprano pipistrelle emerged.

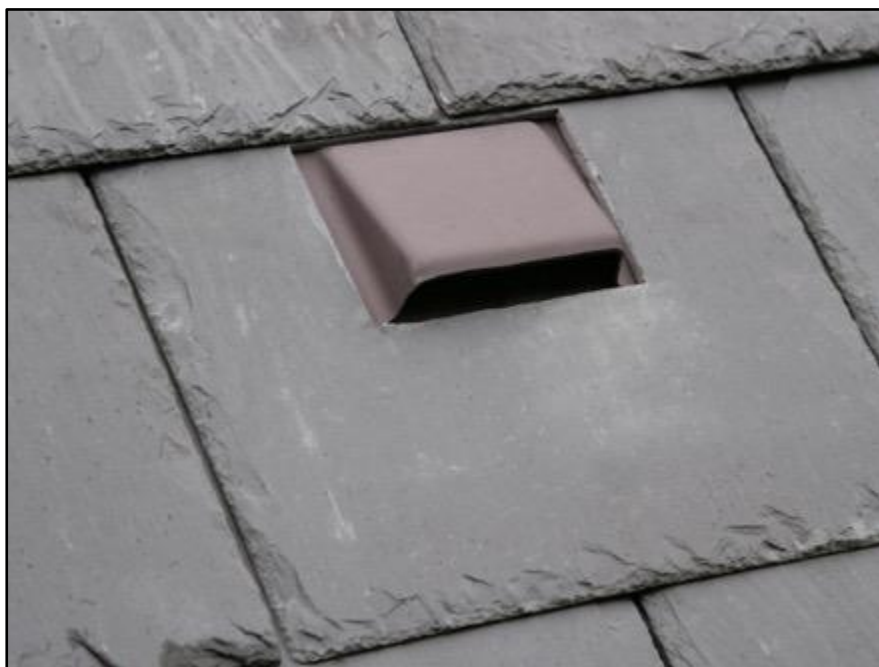
Figure 7. Example of an adapted roof slate that permits bat access to a roof space.

Once water tanks are covered, bat roosts create little, if any, issues when roosting in residential / commercial roof spaces. The installation of permanent access openings into the roof space should be considered, *Figure 7*. Following renovation works, such an action would allow bats to continue to use the roof space as a roosting.

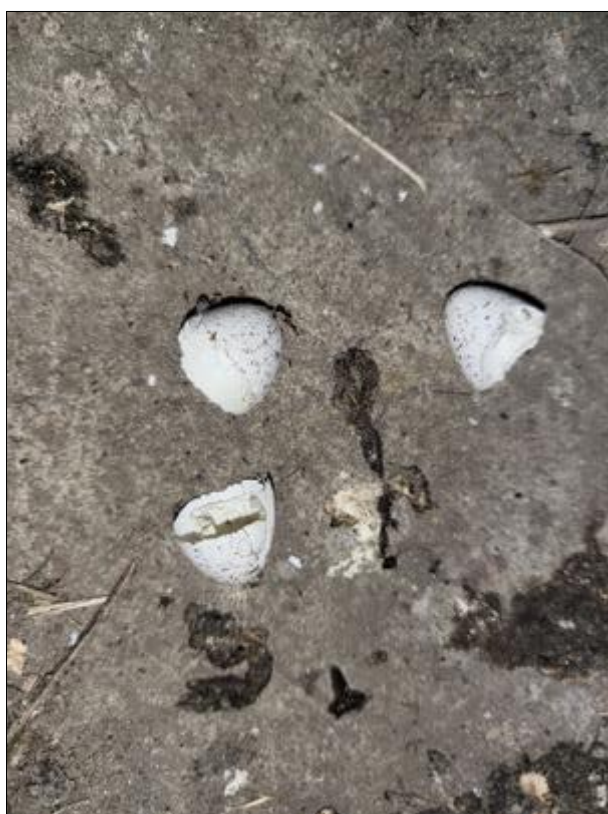
Evidence of recent nesting by barn swallow *Hirundo rustica* was noted inside the building, *Figure 8*. Construction works should be carried out outside the bird breeding season, or the building should be sealed before the bird breeding season starts (March 1st to August 31st) to prevent birds nesting in the buildings.

Figure 8. Remains of hatched barn swallow eggs found on the ground floor of the building.

If construction works commenced or are ongoing during the bird breeding season, then the internal and external surfaces of the buildings should be checked for active nests. If a nest is found, consultation with an ecologist and National Parks and Wildlife Service (NPWS) will be required to determine the best course of action. These measures are required to avoid committing an offence under Section 22 of the Wildlife Act 1976-2018 as amended regarding the enforcement of the protection of wild birds.

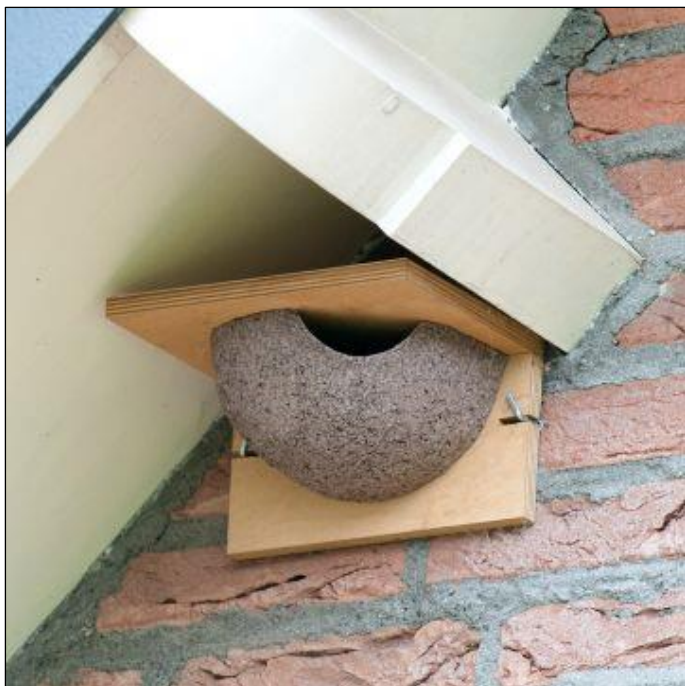
Figure 9. Example of swallow nest box. The open shelter situation is important to mimic that of an open barn/shed.

Alternative and new nesting sites should be provided (if practical to do so) using nest boxes of a specific design to suit barn swallows and affix them to overhanging eaves of the renovated building, *Figure 9*. The installation of the boxes should be advised and overseen by an ecologist.
