**BAT SURVEY AND  
MITIGATION PLAN  
FOR PROPOSED WORKS AT  
TINERANA STABLES,  
OGONNOLLOE, CO. CLARE**

Applicants Gary and Michelle McNamara

Scientific agent: Ruth Minogue

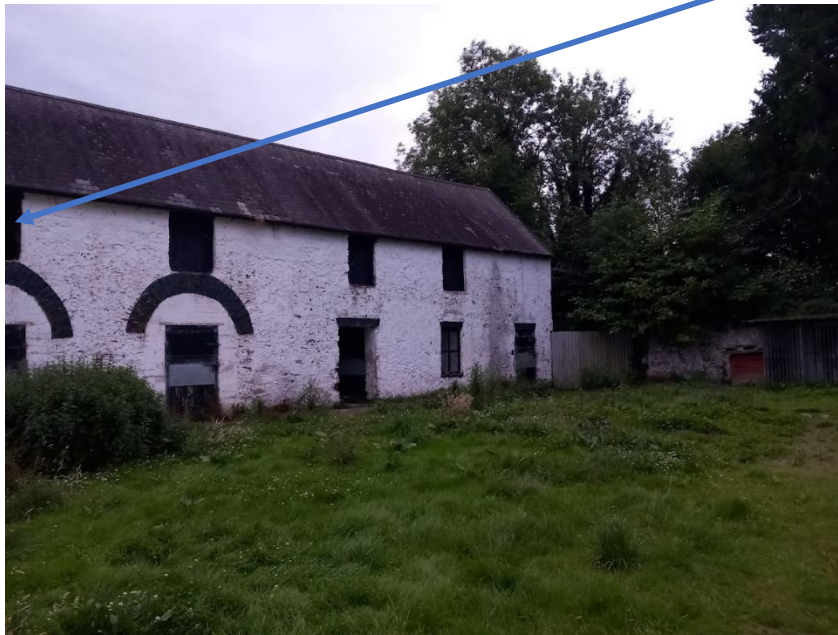
*Plate 3-1 Stable A – exit by Long Brown eared bats.*

Two long brown eared bats were observed flying out (dropping and flying) from Stable A at 23:06. See Plate 3.1 below. Bat species recorded during the emergence survey including foraging behaviour particularly at the scrub in the southern corner of the site.

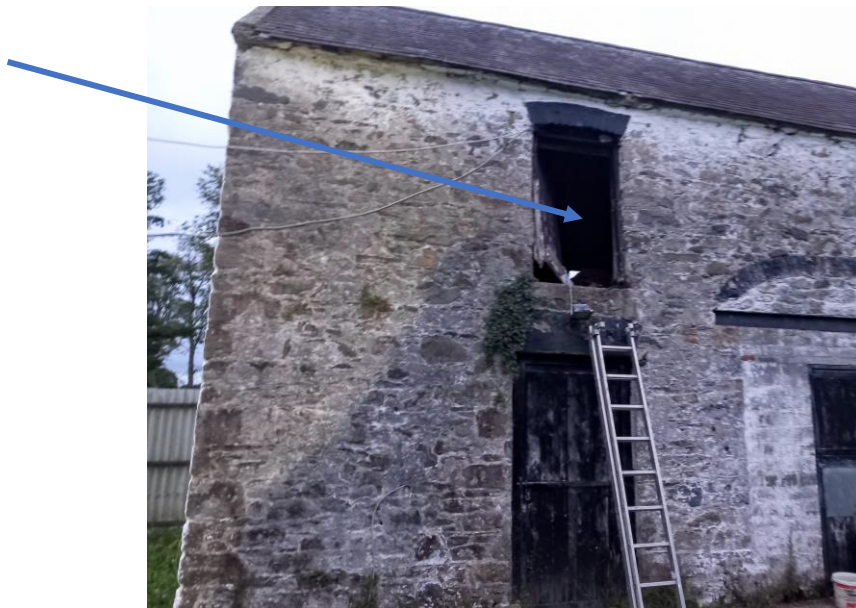
Plate 3.2 Access for Long Brown Eared Bats

During the dawn survey of 19<sup>th</sup> July, between 6 to 8 individual Long Brown eared bats were observed flying into the loft door at Stable B. See plate 3.2 below. No other species were observed returning to the stables during the dawn survey.

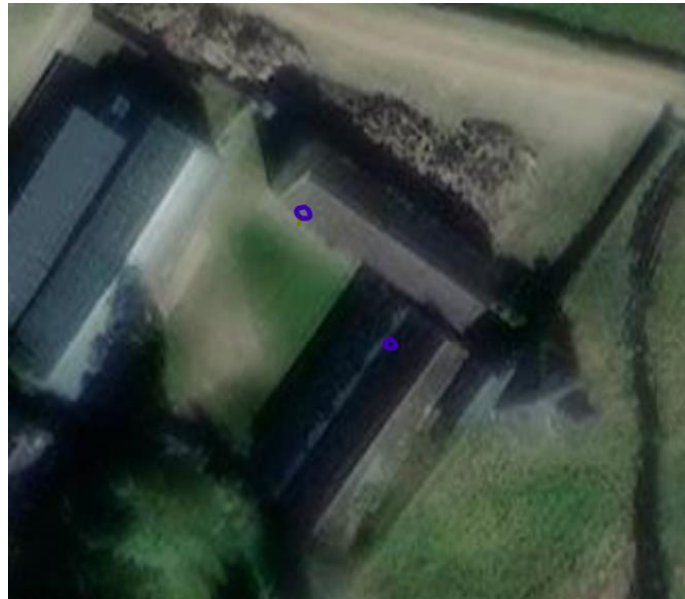
Figure 3-6 Blue circles indicating location on loft floor for static detectors 11<sup>th</sup> to 19<sup>th</sup> July 2023

The location of the static detectors deployed (Batlogger S2) is shown below:

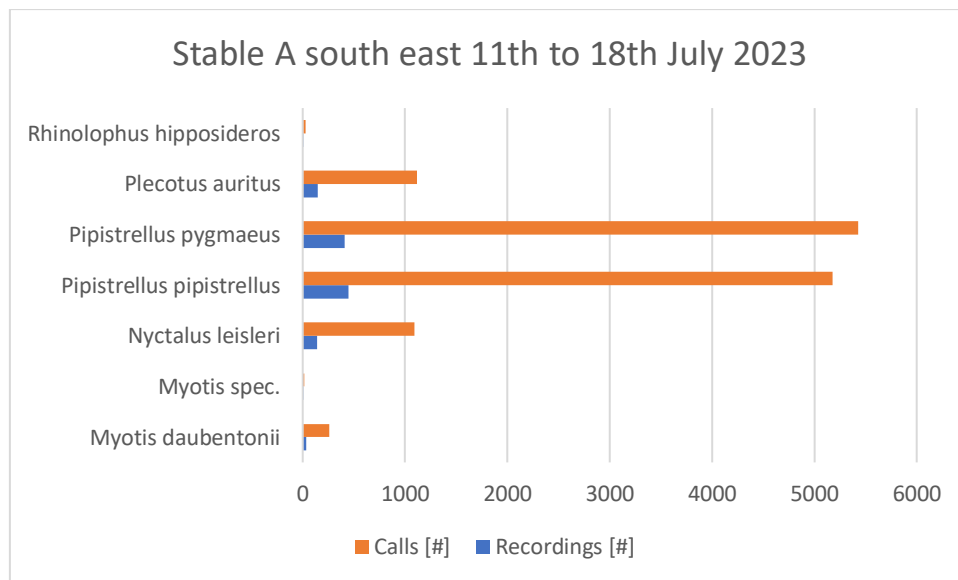
Figure 3-7 Stable A Static Detector results 11<sup>th</sup> to 18<sup>th</sup> July 2023

Over the 8 nights recorded in the loft of Stable A<sup>1</sup>, the most frequently recorded species were Common pipistrelle (446 records), Soprano pipistrelle (410 records), Long brown eared (145 records), Leisler (138 records) and Daubenton bats (33 records). Lesser Horseshoe bat was recorded on one night, the 13<sup>th</sup> July at 00:33, 00:34 and 02:11.

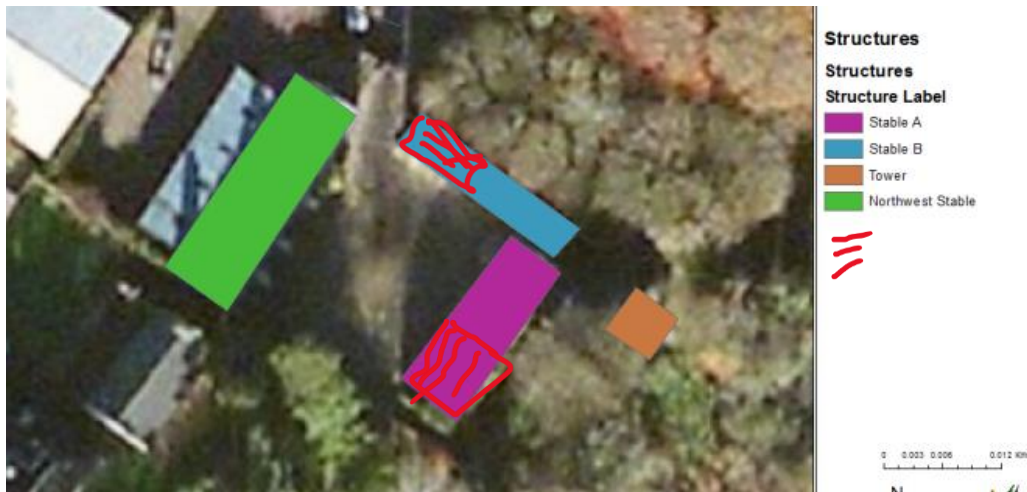
Figure 4-1 Location of dedicated roosts in Stables A and B and C – shown in red is the new locations following NPWS consultation

Dedicated roosts will be retained in the lofts of both Stables A and B and also within the tower (see Figure 4.1 for locations).

The SOUTHERN section of the Stable A and the WESTERN section of Stable B will be retained as a bat roost. A length of 9m of each loft will be retained to be used as a bat roost. The entire existing width and height of the loft space will be retained within the 9m sections for use as a bat roost. The bat loft space will be sectioned from the remainder of the loft space by a stud wall. The existing timber roost, which allows for an uncluttered and unobstructed loft space will be retained. A doorway within the stud partition will be provided for access to the bat roost.

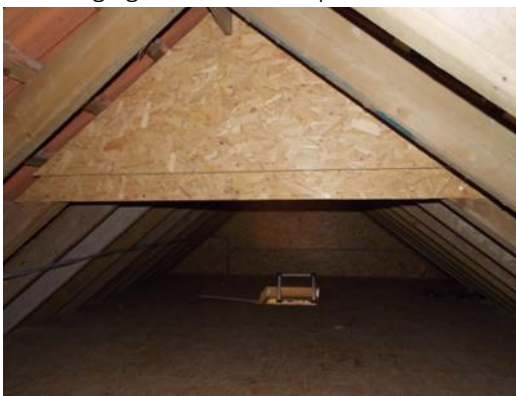
A HOTBOX WILL BE PROVIDED WITHIN STABLE A -this will be simply plywood plates over the 3 rafters with a plywood plate either side from the roof ridge, with a large rectangular access area maintained for the bats; this will enhance roosting conditions within the stable by reducing light into the this part of the building and decreasing draughts.

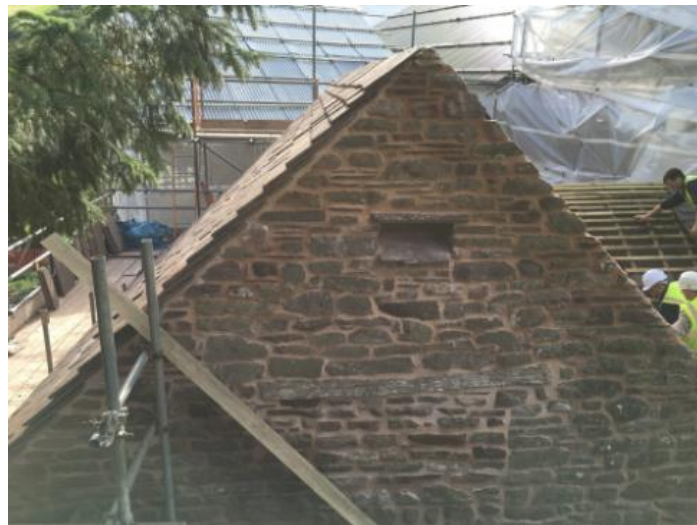
Figure 4-2 Letterbox design for roost access (Wildwood Ecology)

- A letter box access is proposed-. These are installed as low as practically possible on the gable wall but at least 0.4m above the level of the deck. The opening will be a minimum of 20cm x 30cm (600cm<sup>2</sup>) with a larger area preferable. This ensures that bats are away from clutter during access and will not be impeded by any potential bird's nests.

- The access will be open to facilitate access by Lesser Horseshoe Bats as well as Long Brown eared bats. See figure below for design of letter box access.

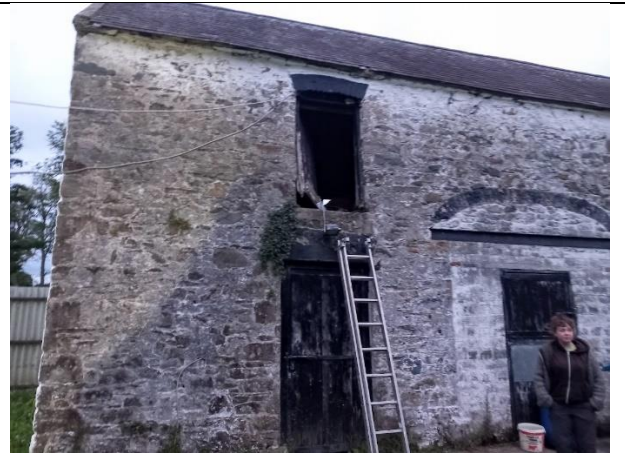
Stable B loft access used by Long Brown Eared Bats

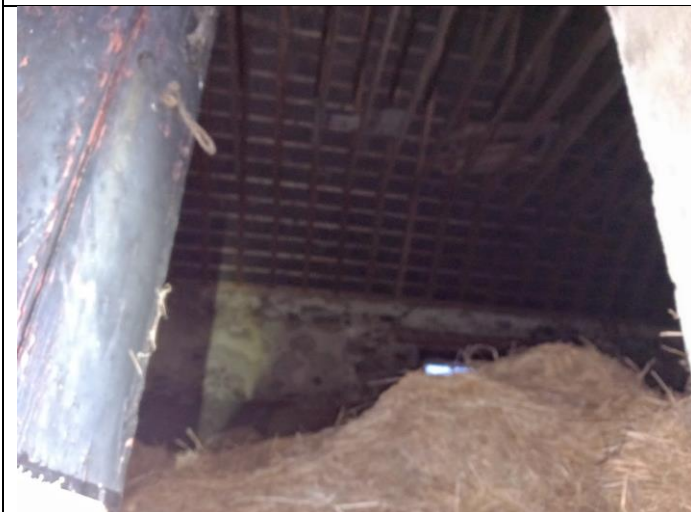
Interior of loft space Stable B

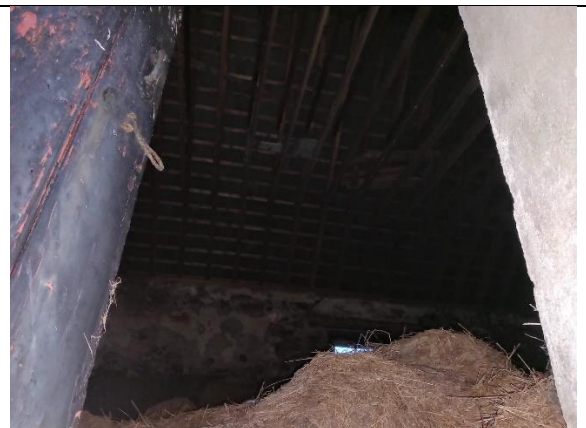
Interior of loft space Stable A

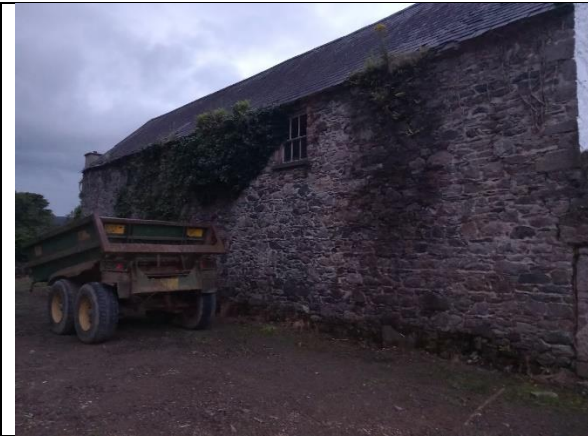
Northern exterior of stable B
