Bat Survey of Glebe House, Ballyfad, Gorey, Co. Wexford

**Sheehan and Barry Architects,
88 Ranelagh Village,
Dublin 6**

**By
Caroline Shiel B.Sc., Ph.D.**

September 2023

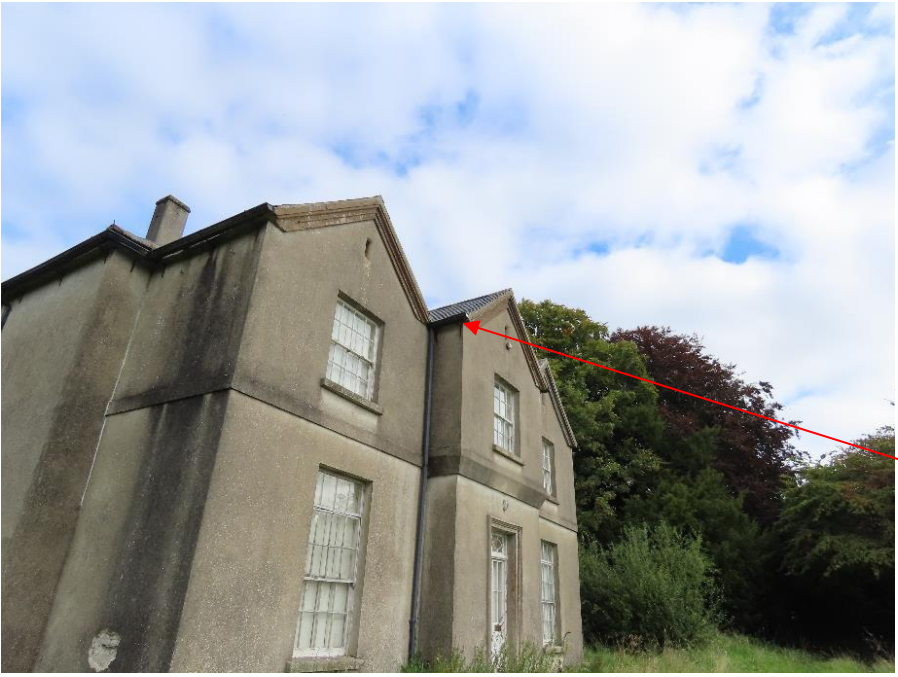
Photo 6 – showing location of exit point used by Soprano pipistrelles

The gap at wallplate level currently used as an exit and entry point by Soprano pipistrelles will be retained. In addition, the vents on the front gables will be left open to allow bats to use them (see Figure 3).

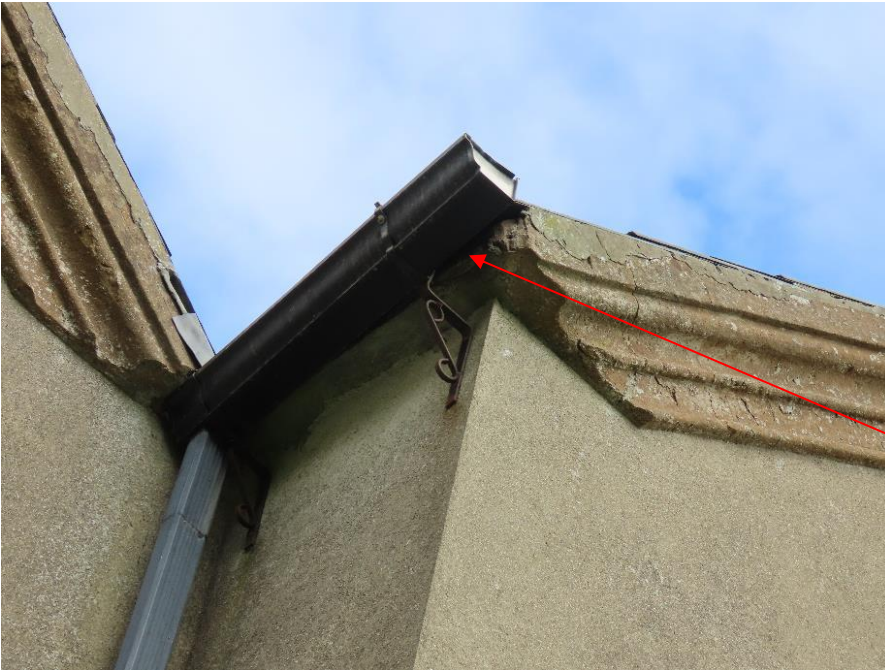
From 21.20 onwards 30 Soprano pipistrelles were recorded emerging from a point at roof plate level at the front of the house. The exit point was to the south side of the centre roof gable. No other bats were recorded emerging from the main house.

Photo 7 – close up of entry/exit point used by Soprano pipistrelles

Main House Re-roofing works to the main house could lead to the loss of a nursery roost site of Soprano pipistrelle bats unless the current entry/exit point is retained. It has been confirmed by the architect and owner that the access point to the roost site in the roof of the main house will be retained for the Soprano pipistrelle colony.

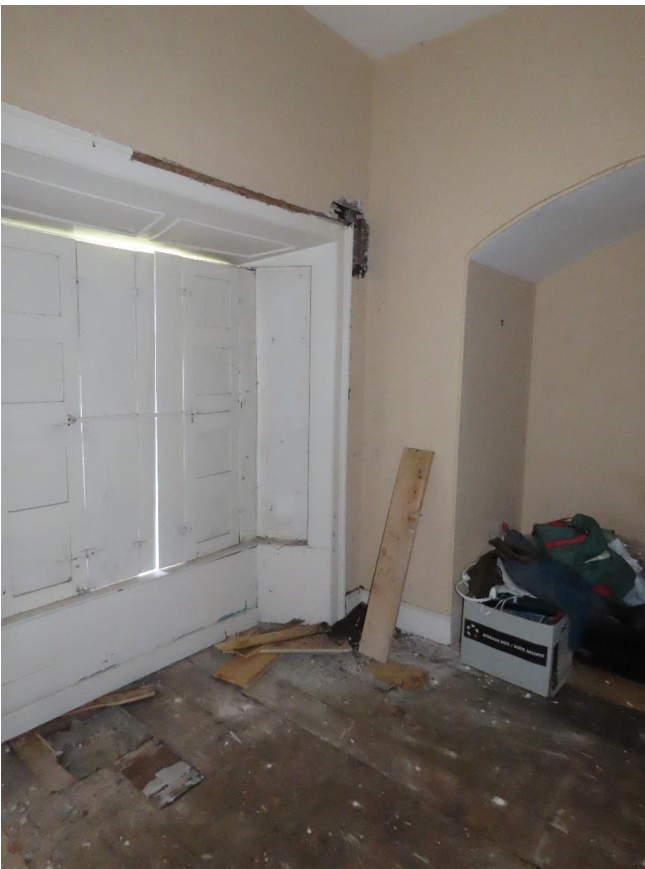
The building was surveyed internally and externally for bats on 5th September 2023. No bats were found in any of the rooms of the main house. However, an accumulation of droppings was found on the timber floor of the central front bedroom. These droppings had fallen from a void in the wall beside the window frame. This void was opened up to facilitate architectural investigations. A survey of the main attic space revealed an accumulation of bat droppings at the base of the front wall. Five Soprano pipistrelle bats were seen clinging to the inner surface of the front wall. Other bats were present but not visible. Several dead bats were also seen in a water tank above the upstairs bathroom.

Photo 12 – section of plaster removed for architectural investigations in centre front bedroom. The pile of bat droppings are visible on the floor under the opening

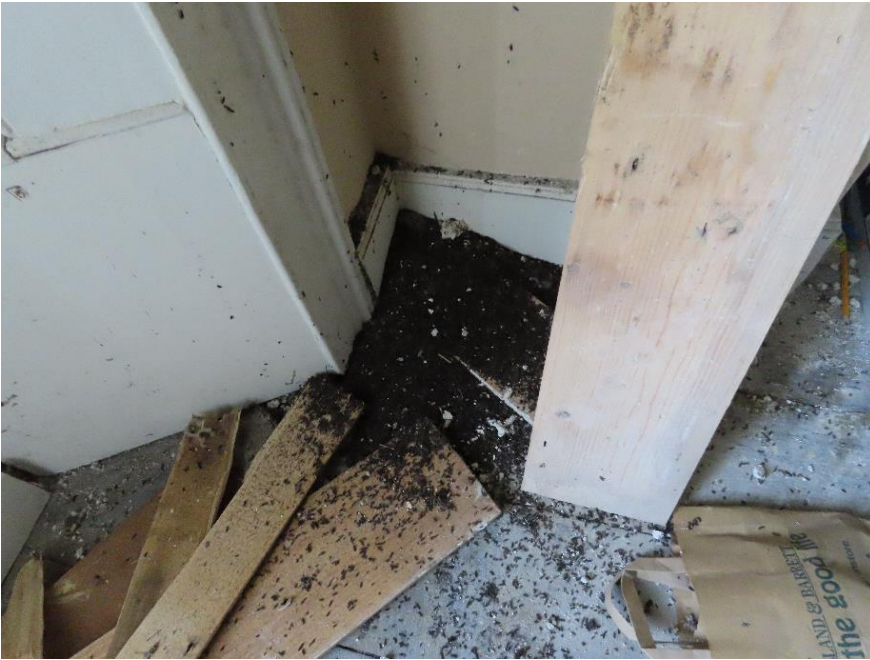
Photo 13 – pile of bat droppings on floor

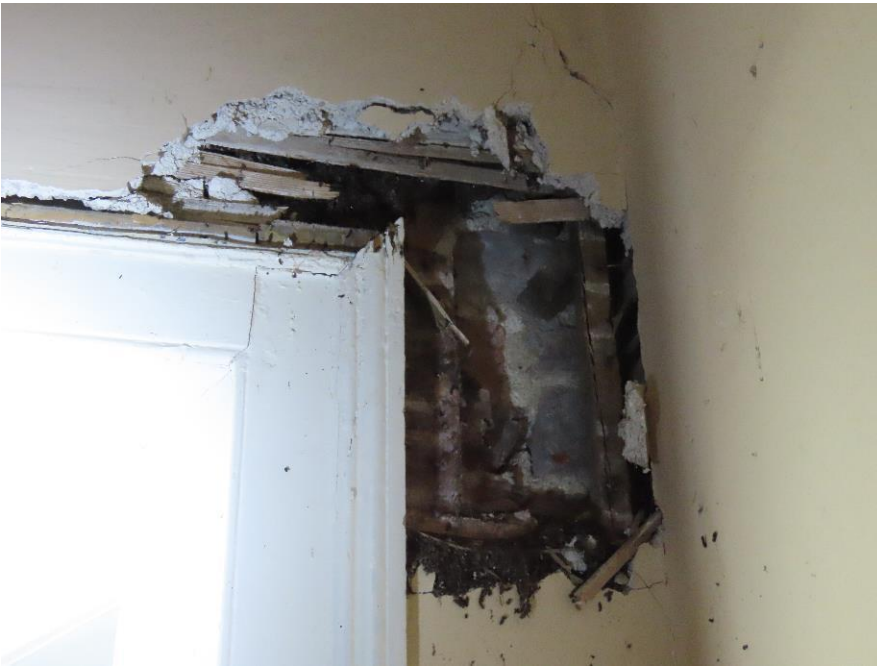
Photo 14 – bat droppings accumulated in space between wall and plaster

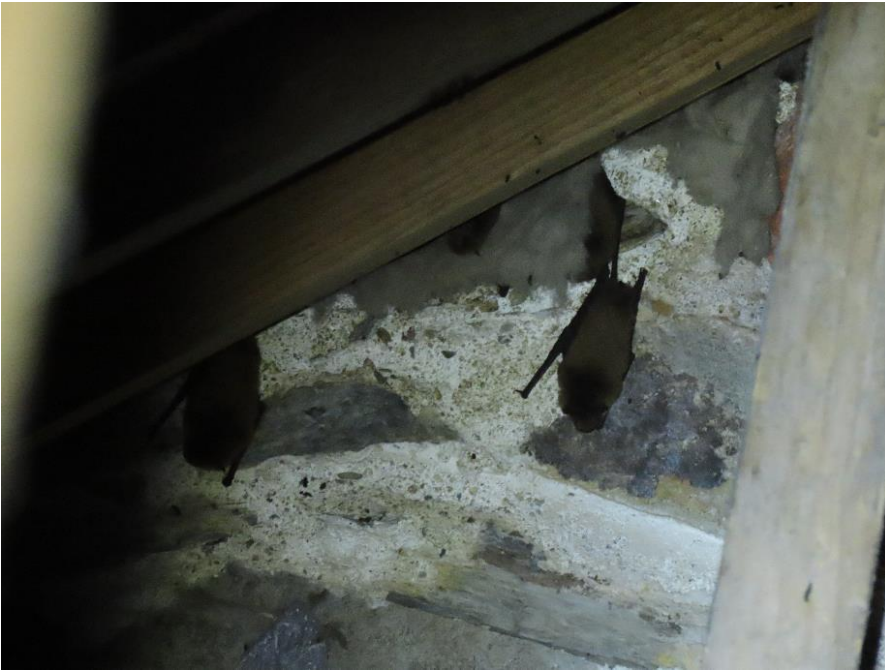
Photo 17 – five Soprano pipistrelles clinging to internal surface of front wall of house

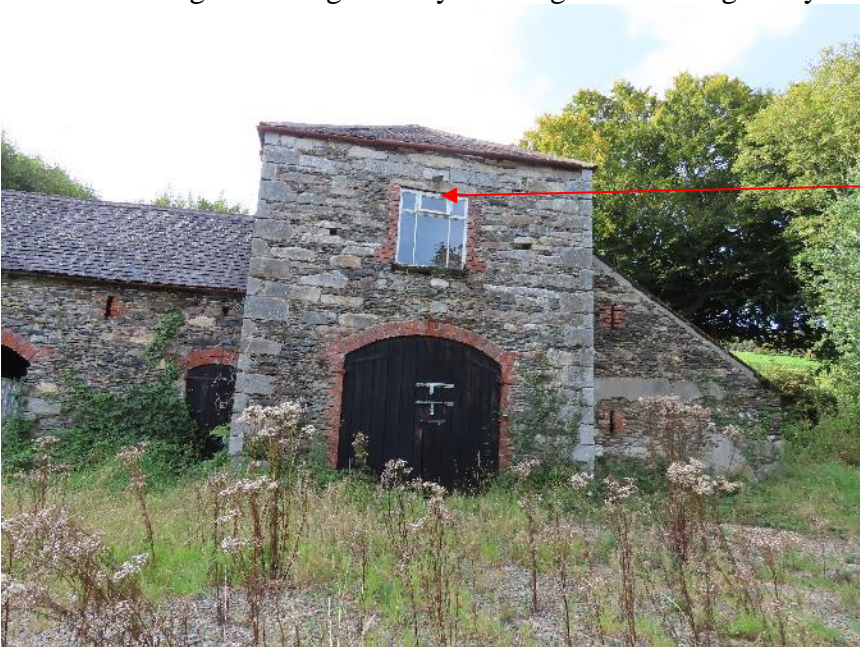
From 20.10 onwards two Brown long-eared bats were recorded flying within the attic space of the granary building. They eventually emerged at 20.45 and 20.47 via a gap above the window on the front of the building. A single whiskered bat was recorded flying within the roof space of the long outbuilding and also in the granary. The exit point used by this bat was not established.

Photo 20 – front elevation of granary. The Brown long-eared bats emerged from a gap above the window as indicated

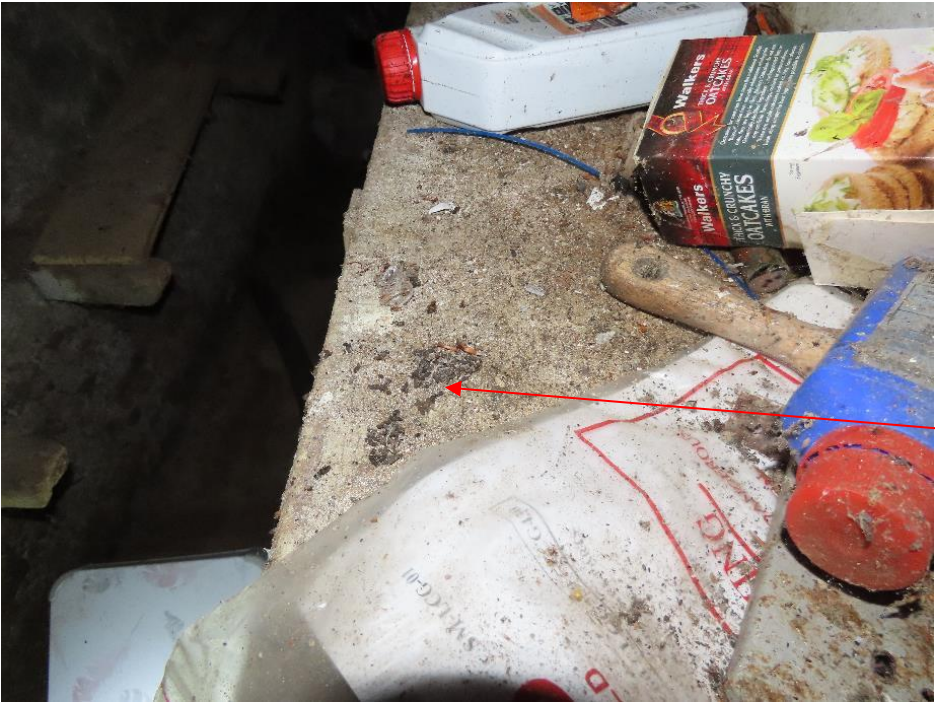
before emergence. Several accumulations of butterfly wings were recorded on the loft floor. The wings are typically discarded by the bats prior to ingestion. Bat droppings were also recorded on the work bench in the southwestern section of the long outbuilding. No bats were visible on the roof timbers of this section of the outbuilding during the torch survey.

Photo 28 – bat droppings on work bench in workroom

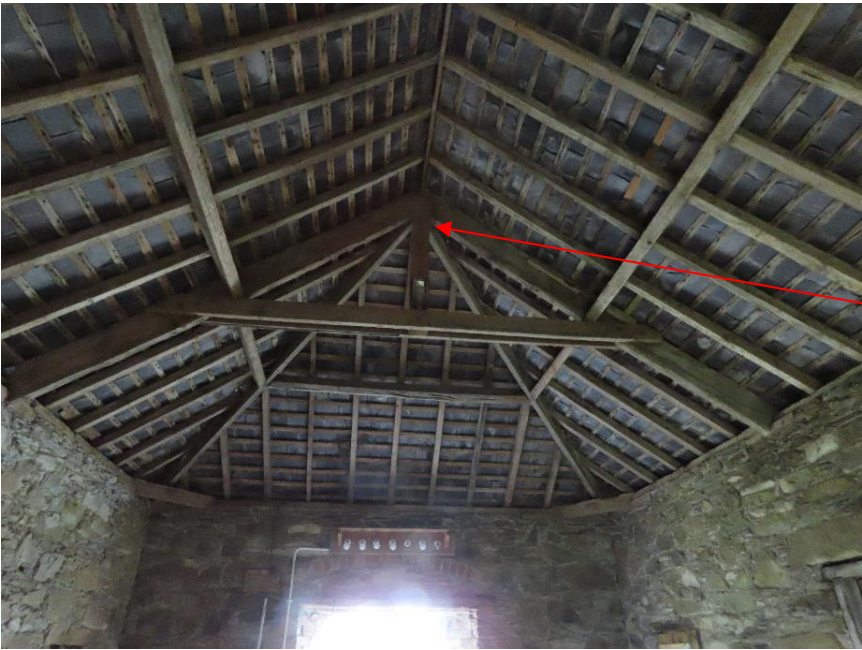
A small accumulation of droppings of the Brown long-eared bat were recorded directly under the point where the front timbers converge. This would be a typical roosts site for Brown long-eared bats. No bats were visible during the torch survey. Brown long-eared bats frequently roost out of sight behind roof timbers and only become visible shortly

Photo 30 – hipped roof of granary. The position of the roosting Brown long-eared bats is indicated

An alternative roost site should be provided in the form of a rocket box. One of these boxes should be mounted close to tree line to the rear of the outbuilding. These boxes are mounted on a 4m aluminium pole.

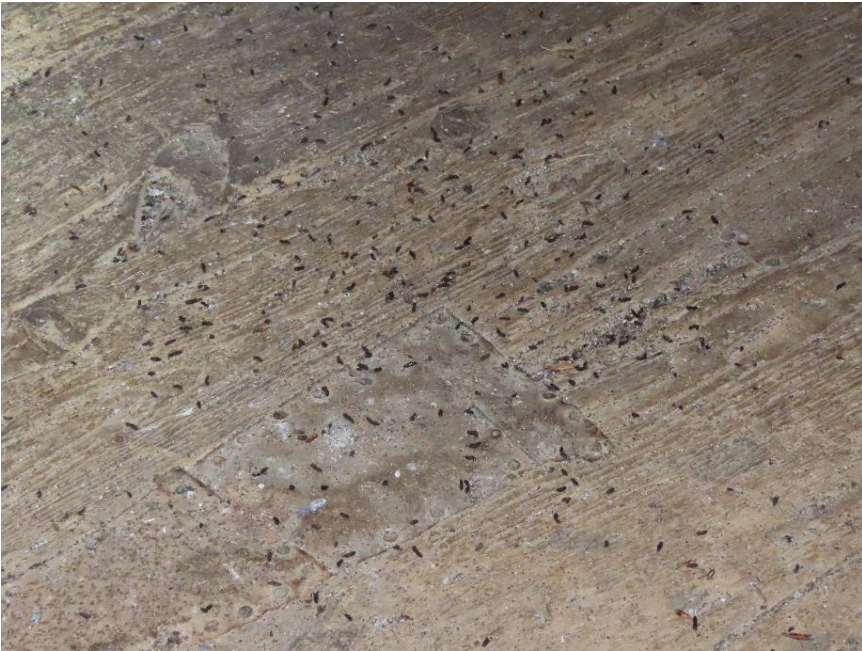
Photo 31 – bat droppings on floor of granary loft
