Supplemental Information – NPWS Derogation Licence Application

Development Description

A housing development of 9no. x New Social Housing Units has been proposed by Tipperary County Council (TCC) on a 0.09 hectare site at the junction of Grove Street and The Crescent, Roscrea, Co. Tipperary. The proposed development will involve the demolition of a terrace of 3no. x existing derelict two-storey buildings on Grove Street and the construction of a terrace of 3no. x Two Bedroom, two-storey houses in their place. Behind these terrace houses the existing vegetation from the gardens shall be cleared for 6 No. One Bedroom apartments, in two separate blocks, facing The Crescent.

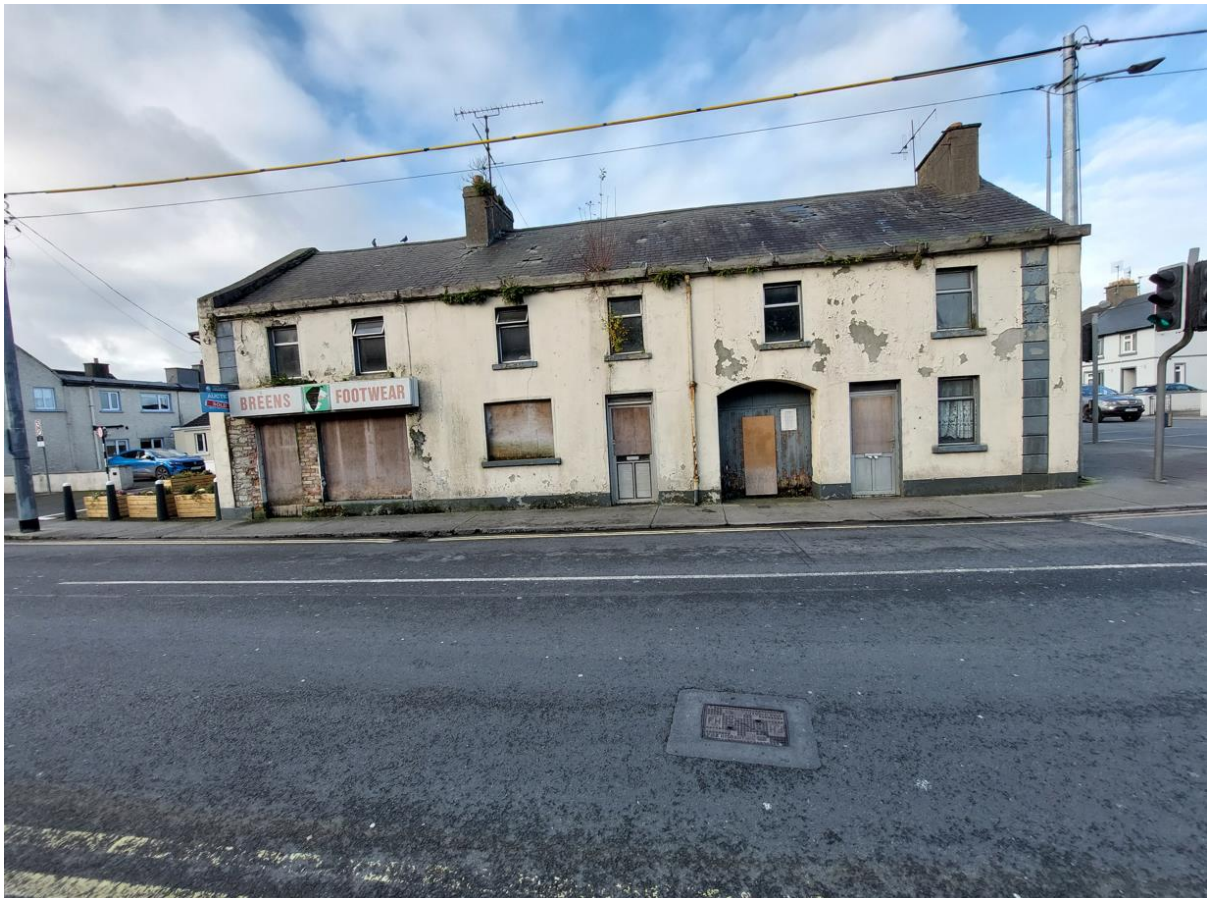
Photo 1: Front of building (adjacent to public footpath/road, roof structure sagging, roof tiles slipping. Gutters removed previously as they were collapsing onto public footpath below). The proposed new row of terrace houses will be narrower and offset further back from the public roadway.

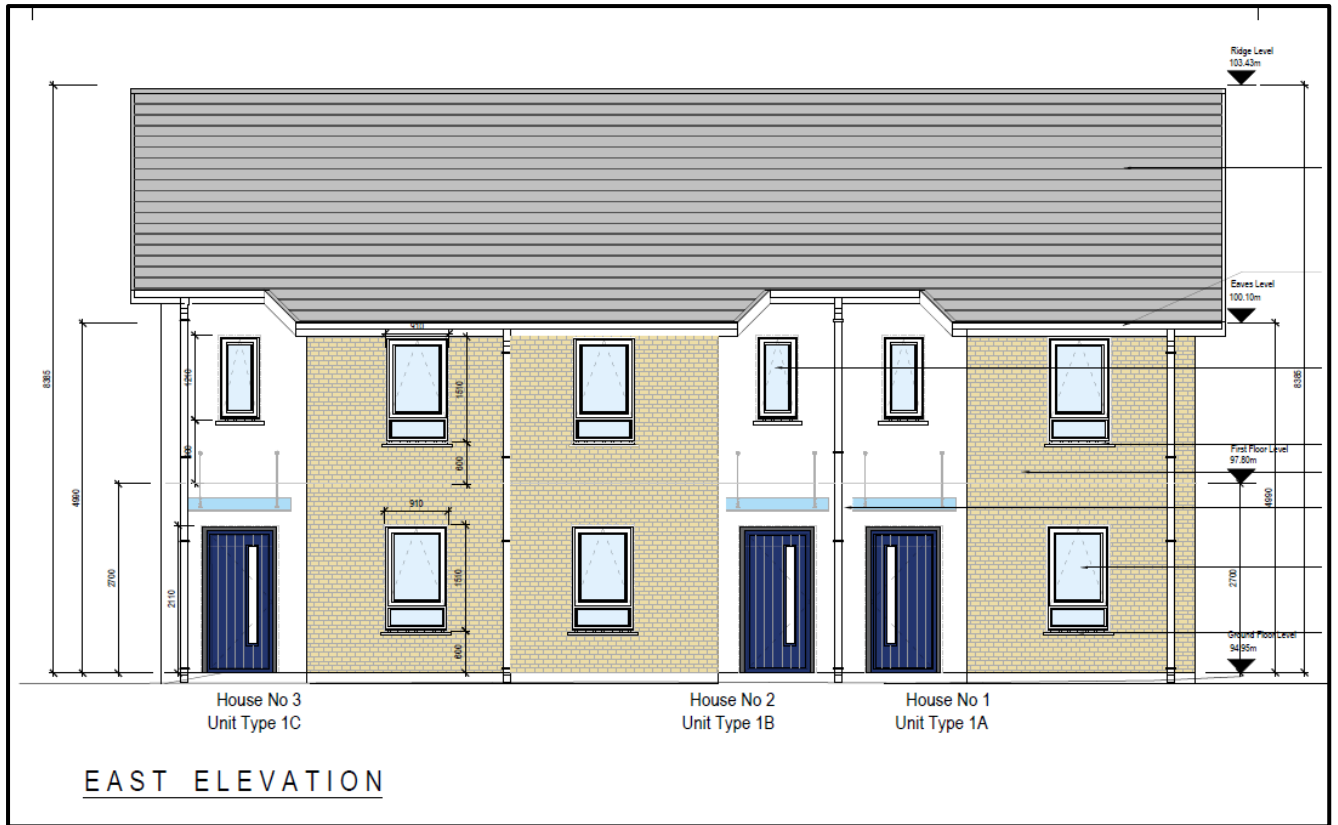
Figure 3: Proposed new Elevations of 3no.x terrace townhouses to replace existing derelict building

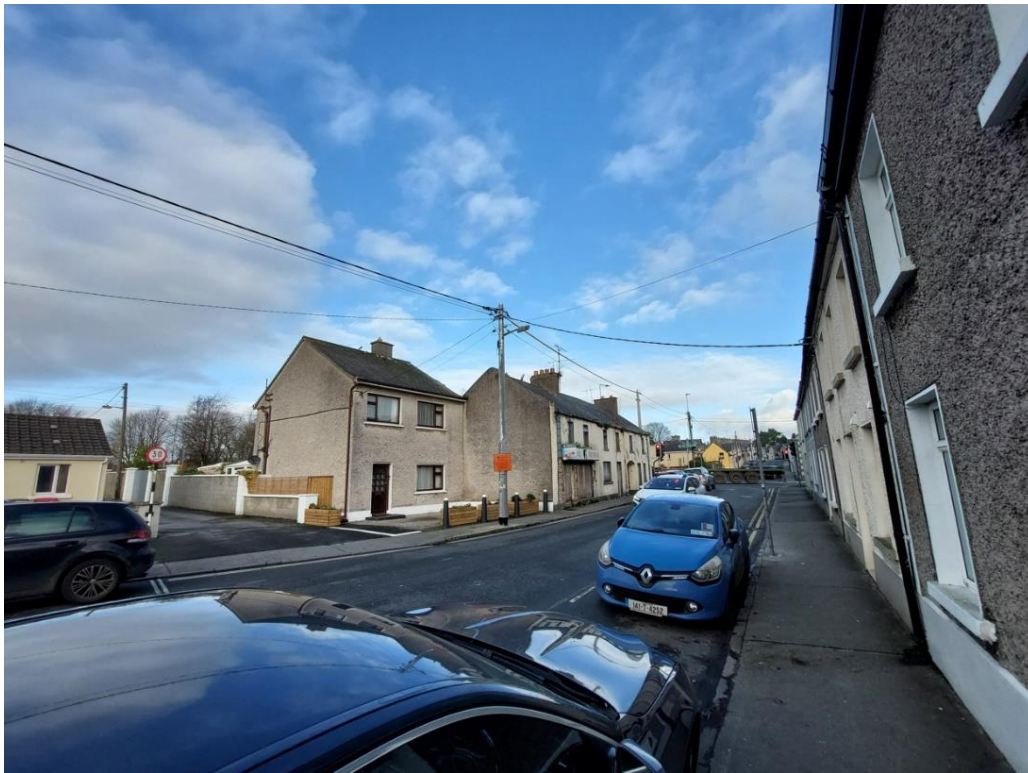
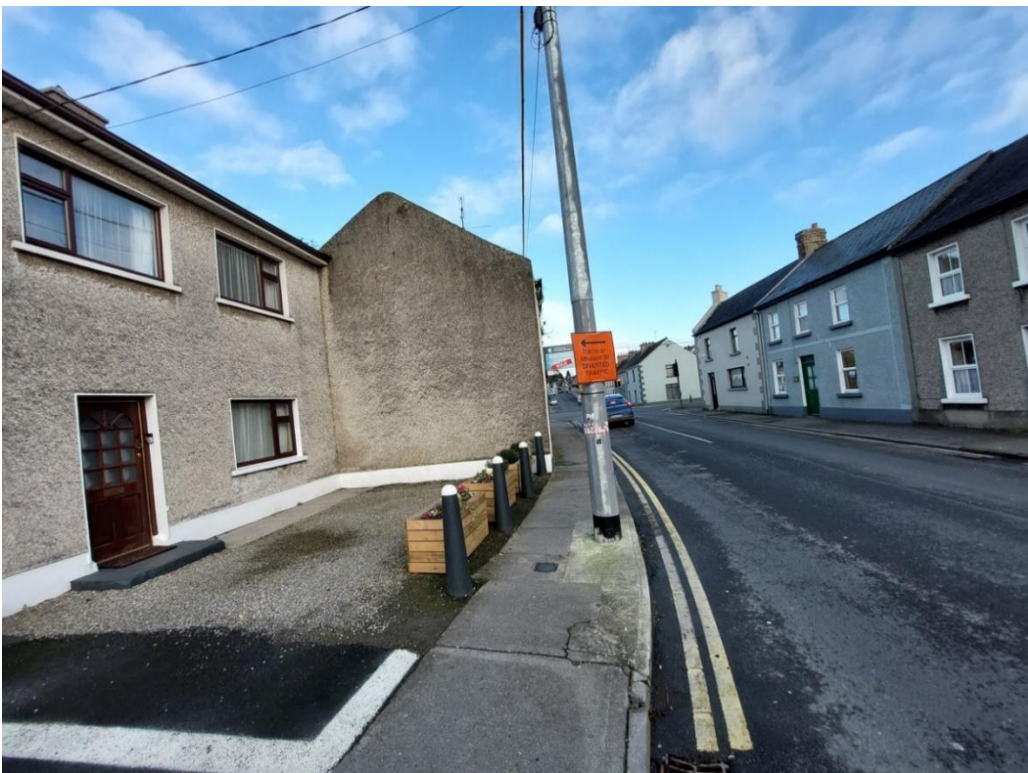
Photo 2: The existing houses are currently joined on the corner with a neighbouring property. This property is privately owned and occupied. This corner shows evidence of cracking, both building appear to be pulling away from each other. The more dilapidated the existing derelict structure becomes will have a direct affect on the private house. The proposed new development separates the new terrace houses from the private house. The new houses will also be set back in line with the front of this private house. This will provide a safer footpath, better visibility at the traffic lit junction and better stability for the private house.

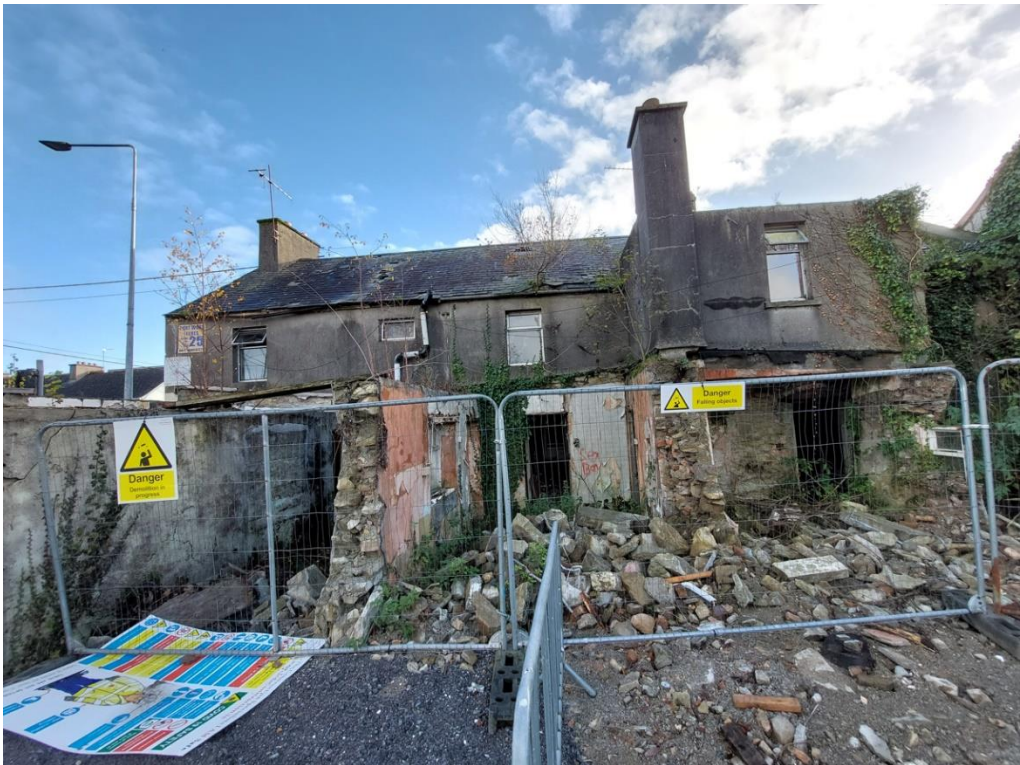
Photo 3: Rear Elevation of Buildings (roof collapsing, roof tiles slipping, access blocked to prevent falling objects, structure generally unstable throughout)

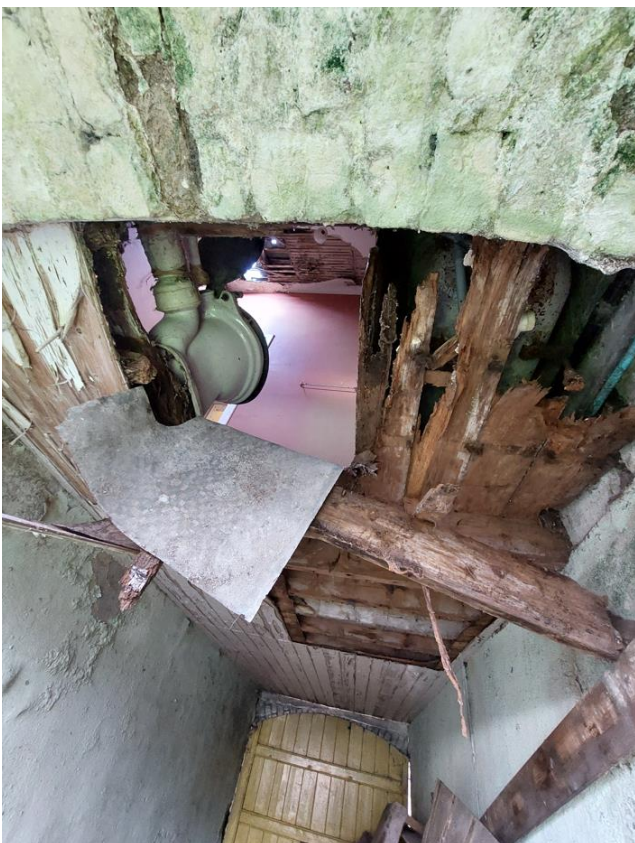
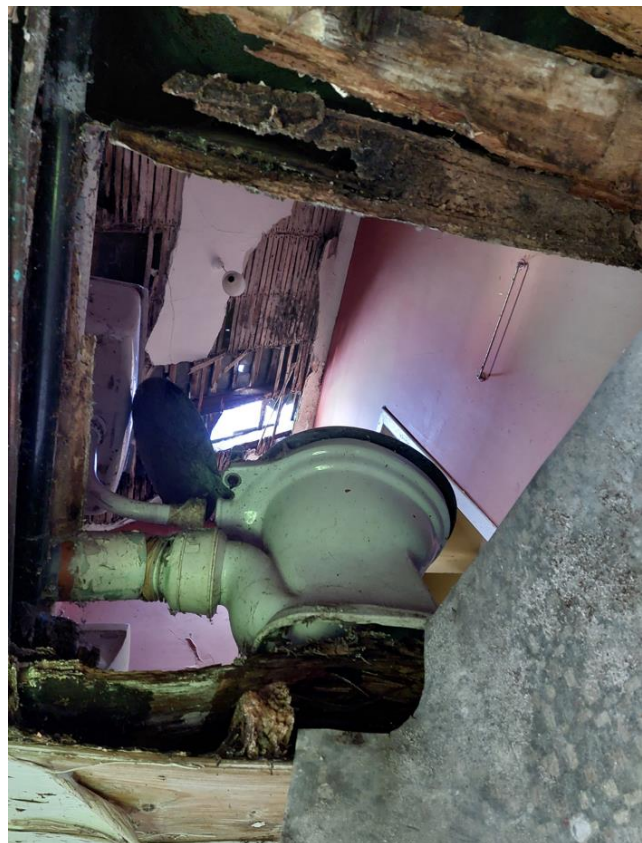
Photos 4: View from Ground Floor looking up to first floor (first floor joists rotting/collapsed, roof structure rotting/collapsed, unsafe to access first floor)

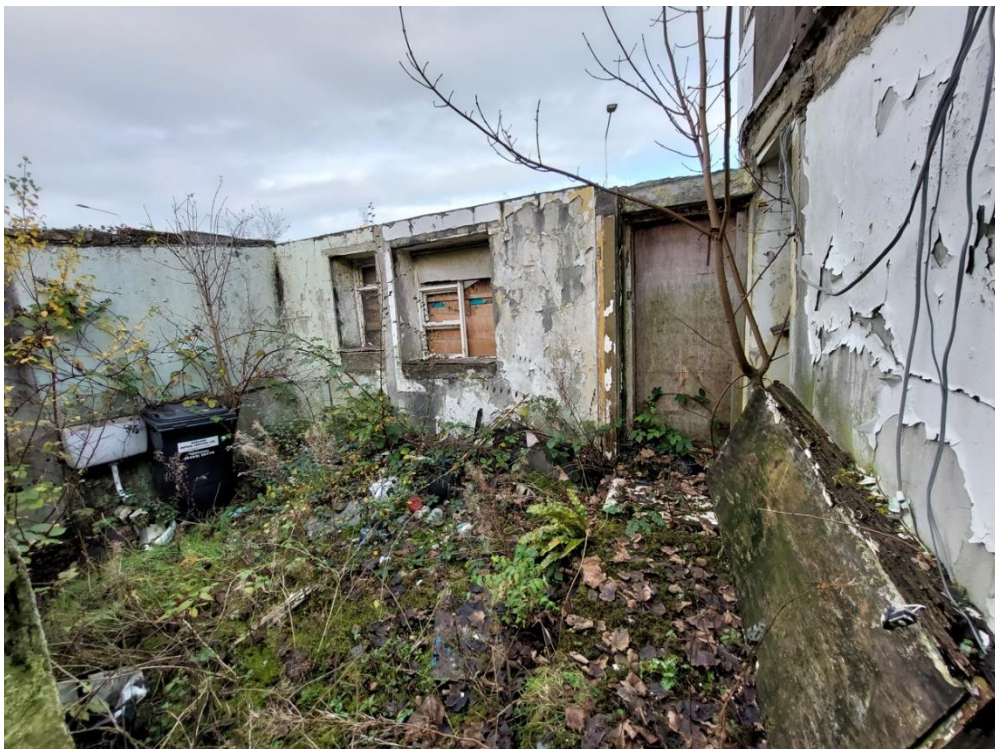
Photo 5: Rear room (roof structure collapsed, rubbish and vegetation collecting in area)

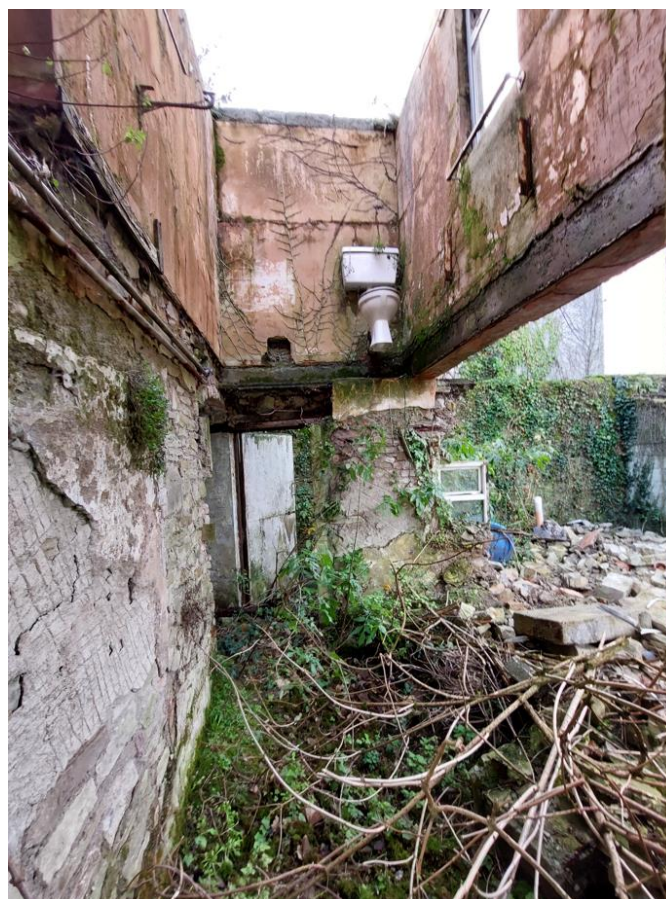
Photo 6: Rear room (roof structure and first floor structure previously collapsed, rear overhanging wall precarious and at high risk of collapse)

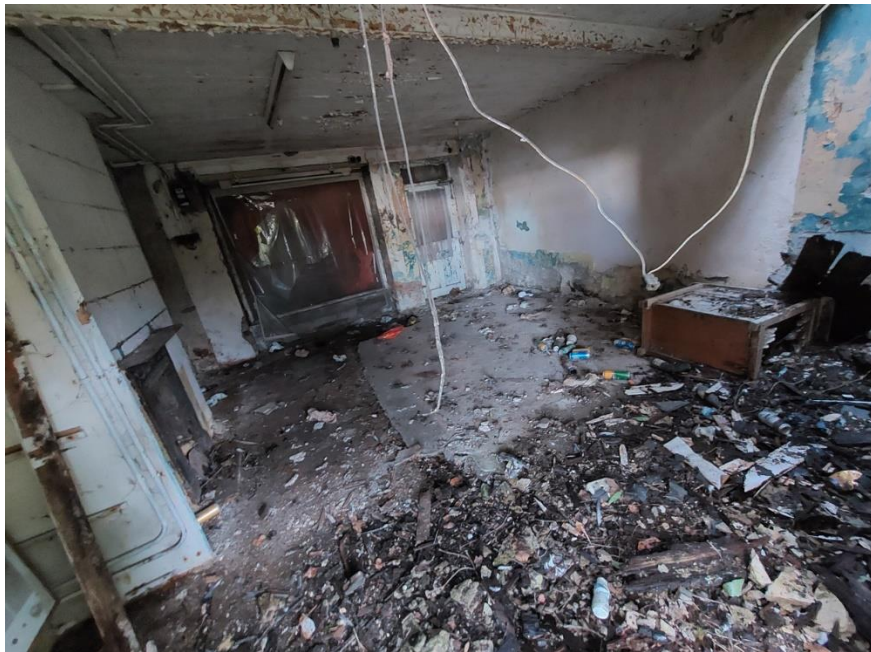
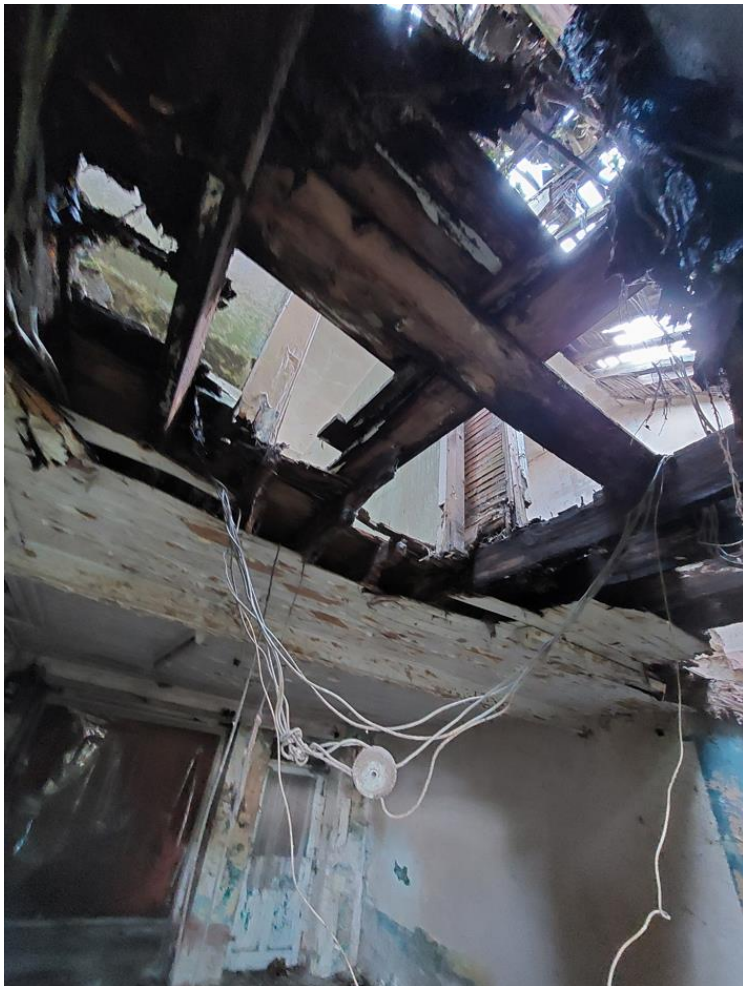
Photo 7: Ground floor looking up (first floor structure rotting/collapsed, roof structure rotting/collapsed, unsafe to access first floor)

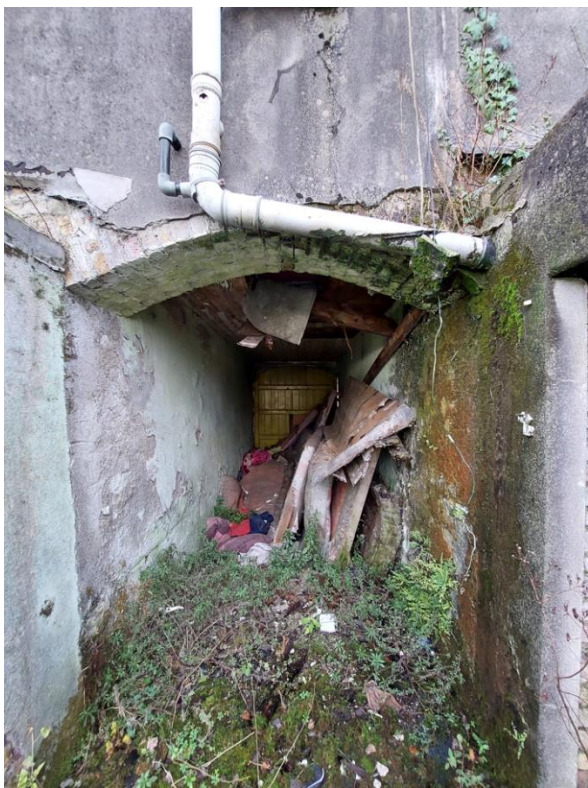
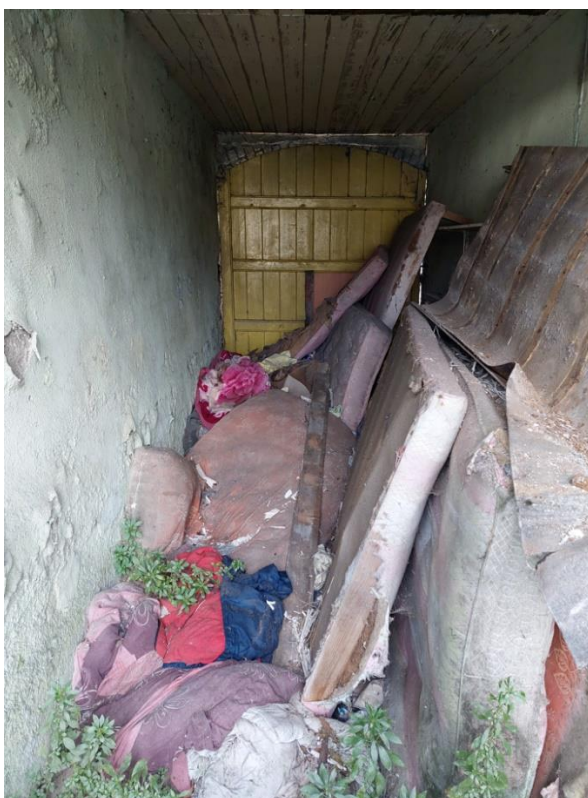
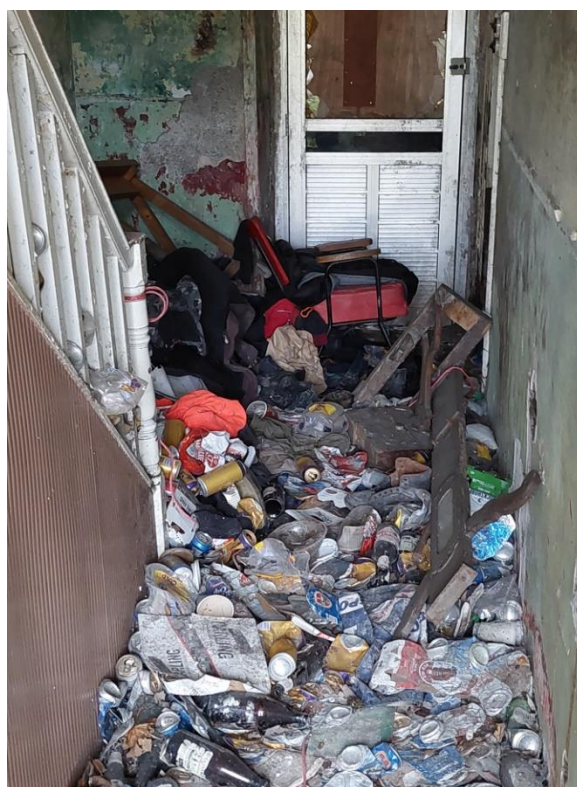
Photo 8: Anti-social activity at house such as rough sleeping, evidence of drink and drug taking.
