# Bat Derogation Licence Application – Supporting Document

## Lissardagh House

**Project:** Lissardagh House Renovation, Co. Cork.

**Purpose:** To inform a bat derogation licence application.

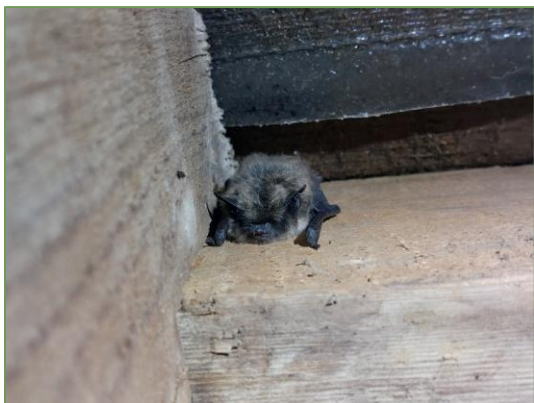
**Plate 2.1** Whiskered Bat roosting along the ridge beam within the western attic section of Lissardagh House.  
(Photo by C. Breslin, NPWS Licence Ref. DER/BAT 2024-09; 008/2024).

From a relatively brief internal inspection of the attic by O'Donnell Environmental, bats appear to roost in a number of spaces throughout the attic and are largely contained in the void space between the bitumen felt and slate roof. Roosting appeared concentrated at along the ridges and hips of the timber roof structure based on the significant accumulation of droppings beneath these locations.

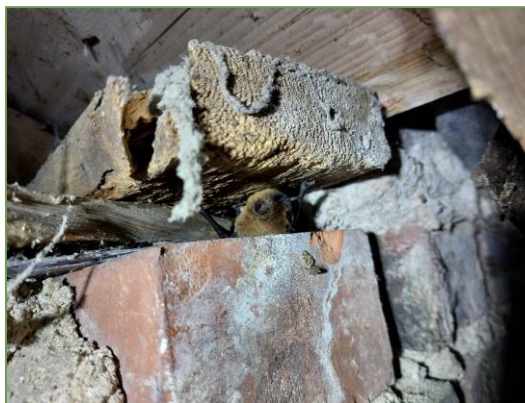
**Plate 2.2** Soprano Pipistrelle within the exposed interior brickwork of Lissardagh House attic.  
(Photo by C. Breslin, NPWS Licence Ref. DER/BAT 2024-09; 008/2024).

While roosting by individuals of a variety of bat species were identified diffusely throughout the attic space, accumulations of Soprano and Common Pipistrelle were identified above the southeastern hip-roof section with significant scratching heard in this location. Additionally, Whiskered Bat were identified within the western attic portion with at least 10 individuals on the wing observed within the roost. A dead juvenile Whiskered Bat was identified within the accumulation of droppings underneath this location. Common Pipistrelle was additionally identified centrally within the southern portion of the attic. No other bat species were identified during the course of interior inspections, with the majority of bat signs (scratching) noted within the inaccessible void between the slate and roofing membrane.

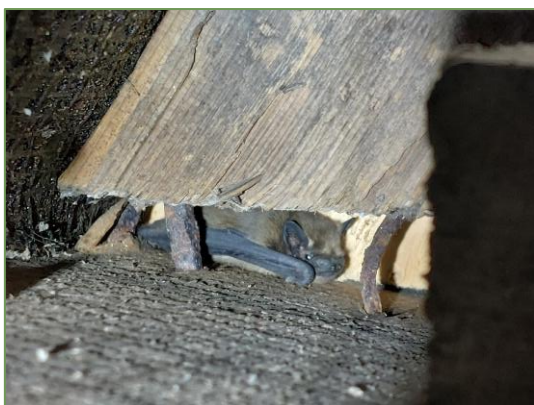
**Plate 2.3** Common Pipistrelle roosting in the ridge beam joinery within the attic of Lissardagh House.  
(Photo by C. Breslin, NPWS Licence Ref. DER/BAT 2024-09; 008/2024)

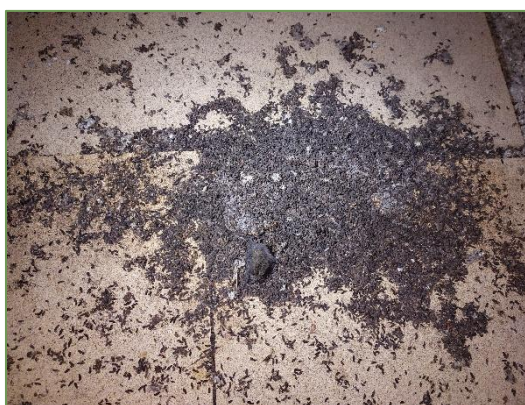
**Plate 2.4** Significant accumulation of bat droppings underneath the hip-roof apex within the western attic portion, with dead juvenile whiskered bat present also.

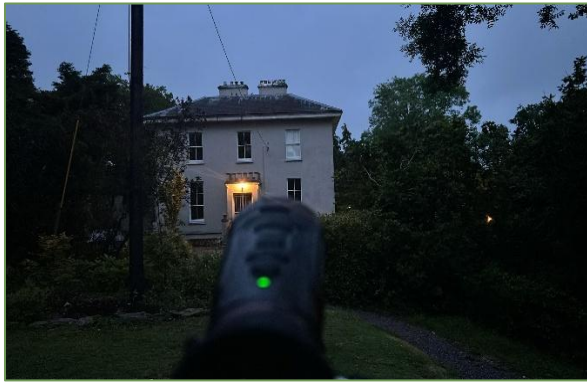
**Plate 2.5** Viewshed of thermal camera overlooking the western aspect Lissardagh Main House.

A surplus thermal night-vision aid (NVAs) was used on Lissardagh Main House on 13<sup>th</sup> June 2024 during the course of surveys on the adjacent Coach House. An ultrasonic bat detector was deployed within the viewshed of this camera to confirm species identification of observed individuals exiting the house.

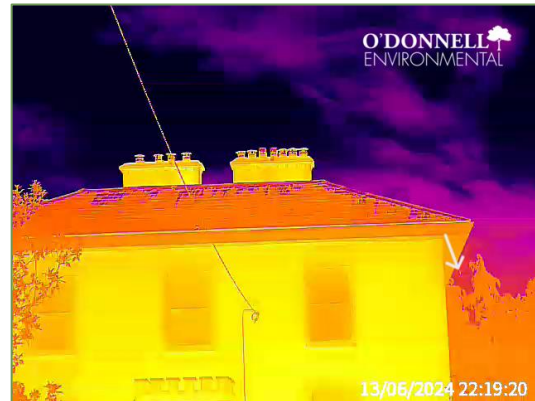
**Plate 2.6** Thermal viewshed of camera overlooking the western aspect Lissardagh Main House, showing Whiskered Bat exiting from the southwestern portion of the fascia-soffit (white arrow).

The thermal camera and associated ultrasonic detector overlooking the western aspect of Lissardagh Main House on 13<sup>th</sup> June 2024 recorded Whiskered Bat exiting from the southwestern portion of the roof, as was identified in the previous EcoFact report (see **Appendix B**).

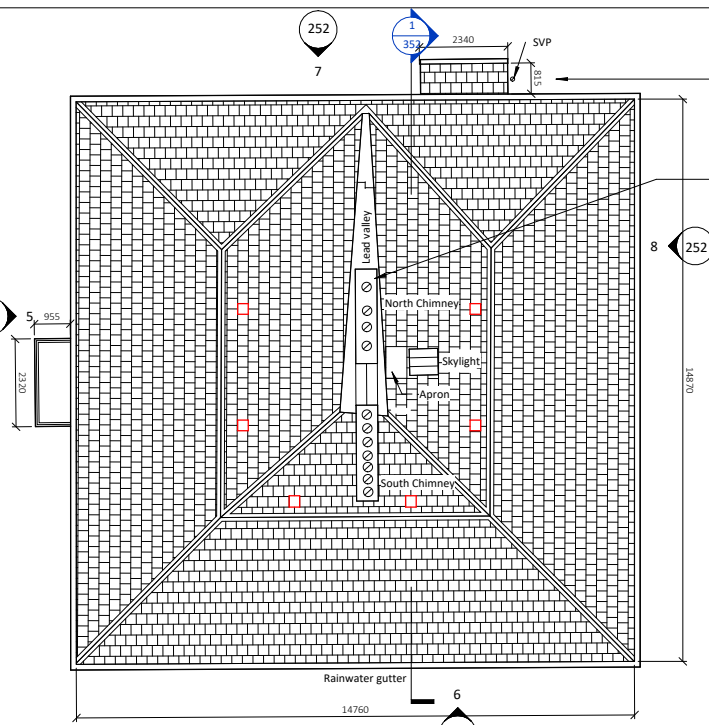
**8 Dwelling Proposed Roof Plan**  
1:100

**North annex tower:**  
Hack of the existing sand cement render and re-render with lime insulating plaster. Test the existing roof finish for asbestos. Remove by specialist, if required. Recover the existing roof structure include insulation, ventilation & flashings.

**Remedial chimney works:**  
Hack the existing sand cement render from the two chimney stacks. Inspect condition of existing brickwork, pointing, coping, flues, lead and pots. Following inspection, allow for repair damage to the above items, as required. Repoint and re-render the chimney stacks with lime render (NHL5). Install a fall arrest tie-off point to chimney, for future roof access.

**Fascias and soffits:**  
Remove PVC fascias and soffits, taking care to retain the existing lath and plaster soffit. Review condition of cross-framing between the truss ends to detail, making good as required. Construct new hardwood fascia and soffits over the retained lath and plaster soffit.

**Timber treatment & repairs:**  
Following inspection, allow for localised timber splice repairs to any decayed or damaged roof timbers. Allow for rebuilding timber valley boards in White Deal. Allow for treatment of roof timbers, with product approved by the project ecologist and the project decay specialist (Wykabor 10 or similar approved).

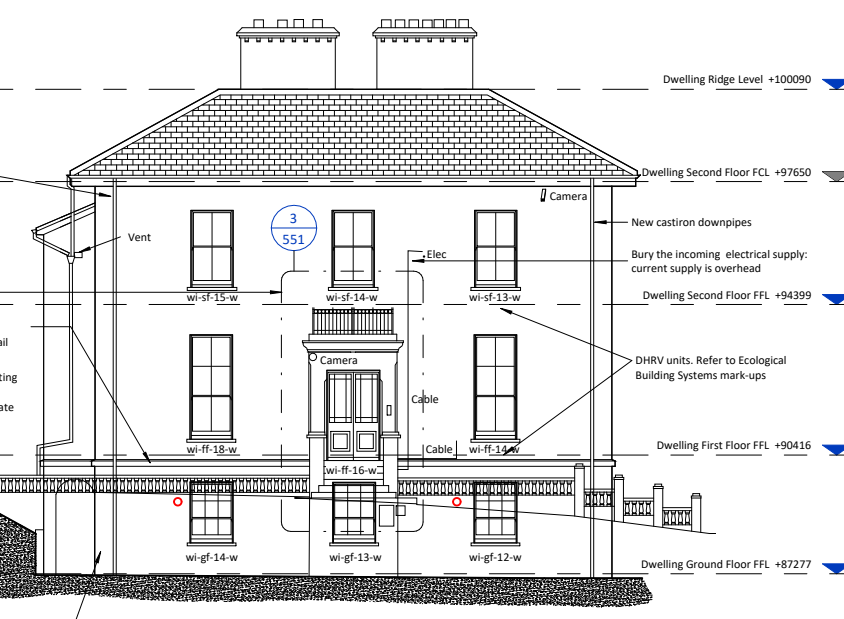
**5 Dwelling Proposed West Elevation**  
1:100

**Façade works:**  
- Render to be installed as per the attached manufacturer's instructions: 'Technical Handbook for External Application of Thermal Plaster'. Windows/doors to be protected during the hacking off and rendering. Temporarily remove the existing wall-mounted services, rainwater goods, SVPs, etc. Hack off the existing sand cement render to stone walls and brick window reveals. Following hacking, carry out local repairs to ope reveals and sundry wall substrates. Substrate must be thoroughly clean, dry, well consolidated, free of loose material. If needed use Diaseen Aquabond primer: in this case, no moisture is required. Apply Diathonite Regularization anti-salt rendering if any masonry salts are present.

- Install 50mm insulated lime render (Diaseen Diathonite Evolution) in 2 layers of 25mm. Timber battens gauges embedded in plaster, removed immediately and backfilled. Do not compress the Diathonite plaster, to preserve the porosity of the product. Include FG Mesh (Polites 140) in fresh plaster, gently pressing it about halfway thickness.  
- Incorporate 'WATstop' at plinth, to encapsulate the plaster and prevent water infiltration. Before applying first coat of 'Argathem Coloured' finishing coat, wet Evolution substrate. Finished wall to be sealed with Diaseen BKK ECO, as a breathable siloxane coating.

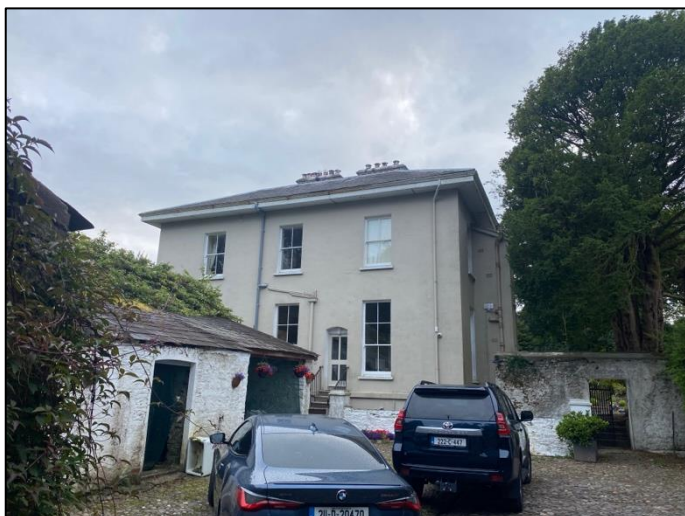
**Plate 1** Eastern face of the subject house. During the activity survey a Soprano pipistrelle was often recorded foraging here.

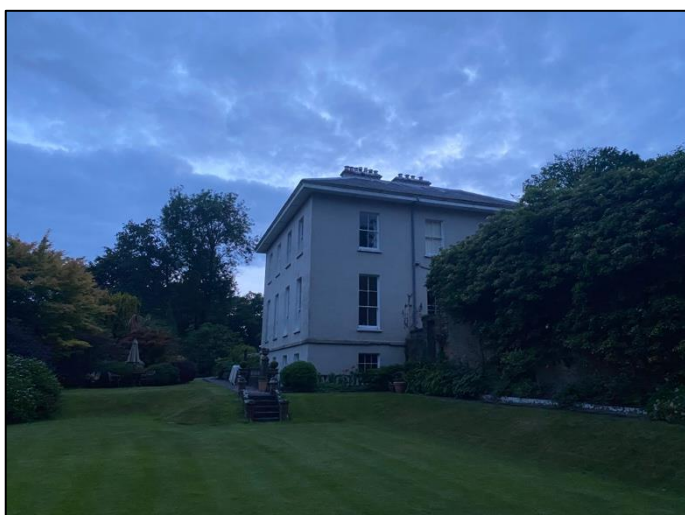
**Plate 2** The south-eastern section of the house immediately before the survey commenced. Approximately 12 bats were recorded emerging from this corner.

- Assuming weatherproofing the roof involves sealing all holes and gaps the permanent loss of the roost will occur.
- It is planned to install scaffolding on southeast corner – this is where most of the bats were observed. Works here to open the area would directly impact the ingress/egress point.

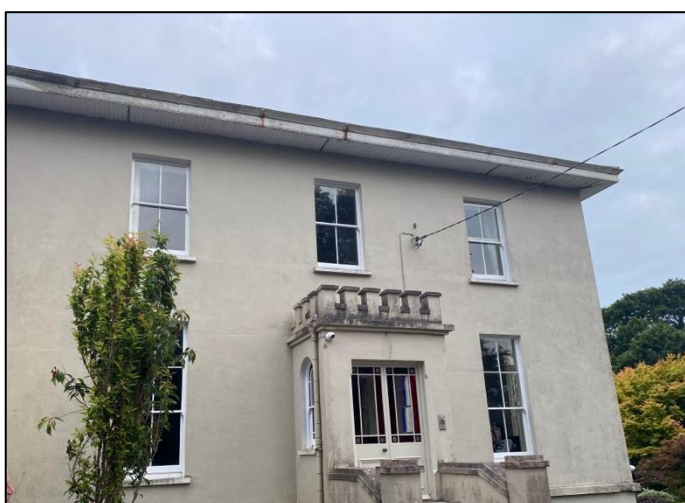
**Plate 3** Western face of the subject house. Bats were recorded emerging from the roof here.

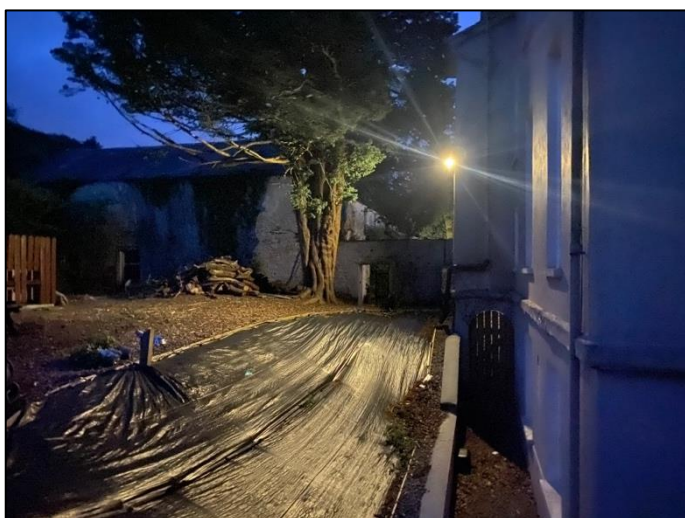
**Plate 6** Sensor lighting on the proposed development site. There were sensor lights to the north and east of the house.

- If any roof works are undertaken in the summer disturbance impacts from noise, increased human activity and lighting.
- Bats exiting the roof flew along the edge of the south facing outbuilding, which has a lot of ivy growth. If this was illuminated for example by lighting associated with CCTV this could cause disturbance and potential loss of the roost.
