# Dripsey Castle Estate Bat Survey Report

**Final**

October 2024

Prepared for:  
Meitheal Architects

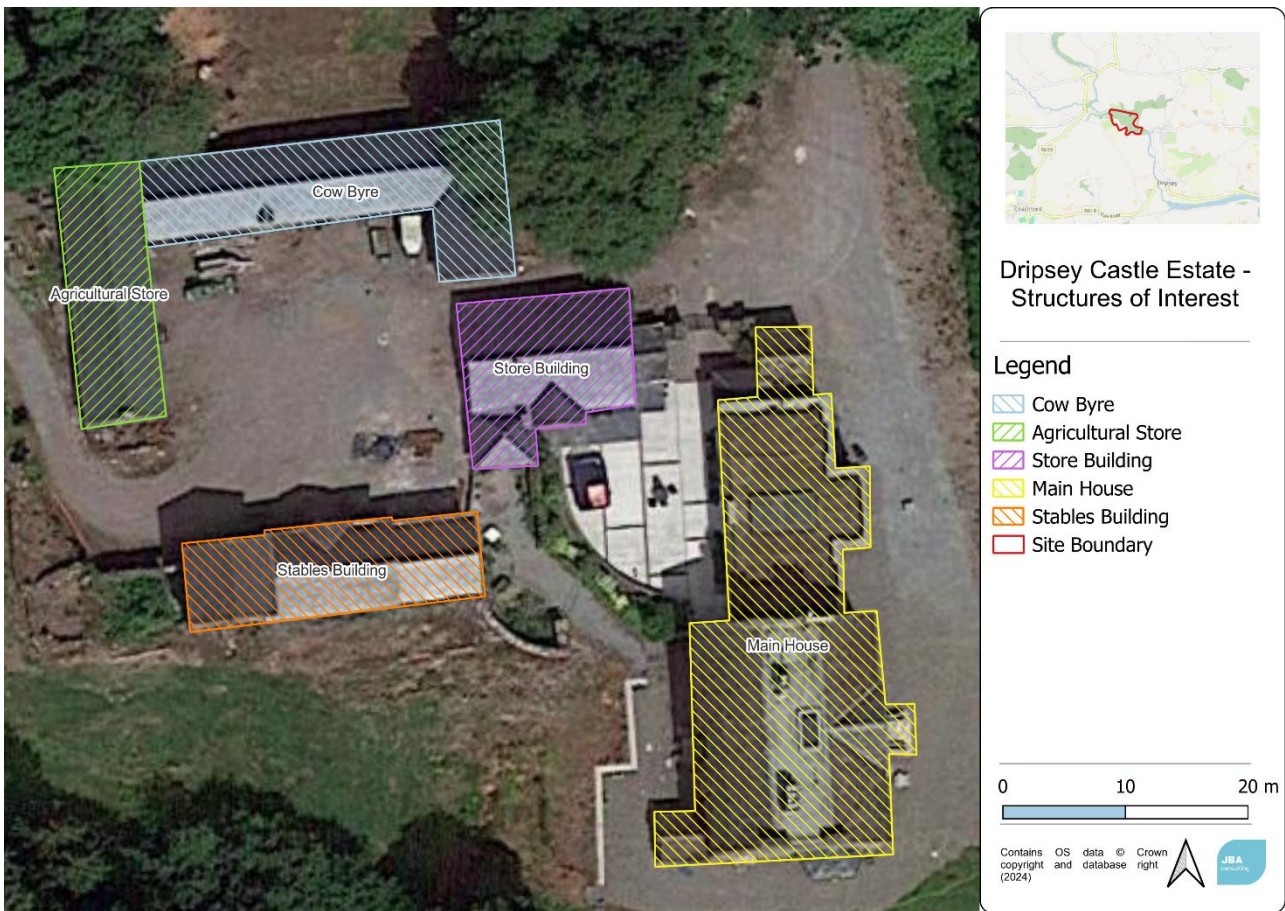
Figure 1-2: Proposed project buildings of interest.

The stable yard buildings are comprised of the following buildings: a single-storey cow byre to the north, double-storey building currently serving as an agricultural store, southern building historically used as the stables on the lower floor and store on the upper floor and a single-storey element to the east currently serving as a plant room.

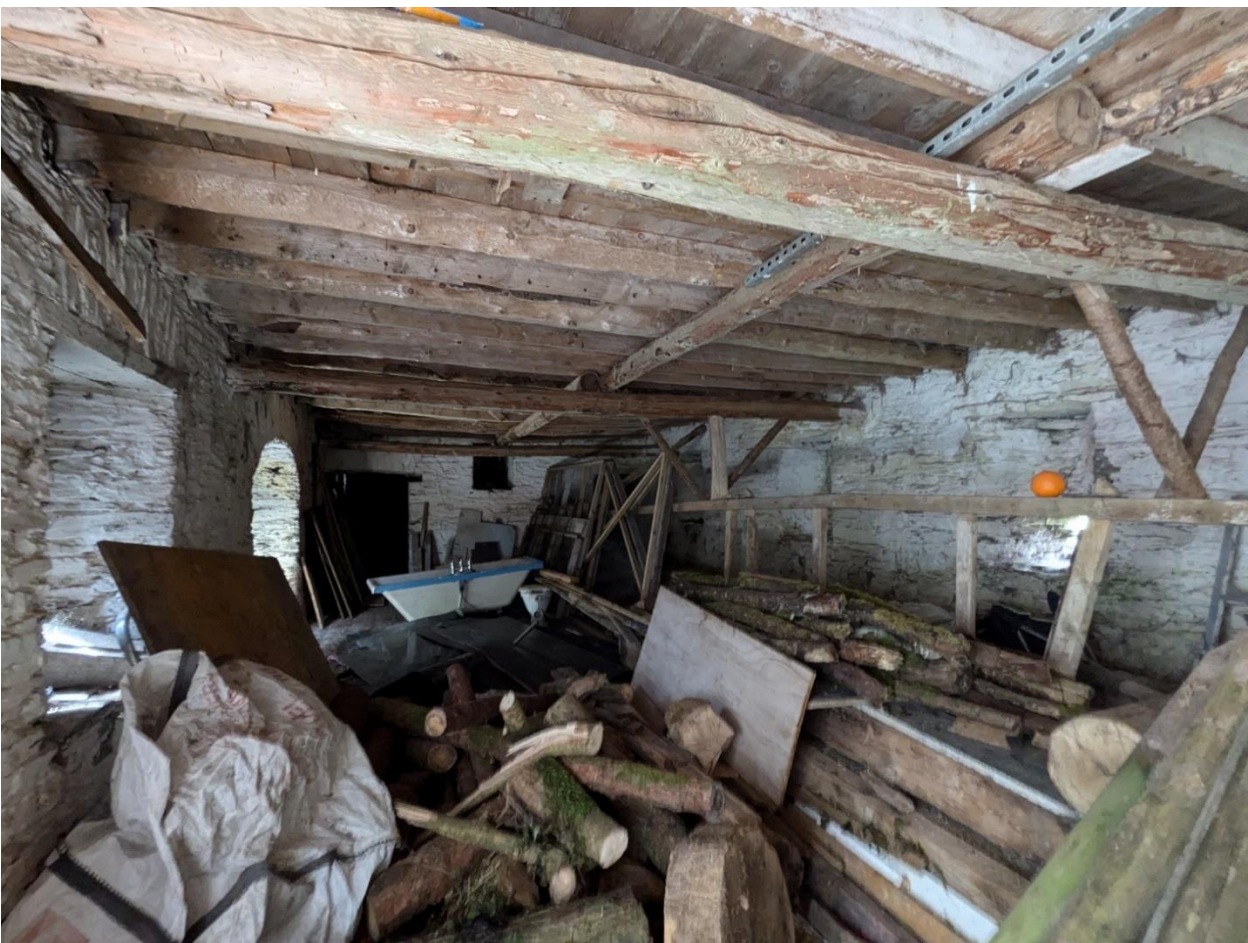
Figure 3-2: Cow byre building interior photograph of ground floor. A pool is proposed for this building.

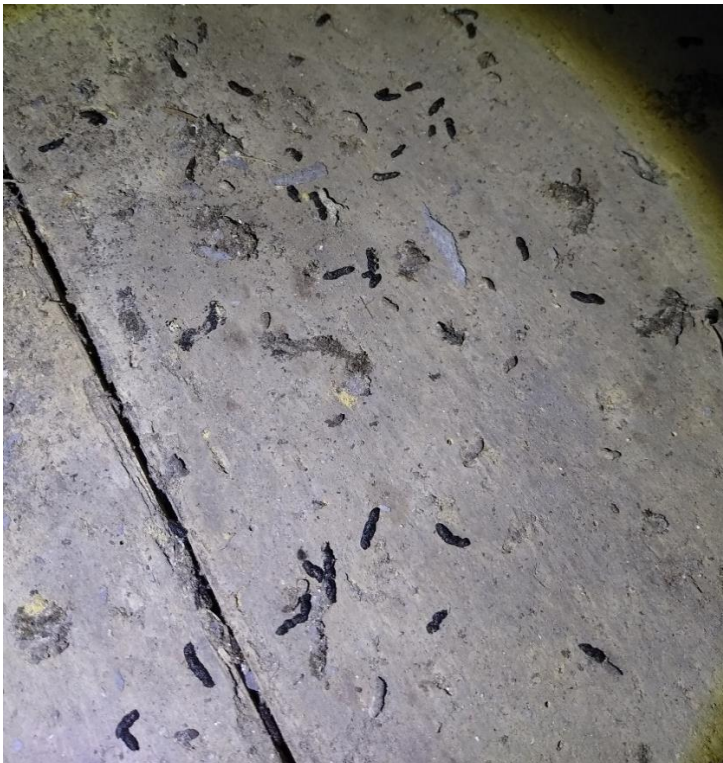
Below this cut, 60-80 fresh droppings were observed (Figure 3-4). These were very dark in colour, and slightly sticky indicating recent deposition. Other dried and faded droppings were also recorded. A sample of the droppings was collected for DNA analysis to confirm species.

These observations confirm the presence of roosting bats in the building.

Figure 3-4: Droppings on the floor below the hole.

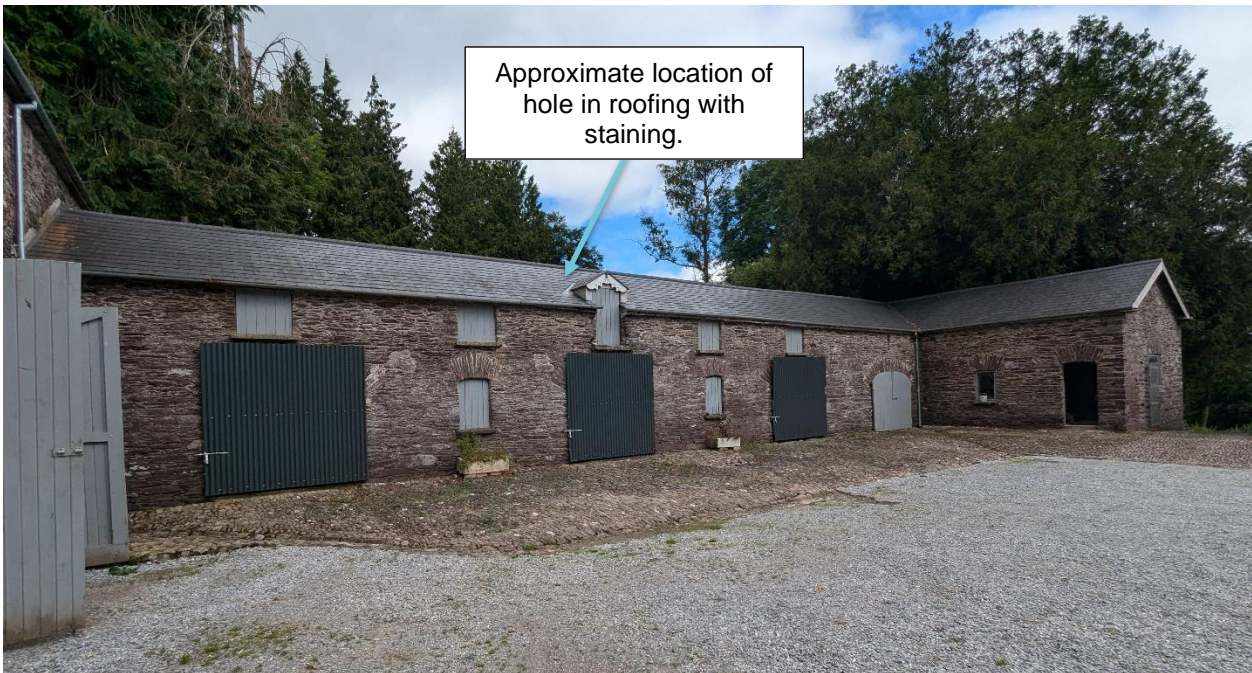
The cow byre building (Figure 3-5) was assigned a high level of suitability for roosting bats. The second level of the building had previously been inaccessible to surveyors due to the uncertainty of the stability of the floor. It was noted that gaps in the galvanised doors and wooden boarded windows could provide access points for bats entering the building.

Figure 3-5: Cow byre building.

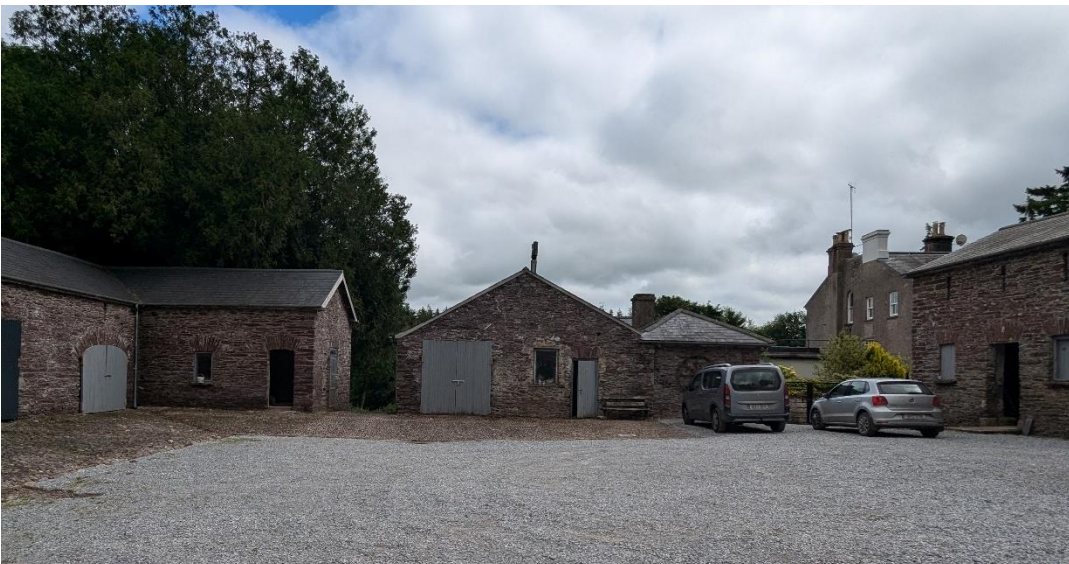
This was assigned low-moderate level of suitability for roosting bats. The building a few potential access points for bats. It is the most used of all the sheds with a wood burner for heating. It will remain a store building.

Figure 3-6 Store building.

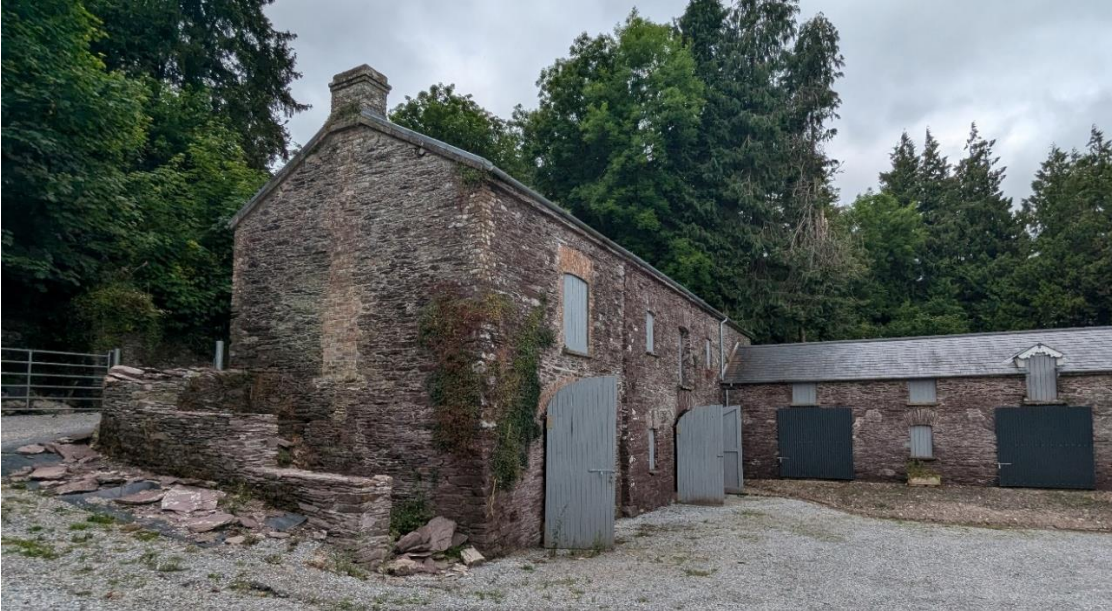
including two open chimneys, gables and gaps in roofing and doors. The second level of this building was accessible from the rear.

No physical evidence of bat usage was identified within the building.

Figure 3-7: Exterior photograph of the agricultural store building.

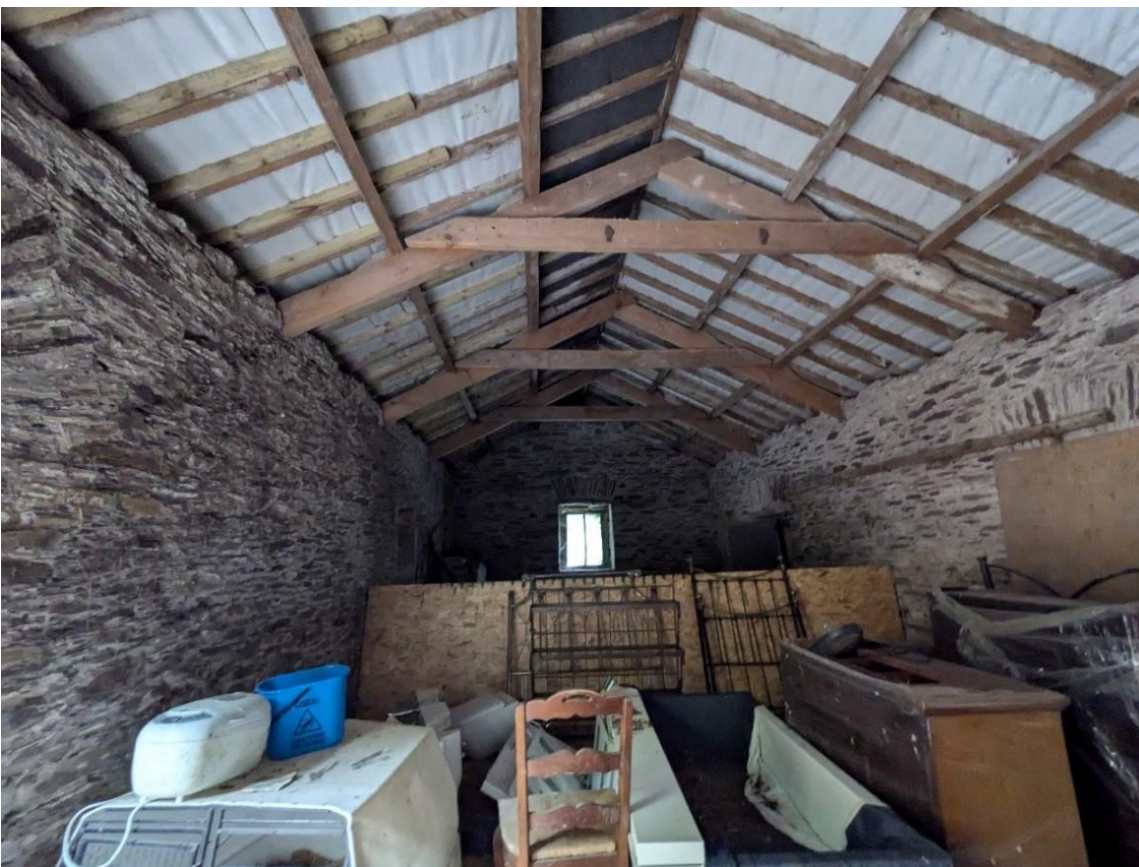
Figure 3-8: Interior photograph of second floor of agricultural store building.

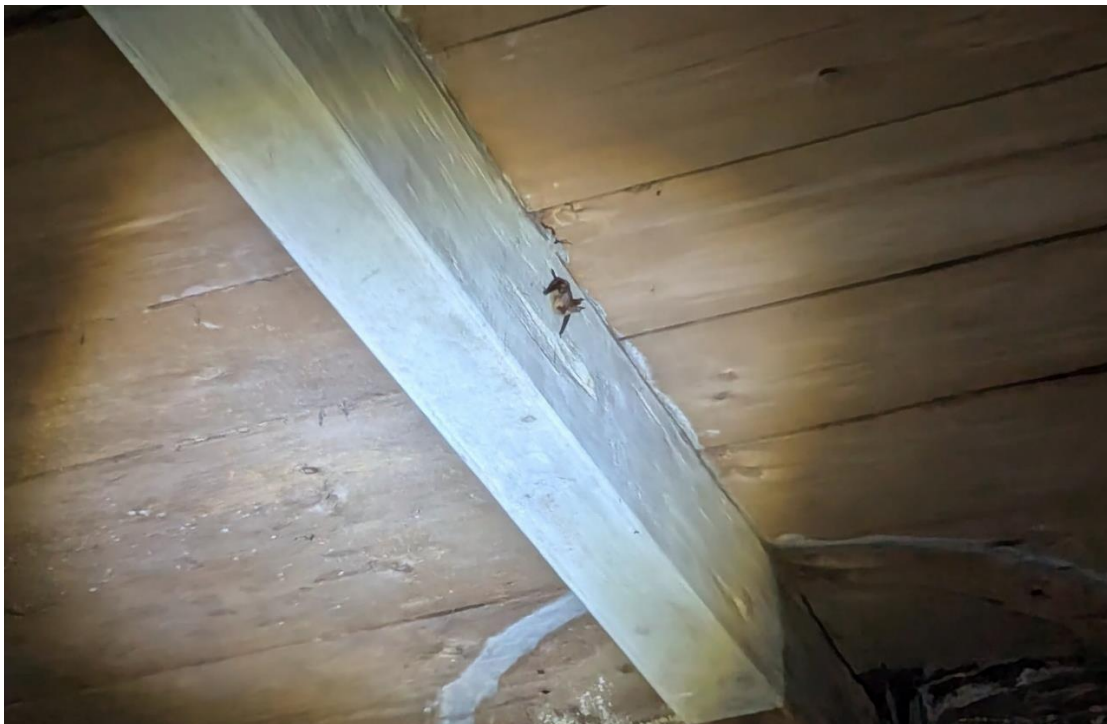
Figure 3-13: Brown Long-eared Bat recorded at 23:10 in the stables to be renovated for accommodation. This building is confirmed roost for BLEs.

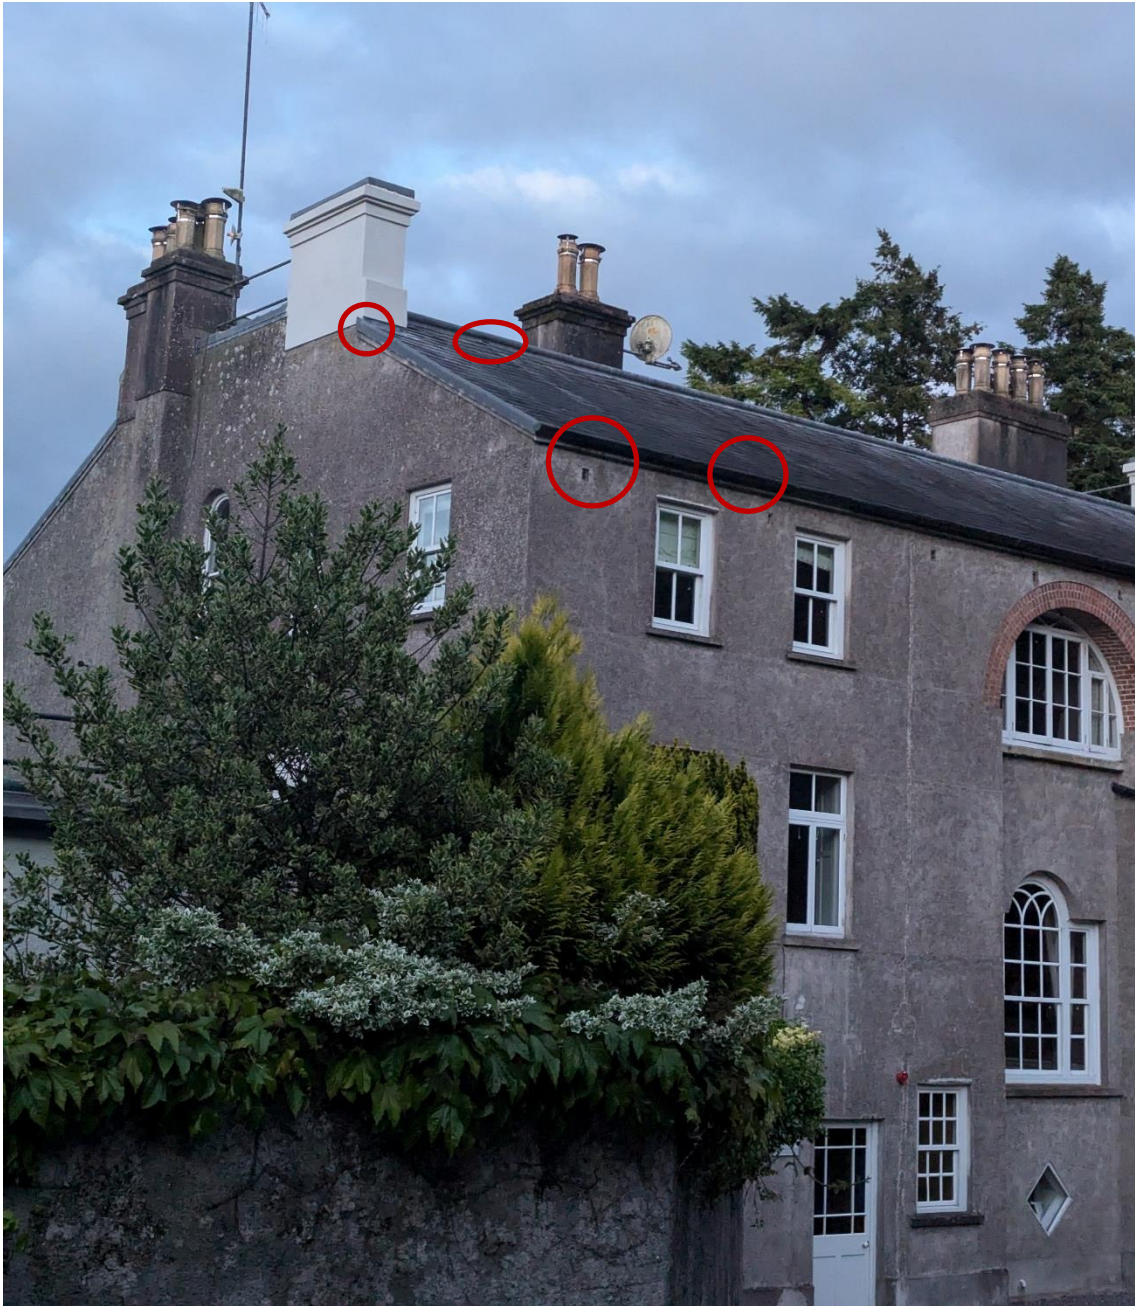
Figure 3-14: Emergence points used by the Soprano Pipistrelles from Dripsey House. No works are proposed on this building for the proposed project and this roost will not be impacted.

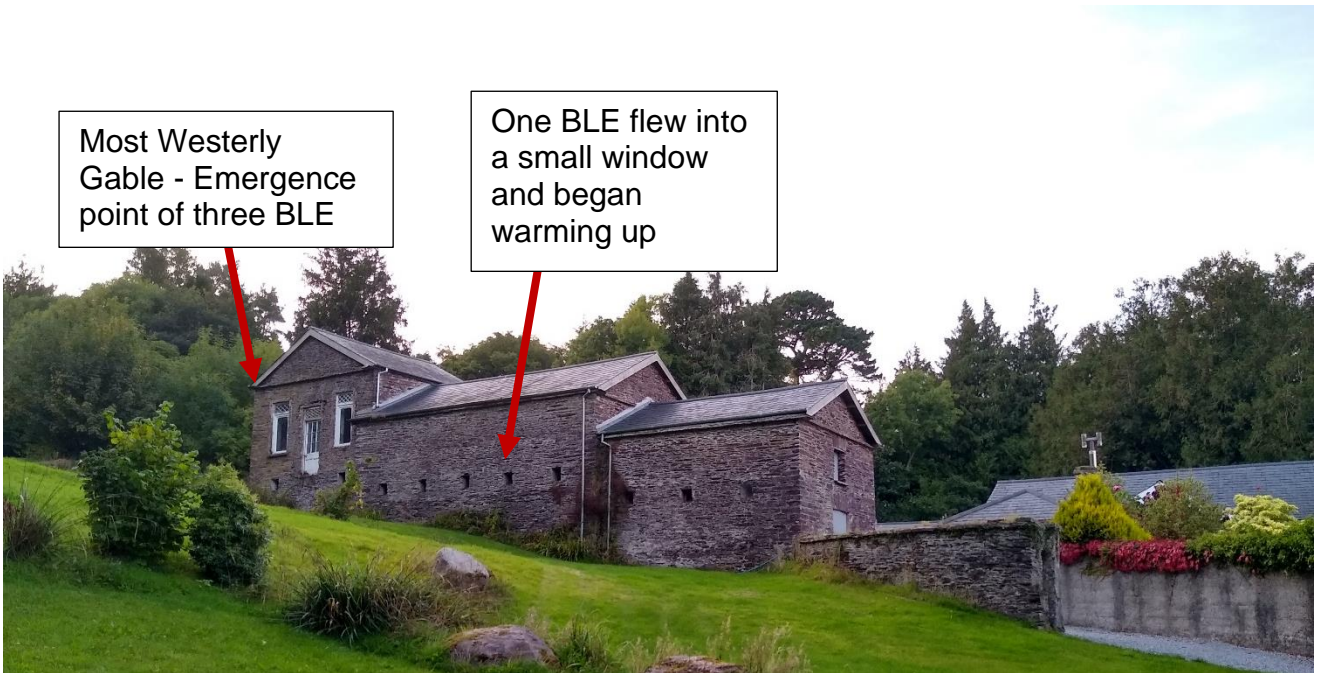
20:07	Brown Long-eared Bat	Stables	Single BLE emerges from the most westerly gable of the Stables building, flies directly into the central building's attic space (Figure 3-15).

Figure 3-15: Rear of Stable building.

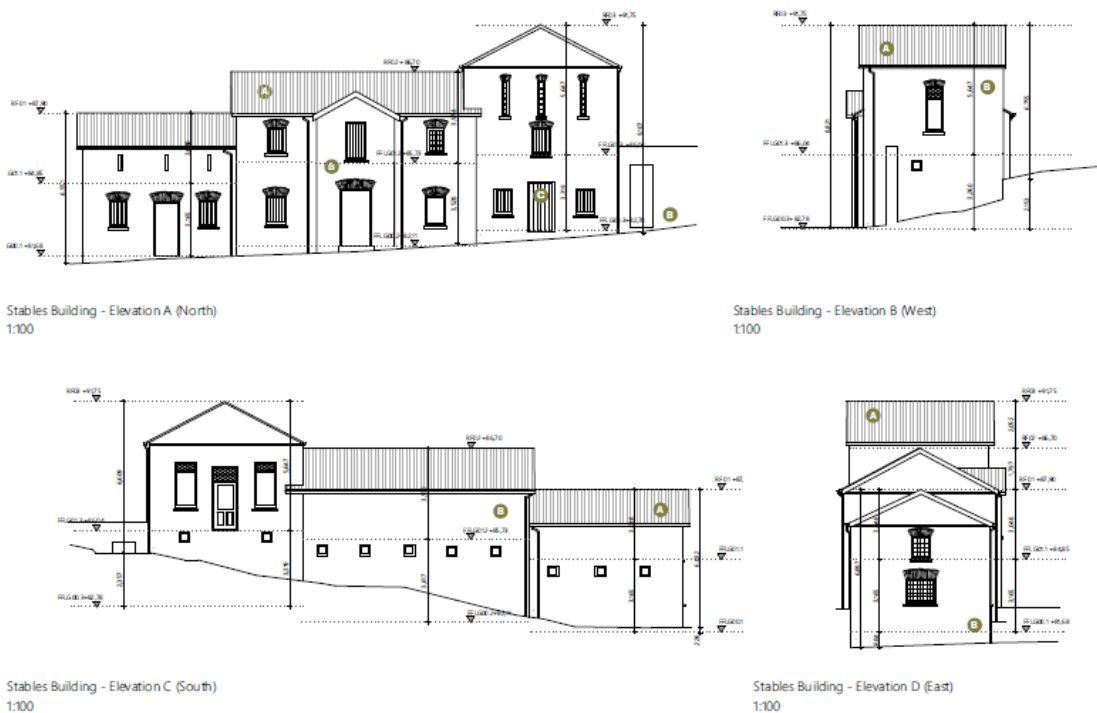
#### STABLES BUILDING & STORE BUILDING - EXISTING ELEVATIONS

Figure 4-1: Drawings made of the current extent of the Stable building in which the BLE roost was recorded. This will be renovated to be guest accommodation.

The works to the old stables will include alterations, renovations, extension and change of use of this building into a garden room and 4 no. bedroom suites, for short-term letting.
