## BRIEFING NOTE

Project Reference	220255
Date	10.09.2024
Subject	Phase 2 Bat Survey at Belvedere House
Authors	Laura McEntegart (BSc.), Aoife Joyce (BSc., MSc.)

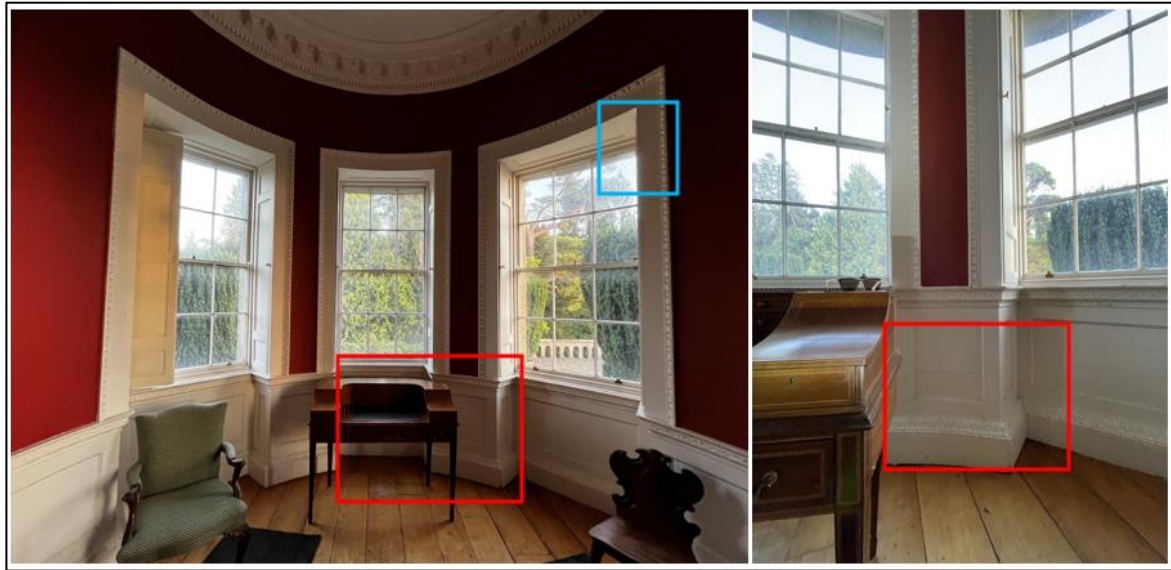
A total of 70 bats were recorded emerging from the crevice above the ground floor southwestern bay window. Species consisted of predominantly Soprano pipistrelle with some Common pipistrelle also present. Additionally, 15no. bat carcasses (10no. male, 5no. female pipistrelles) were identified in the building interior since the surveys carried out the previous year. Seven were identified in the ground floor room, five identified in first floor room and two identified in central hallway. Following a thorough inspection, it was not evident where exactly the bats were entering the building; however, small gaps are present under skirting boards and floorboards. It's clear that bats are roosting behind a cavity in panelling along the southern bay window at ground level (audible during daytime). There may also be access to the first floor within this cavity. No other roosts or evidence of roosting bats were identified.

*Plate 1 Ground floor – south-west bay area. Bats audible within the panel marked (red). Exterior roost entrance (blue).*

- *The identified roost entrance on the southern bay window and wall cavity will be retained throughout the works. Access by bats to the interior of the structure will be identified and restricted to ensure bats can no longer get trapped inside with no exit.*

- *Any internal works on the southern bay panelling will be supervised by a licenced ecologist to ensure the internal roost cavity remains intact during the works and bats can return.*

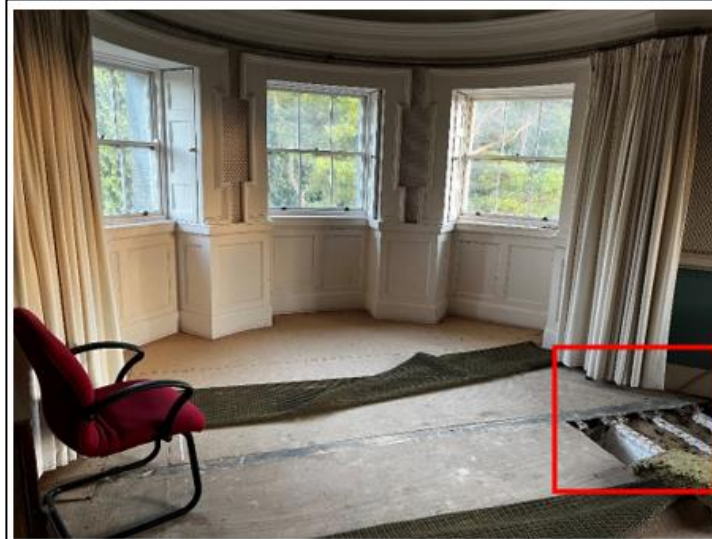
*Plate 2 Evidence of bats accessing 1<sup>st</sup> floor interior potentially through floor gaps/panelling.*

- *In the interim, as interior access points are still unconfirmed, in order to allow bats to escape from the building, a window on the ground and first floor have been left open slightly to allow for exiting.*

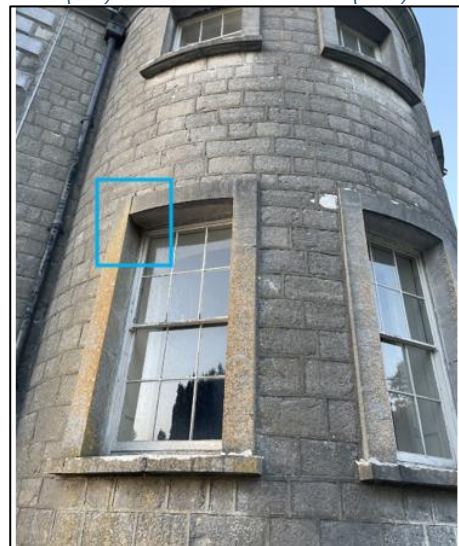
*Plate 3 Bats recorded emerging from window crevice.*
