**RE: Bat derogation licence application to (i) interfere with a bat roosting site and (ii) potentially disturb roosting bats associated with permitted renovation/demolition works associated with Sprayfield House at Ballynabooley, Sandycove, Co. Cork.**

### **OVERVIEW OF BAT ROOSTING AT THE STABLES BUILDING**

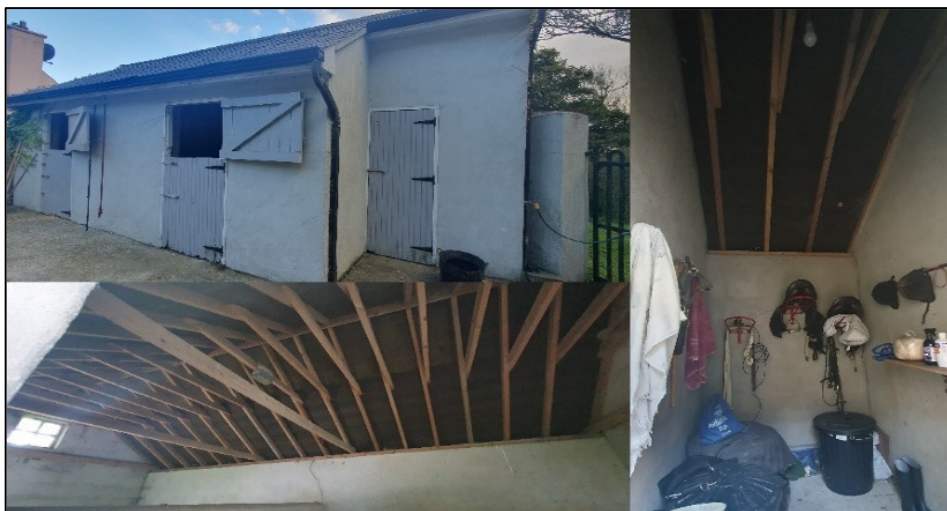
A Brown Long-eared Bat day roost was noted in association with exposed roof timbers in the tack room of the stables located west of Sprayfield House (see Plate 3). During both September dusk emergence surveys in 2023, five Brown Long-eared Bats were observed roosting on each occasion with all exiting during the dusk survey. The exit points used by the Brown Long-eared Bats from the building were not confirmed though, where two external walls are covered by ivy. The overall roof (tack room & associated stables) is slated with a membrane on its underside and exposed timber roof timbers, where the membrane has holes (see Plate 3).

A relatively extensive amount of Brown Long-eared Bat droppings was also noted on the ground of the tack room, adding to the indications of a maternity roost here in 2023. Droppings were also noted on the ground within the stables part of the overall building, along with several Small Tortoiseshell butterfly wings at various locations indicating relatively frequent night roosting activity from Brown Long-eared Bat when handling its butterfly prey from a perch overhead (*i.e.* exposed roof timbers in this case). No daytime roosting bats were ever observed at the exposed roof timbers within the stables area of the overall building and there are no substantive crevice opportunities for such bat species present either (see Plate 1).

**Plate 1: Stables building with tack room (top left) and internal area of tack room that likely supported a brown long-eared bat maternity roost in 2023 (right) and internal area of stables that was used for night-roosting activity by Brown Long-eared Bat in 2023 (bottom left).**

In summary, the stables building likely supported a relatively large Brown Long-eared Bat maternity roost in the 2023 Summer period with daytime roosting continuing into the Autumn/early Winter period. Brown Long-eared Bat is a widespread resident bat species in Ireland, although not as frequently recorded as both Pipistrelle species (Roche *et al.* 2014). The conservation significance of the likely Brown Long-eared Bat maternity roost site at the tack room of the stables building in 2023 was potentially of medium to high conservation significance (see Figure 20 in Marnell *et al.* 2022).

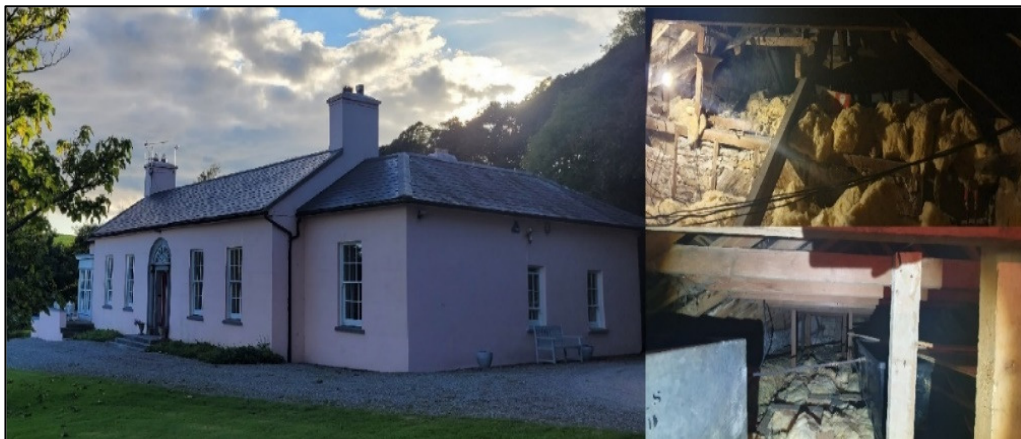
Sprayfield House (dwelling) has two attics that were accessed as part of the 2023 assessment. Both attics had exposed roof timbers with membrane under the slated roofs in some sections but not all (see Plate 2). Mortar was generally present between exposed stonework thereby limiting roosting opportunities at crevices between stonework (see Plate 2). Inspection of both attics noted that they had a lot of cobwebs with no signs of bats (including droppings, staining, water tanks, etc.) nor any day roosting bats ever noted during the 2023 assessment.

**Plate 2: Sprayfield House dwelling (left) and internal attic spaces (top & bottom right).**

In summary, there was no evidence of bat roosting associated with Sprayfield House in 2023 and again in 2024.

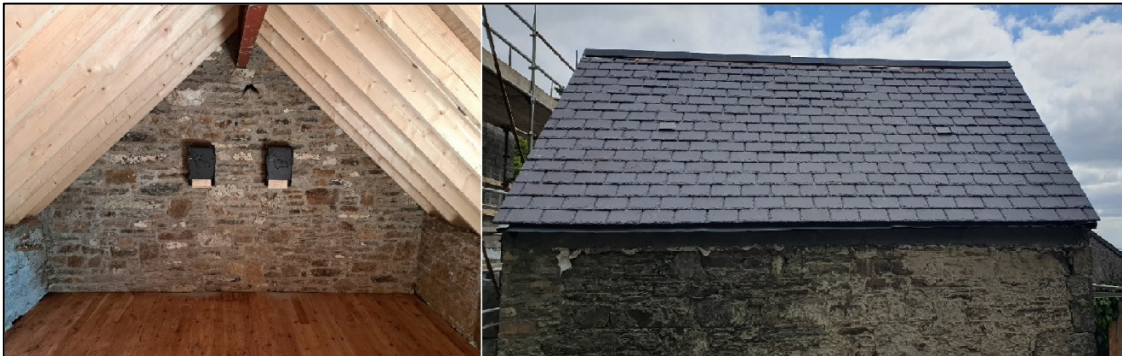
As previously mentioned, a dedicated Bat Roosting Loft was created by redeveloping an existing Loft space (in May 2024, Plate 3) as part of mitigation commitments for Soprano Pipistrelle under Bat Derogation Licence (DER/BAT 2024 – 07).

A passive detector has been deployed within this space as part of monitoring commitments since 10<sup>th</sup> July 2024 date, which has confirmed some activity within this feature by Soprano Pipistrelle, Natterer's Bat *Myotis nattereri* and possibly Common Pipistrelle *Pipistrellus pipistrellus*. The activity in question to date has comprised of night activity with no evidence of day roosting so far but confirms that the installed bat access points are accessible for bats and are allowing bats to explore this relatively new redeveloped space. Roosting features within the dedicated Bat Roosting Loft include additional timbers at the rafters to create roosting crevices (in line with BCI 2015), along with bat boxes (4 x Schwegler Flat Bat Box 1FF with built-in wooden rear panel). A total of four bat access slates were installed, two on each roof slope.

**Plate 3: Internal area of dedicated bat roosting loft showing rafter roost crevice timbers & bat boxes (left) and western roof slope with 2 x bat access slates (right).**

5. Install sections of boarding to rafters: Install untreated 1.2m wide board (e.g. plyboard) to underside of rafters (towards apex), leaving 1 inch along the apex for bat access. Cover half the length of the roof on one side of the apex and also half the length on the other side (staggered or alternated from each side) to increase both secure closed and open roosting opportunities for adult and young Brown Long-eared Bats. ***The implementation of same will be undertaken under advice/supervision of Dr Kelleher & her Ecology team at site.***

6. Improve roughness of (new) exposed timbers under roof: Horizontally score new exposed timbers under roof (rafters, boards) to make it less smooth so that bats can more easily latch onto the timbers with their feet and move about. Horizontal grooves to be about half an inch apart. ***The implementation of same will be undertaken under advice/supervision of Dr Kelleher & her Ecology team at site.***
