Dingle House, Ballycorus Road, Kilternan, Dublin 18

Bat Survey

FINAL REPORT

30th July 2024

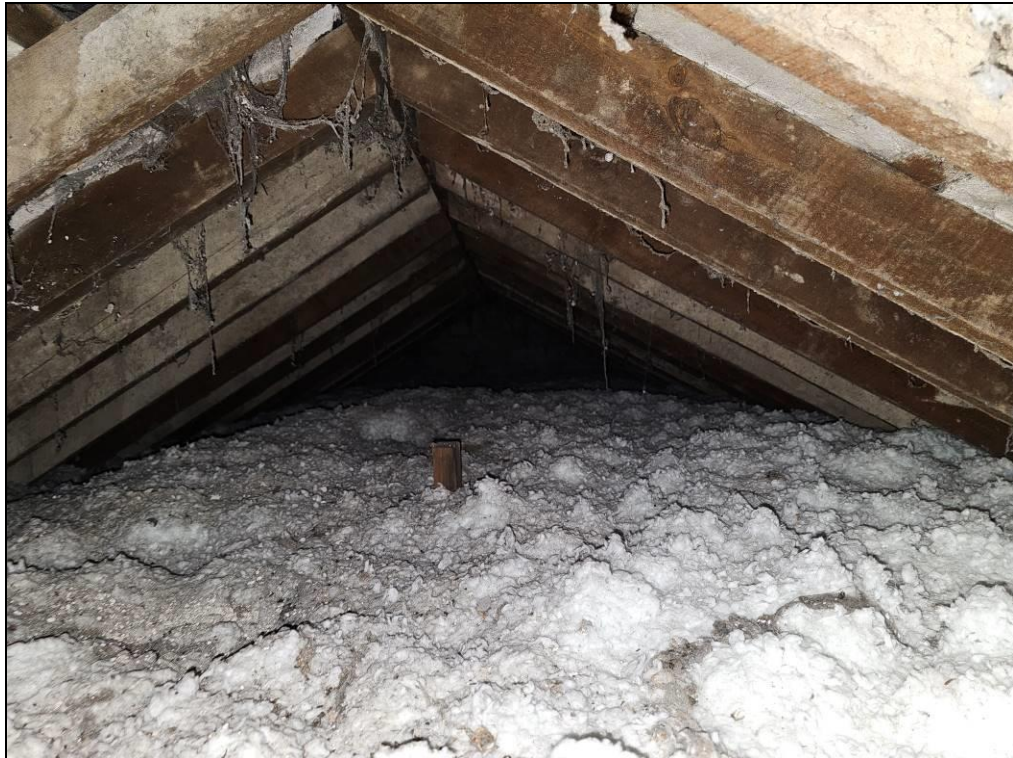
The buildings were examined internally, where possible, by Faith Wilson. The attic of the main house is insulated with a natural wool type of insulation but is very small and could not be fully accessed. A small number of pipistrelle bat droppings were recorded on the cover of the attic hatch indicating that this building had been used in the past, very rarely, by a bat for roosting purposes. The attic is festooned with several cobwebs and the house is roofed with traditional slates on battens with traditional lime parging. A slipped slate offers access to this attic but there was no evidence of any significant use by bats for roosting purposes.

Plate 1. The attic of the main house.

Should the roof of the main house need to be stripped and/or fully replaced this must be done under the supervision of a licensed bat specialist and ideally conducted when bats are active and can escape out of harm's way. Ideally these works would be done during the autumn months when bat numbers are known to be lower in buildings and they are not yet in hibernation.

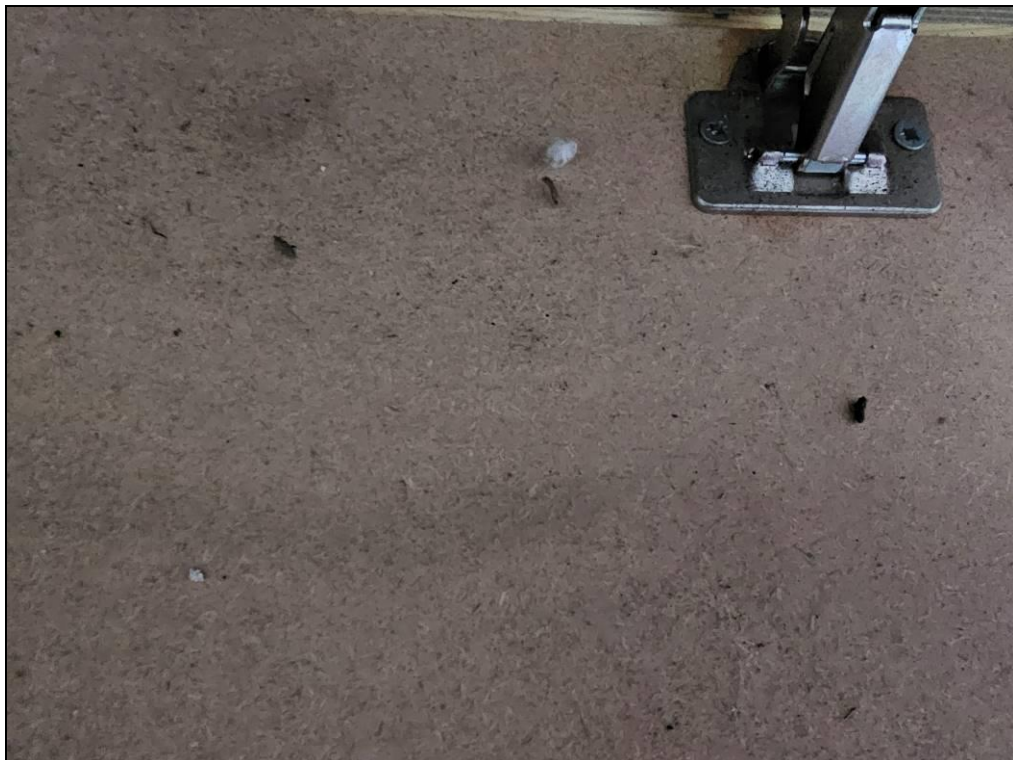
Plate 2. Bat droppings on the attic hatch in the main house.

Any minor repairs to existing roof should be done carefully with the expectation that individual bats may be found. If discovered, the animals should be retained in a box until dusk and released on site. Please inform a bat specialist and ask for further advice.

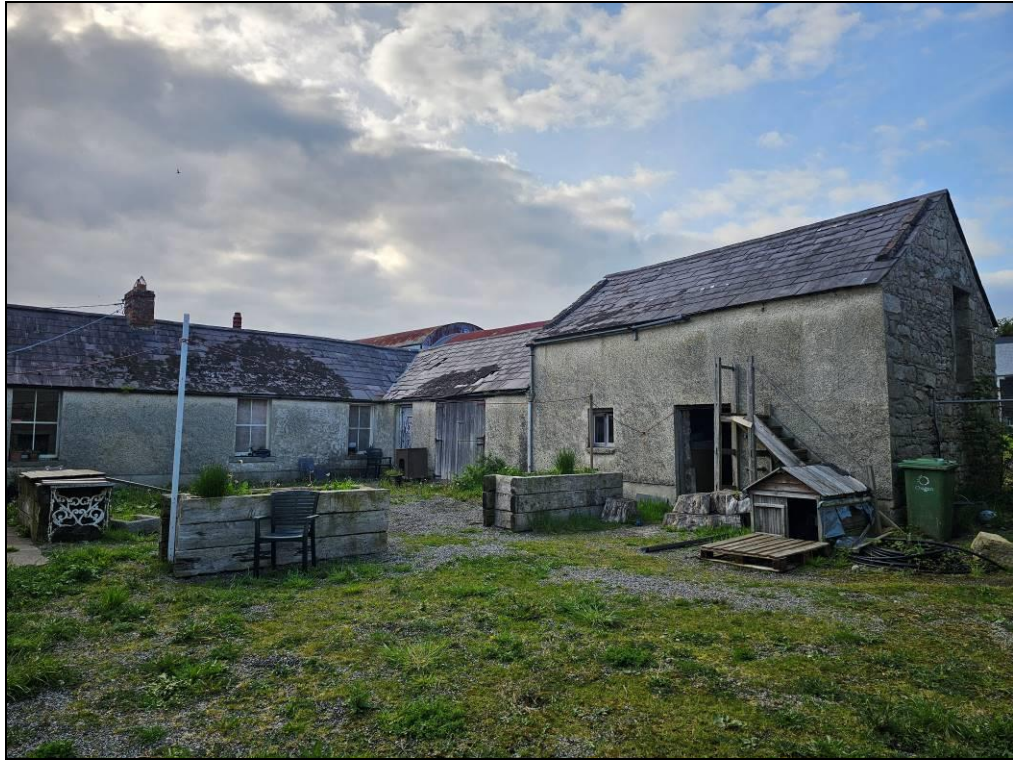
On the northern side of the yard there are three buildings running from east to west. These are the 'Dog Shed', the 'Wood Shed' and the former dairy 'Store'. These buildings are all roofed with traditional slates on battens with traditional lime parging.

Plate 3. The 'Dog Shed', the 'Wood Shed' and the former dairy 'Store'.

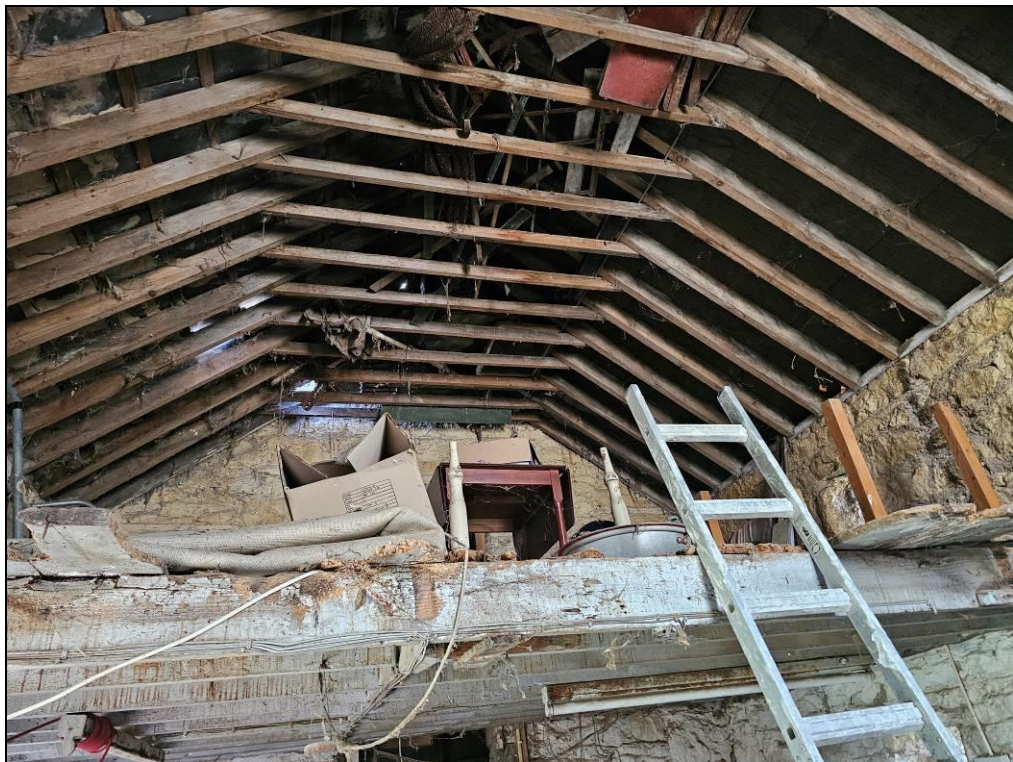
The 'Dog Shed' is a two storey shed with a loft of rotten timbers rendering the area unsuitable for safe survey. This area was very bright on account of a large window in the eastern gable wall, rendering it less favourable to roosting bats.

Plate 4. The interior of the 'Dog Shed'.

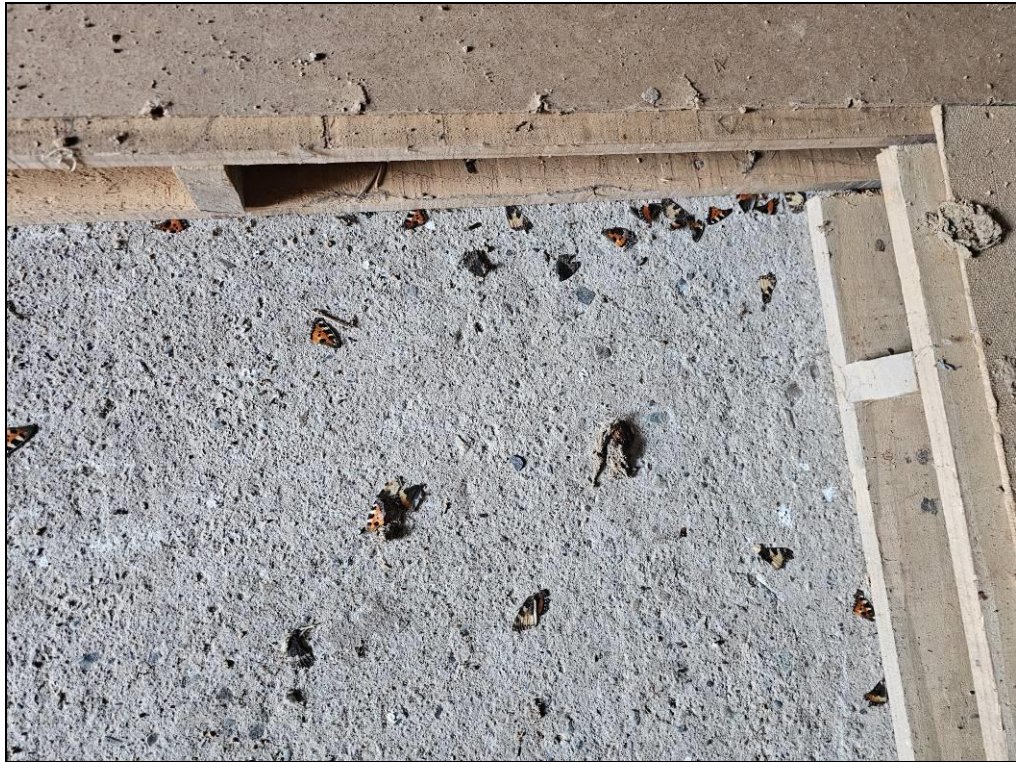
Adjoining this is the 'Wood Shed', which is darker, but is linked by an open door at loft height to the 'Dog Shed'. A number of slates are missing off the roof affording bats access to the space. Many discarded Small Tortoiseshell butterfly wings were recorded in the 'Wood Shed' - these are typical signs of

roosting Brown long-eared bats (*Plecotus auritus*), which perch to eat their foraged Small Tortoiseshell butterfly prey.

Plate 5. Discarded Small Tortoiseshell butterfly wings in the 'Wood Shed'.

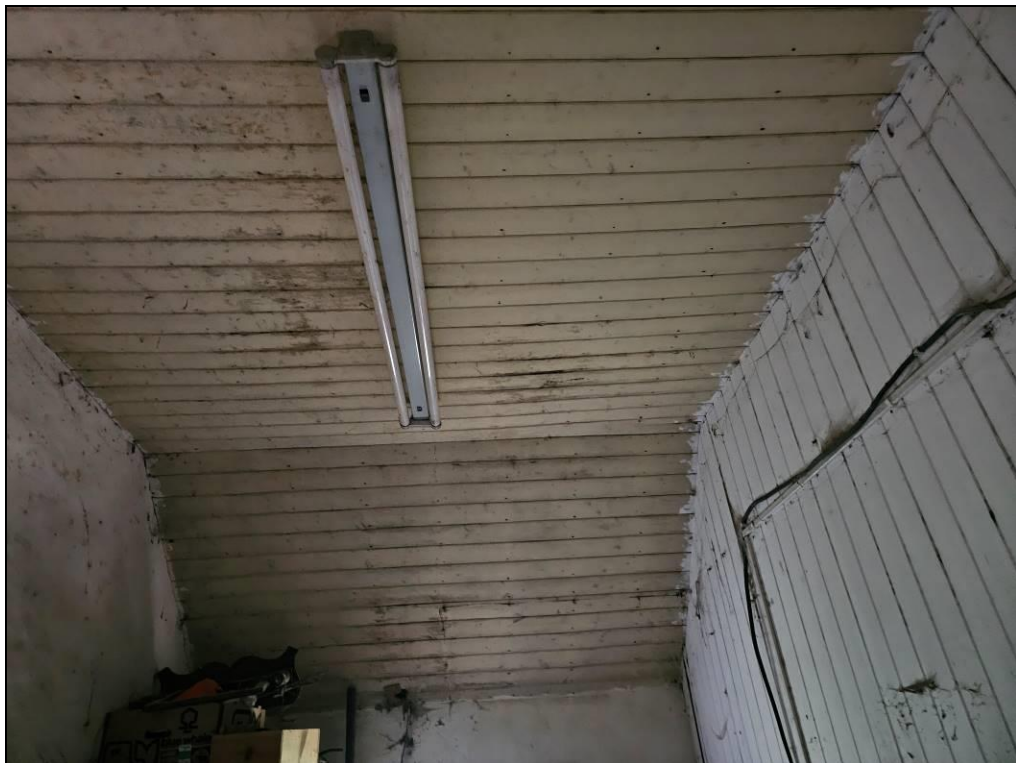
Plate 6. TG and V ceiling in 'The Store'.

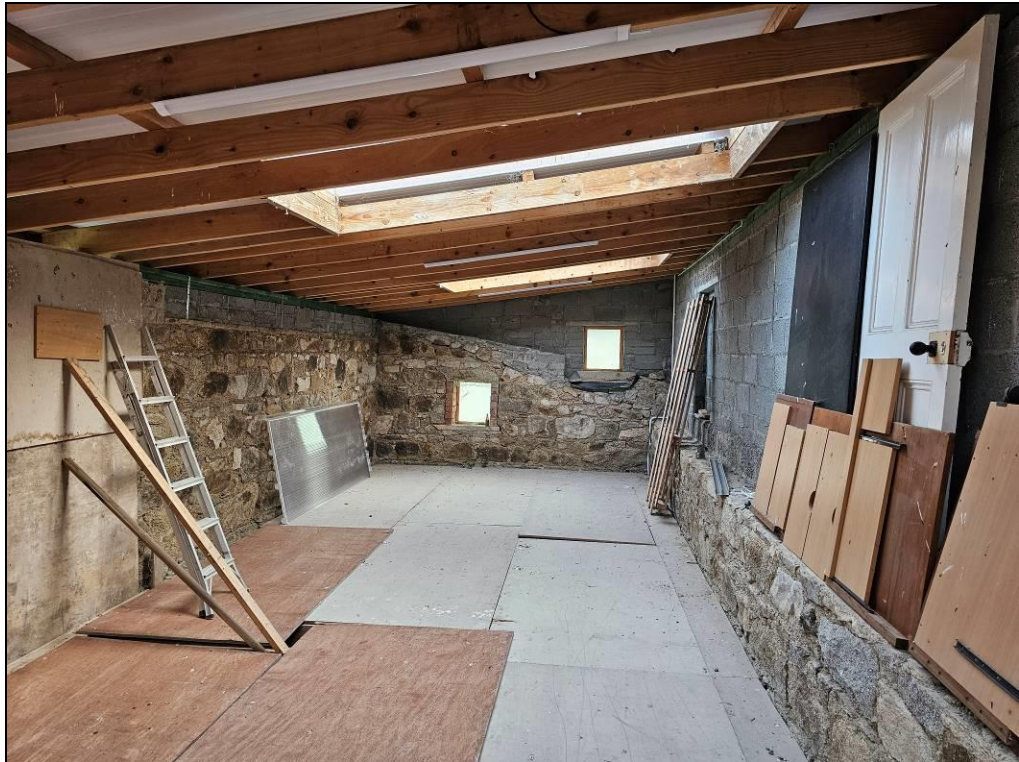
Small Tortoiseshell butterfly wings and bat droppings were also recorded in the loft of 'The Former Cow Houses' building which is roofed with modern insulated metal sheeting.

Plate 7. The loft of 'The Former Cow Houses'.

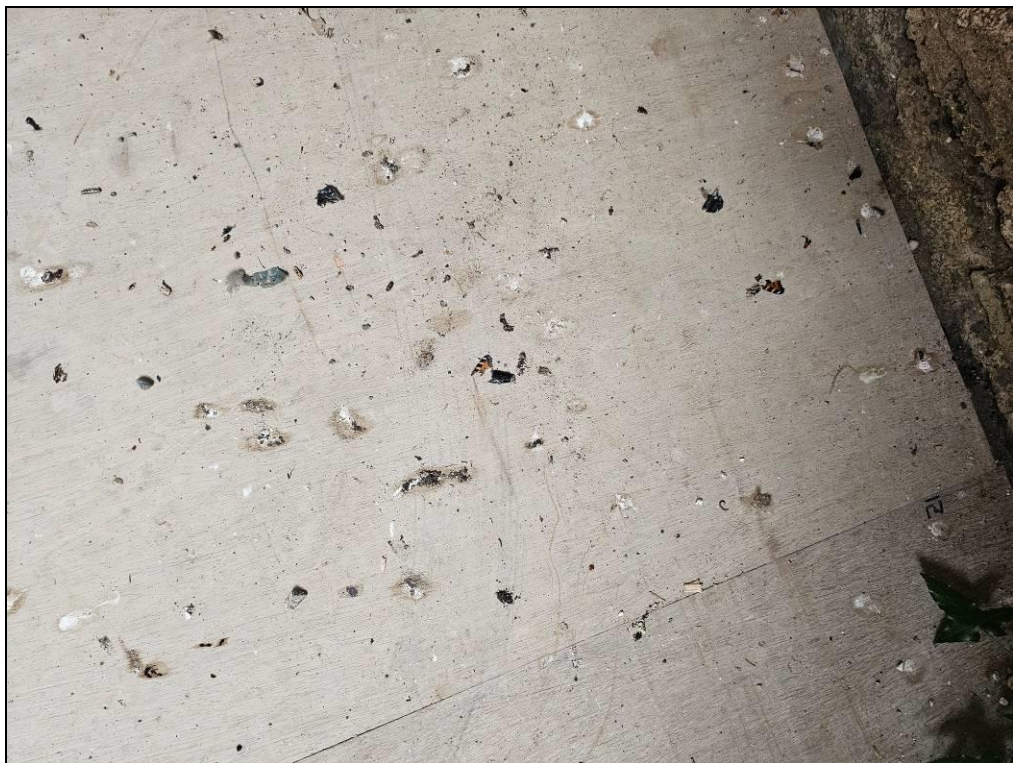
Plate 8. Discarded Small Tortoiseshell butterfly wings and bat droppings in 'The Former Cow Houses'.

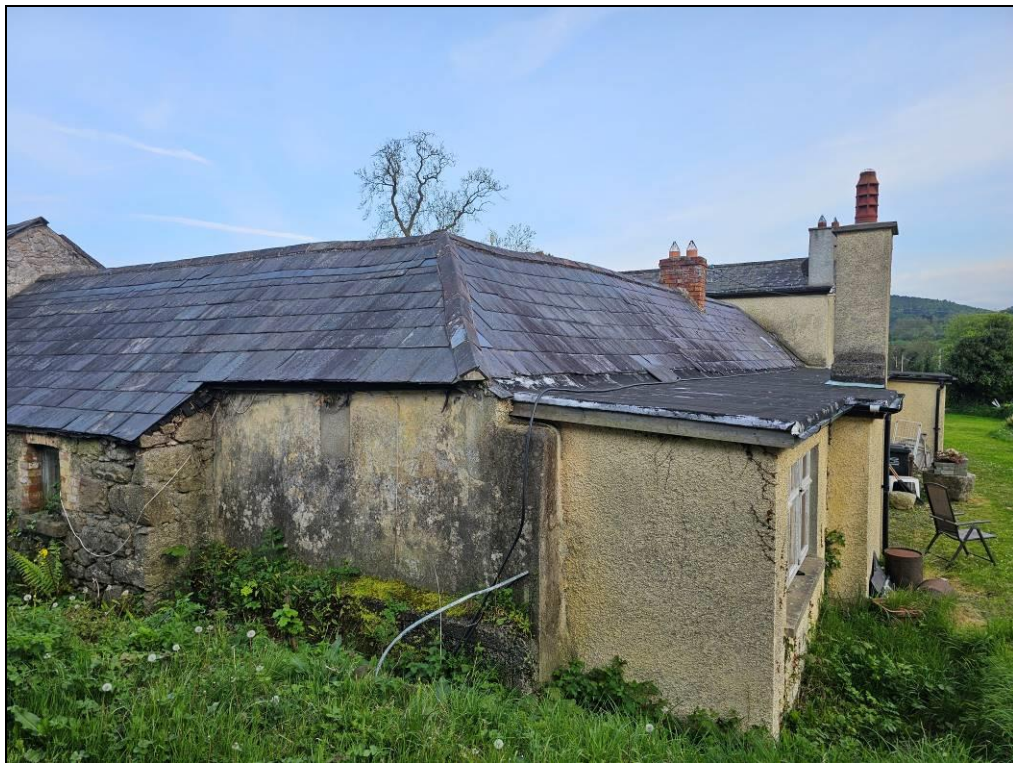
Plate 10. Looking south over the flat roof extension adjoining The 'Games Room', 'File Storage Room' and 'Office'.

The roof above the Office/File Storage/Games Room is also traditional slate on battens with lime parging. A flat roof extension is found to the west of this as can be seen above.

The flat roofed extension at the rear of the house, which is scheduled for demolition and replacement, will be resurveyed for bats prior to any proposed demolition works as some time may have elapsed between the present survey and these works once planning permission is granted.

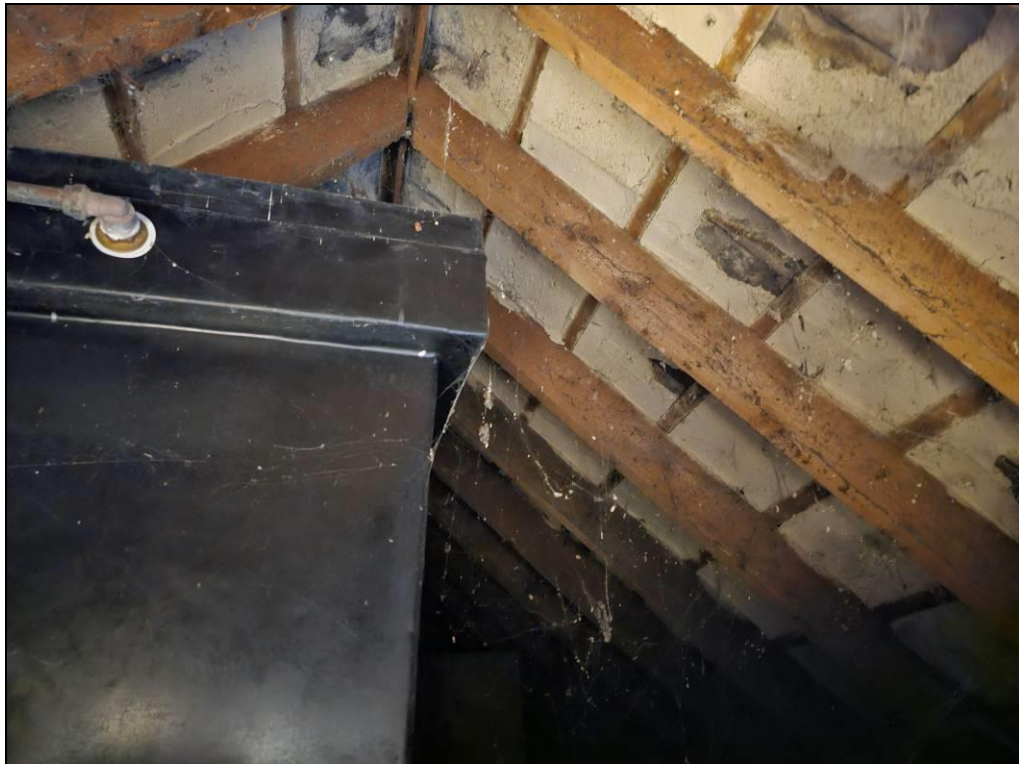
Plate 12. The water tank in the attic above the Office/File Storage/Games Room.

The original stone extension which contains the Office/File Storage/Games Room has a very cobweb festooned attic with a water tank which was accessed from the small hallway between the Kitchen and the Office. Here

too is roofed with traditional slates with parging on battens, whilst the underside of the attic has traditional lathes with plaster.

Should the roof of the original stone extension which contains the Office/File Storage/Games Room need to be stripped and/or fully replaced this must be done under the supervision of a licensed bat specialist.

Any minor repairs to existing roof should be done carefully with the expectation that individual bats may be found. If discovered, the animals should be retained in a box until dusk and released on site. Please inform a bat specialist and ask for further advice.

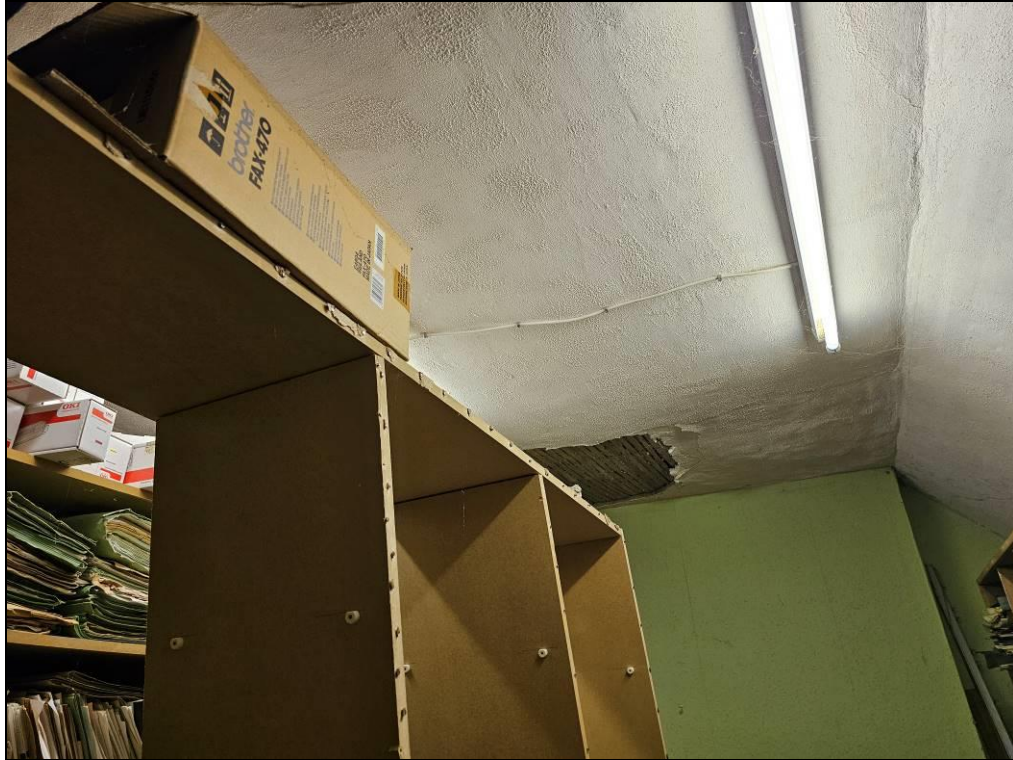
Plate 13. Traditional lathes with plaster on the ceiling of the 'File Storage Room'.

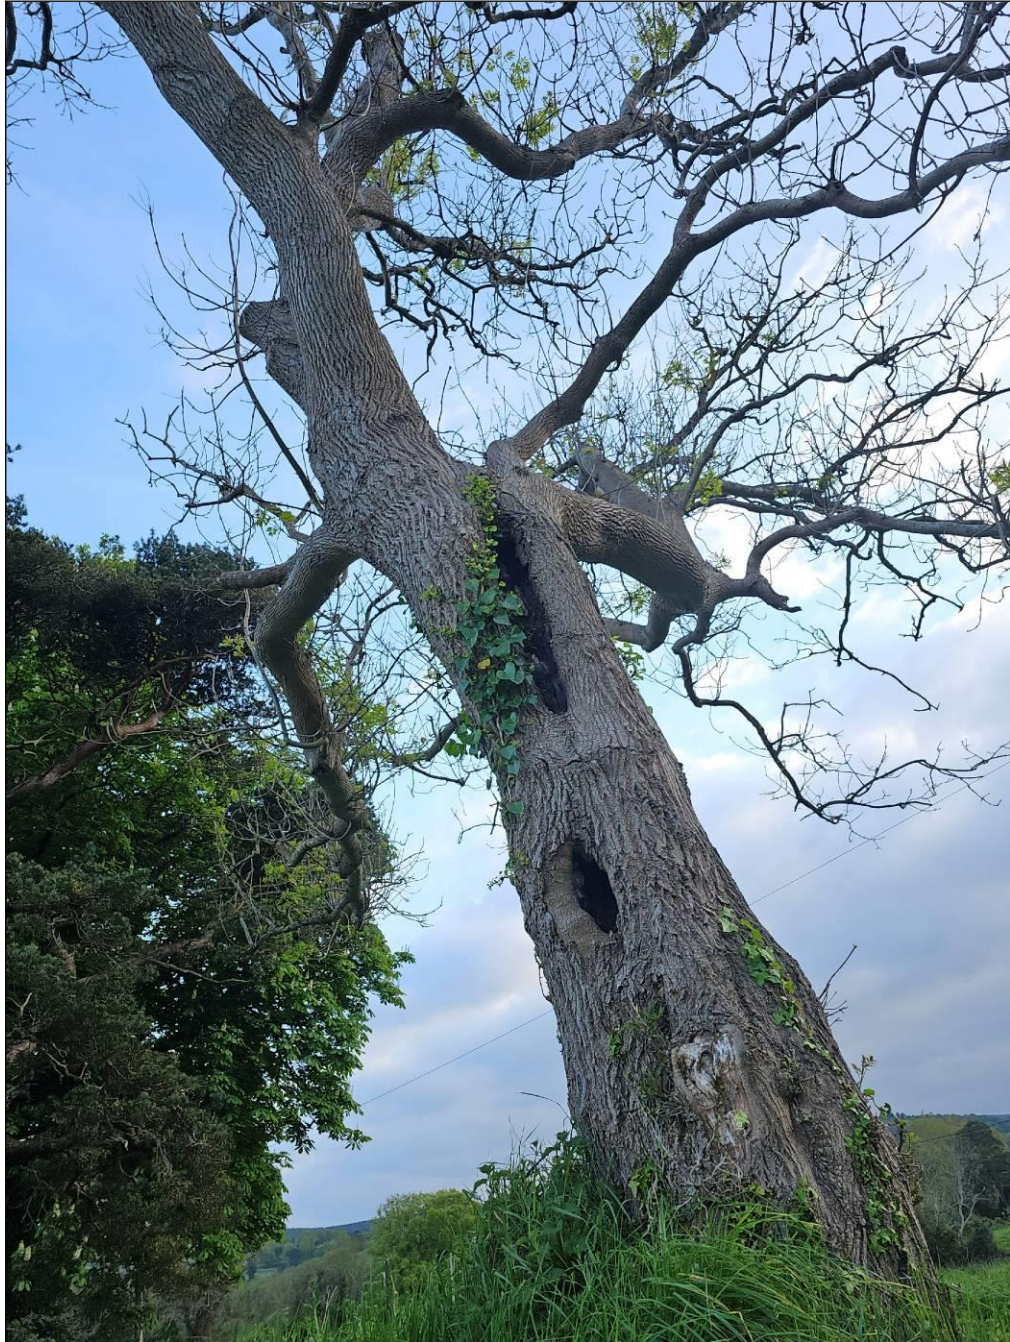
A mature Ash with large cavities offers bats roosting potential on the drive. This and other Ash trees in the area are suffering from Ash die-back disease.

Plate 14. Ash tree with large cavities offering bats roosting potential on the drive.

There is also a potential loss of suitable roosting habitat in adjoining trees in the long term as these are affected by Ash die back disease.

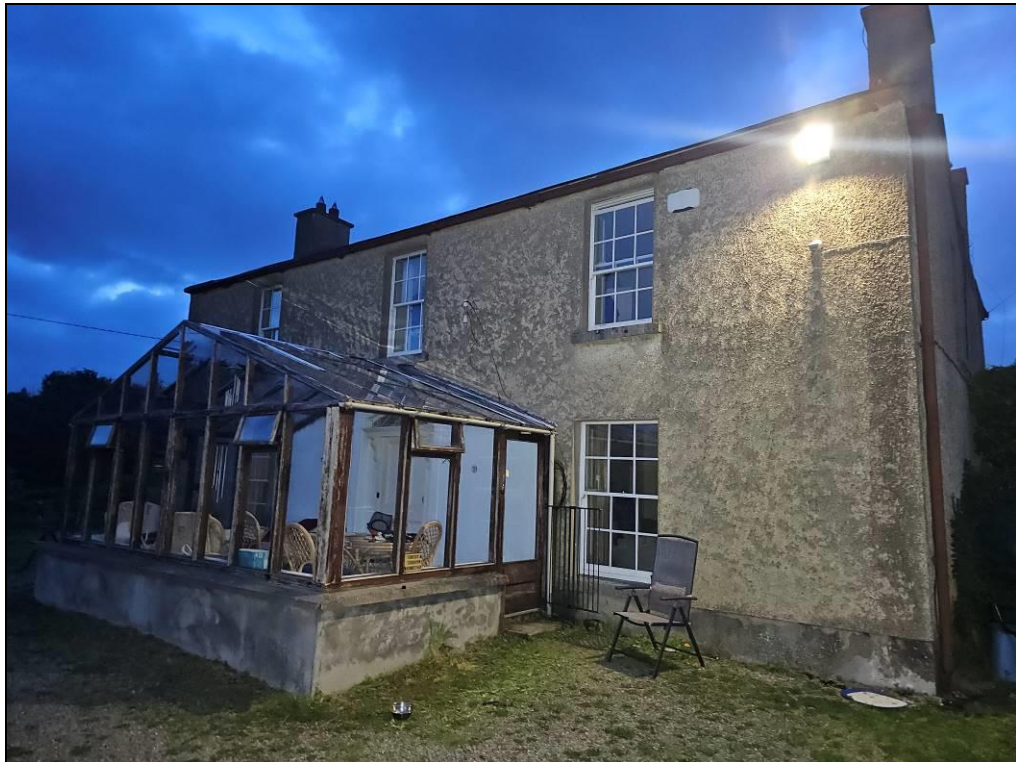
There are a number of flood lights, which are motion activated, surrounding the house and these render large parts of the buildings and the adjoining land less favourable to bats that are light sensitive.

Plate 15. Lighting at the front of the house.

Many species of bats are sensitive to lighting and it has been shown that artificial lighting at night (ALAN) can deter bats from using an area for foraging and can cause desertion of a roost.

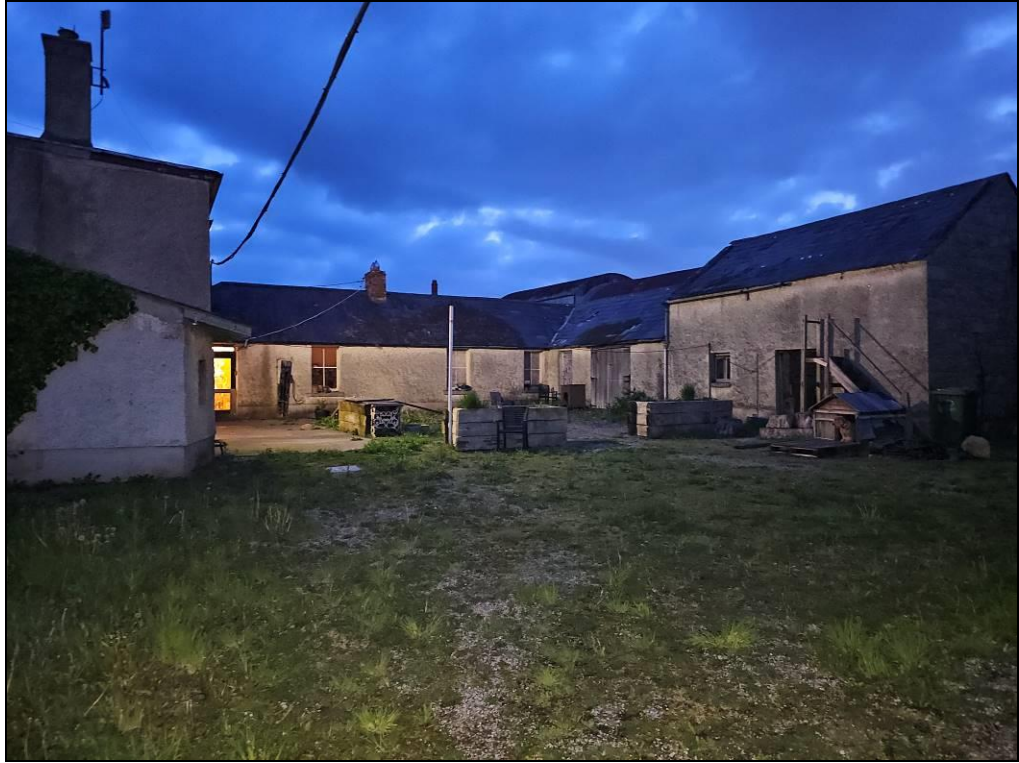
Plate 16. Lighting in the inner yard at the rear of the house.
