The French Church, Greyfriars Street, Waterford

Ecological Survey

14th August 2024

FINAL REPORT

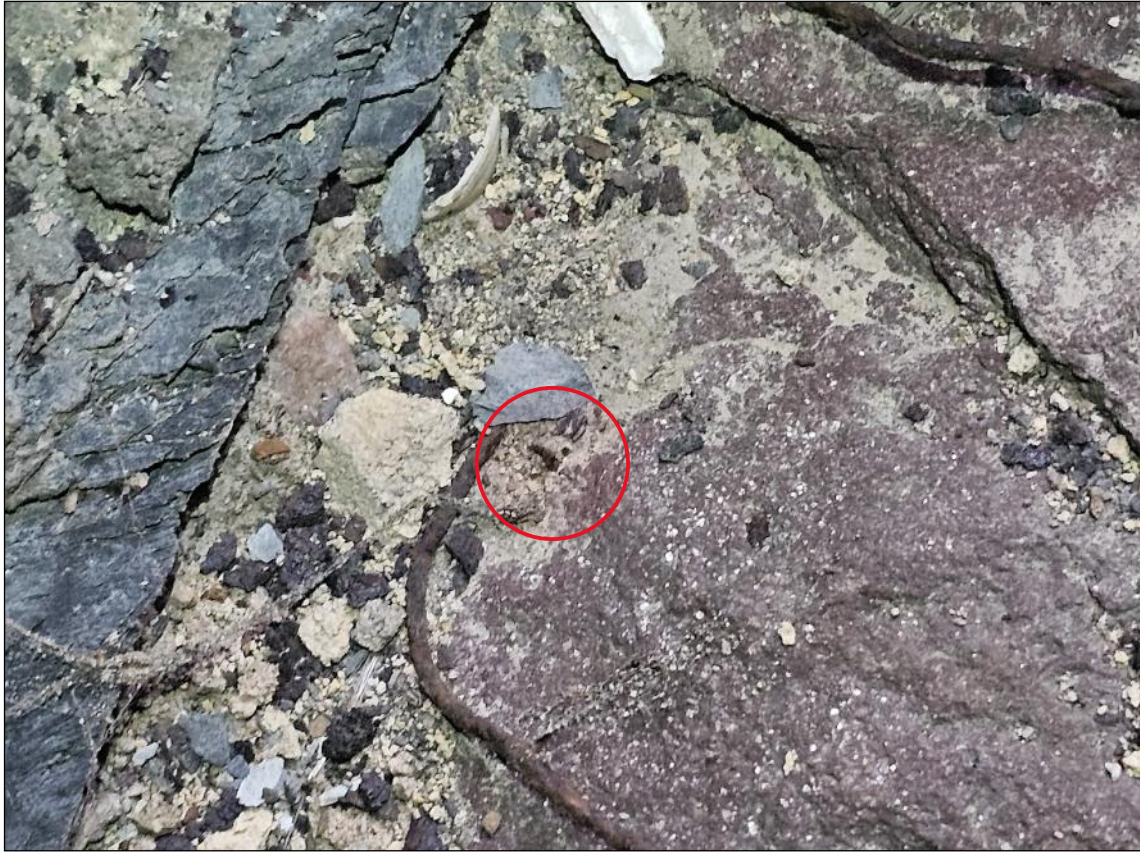
Evidence of old bat droppings were also found during investigations within the tower (**Plate 5**). The small number and scattered nature of the droppings are indicative of use by a small number of bats as opposed to a maternity roost.

Plate 5. Bat droppings found in on the window sill (circled in red).

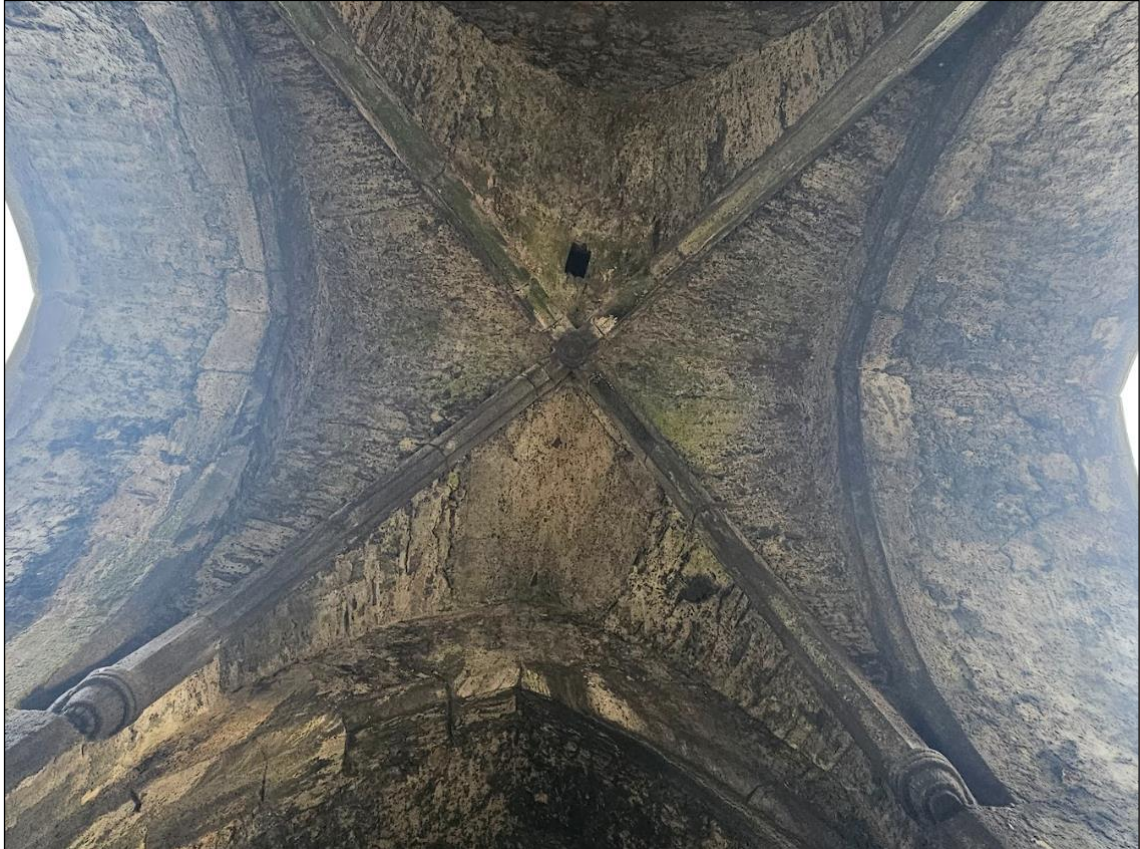
Plate 6. Level 0, Transept archway. There are many suitable locations in the stonework here that bats could avail of for roosting purposes.

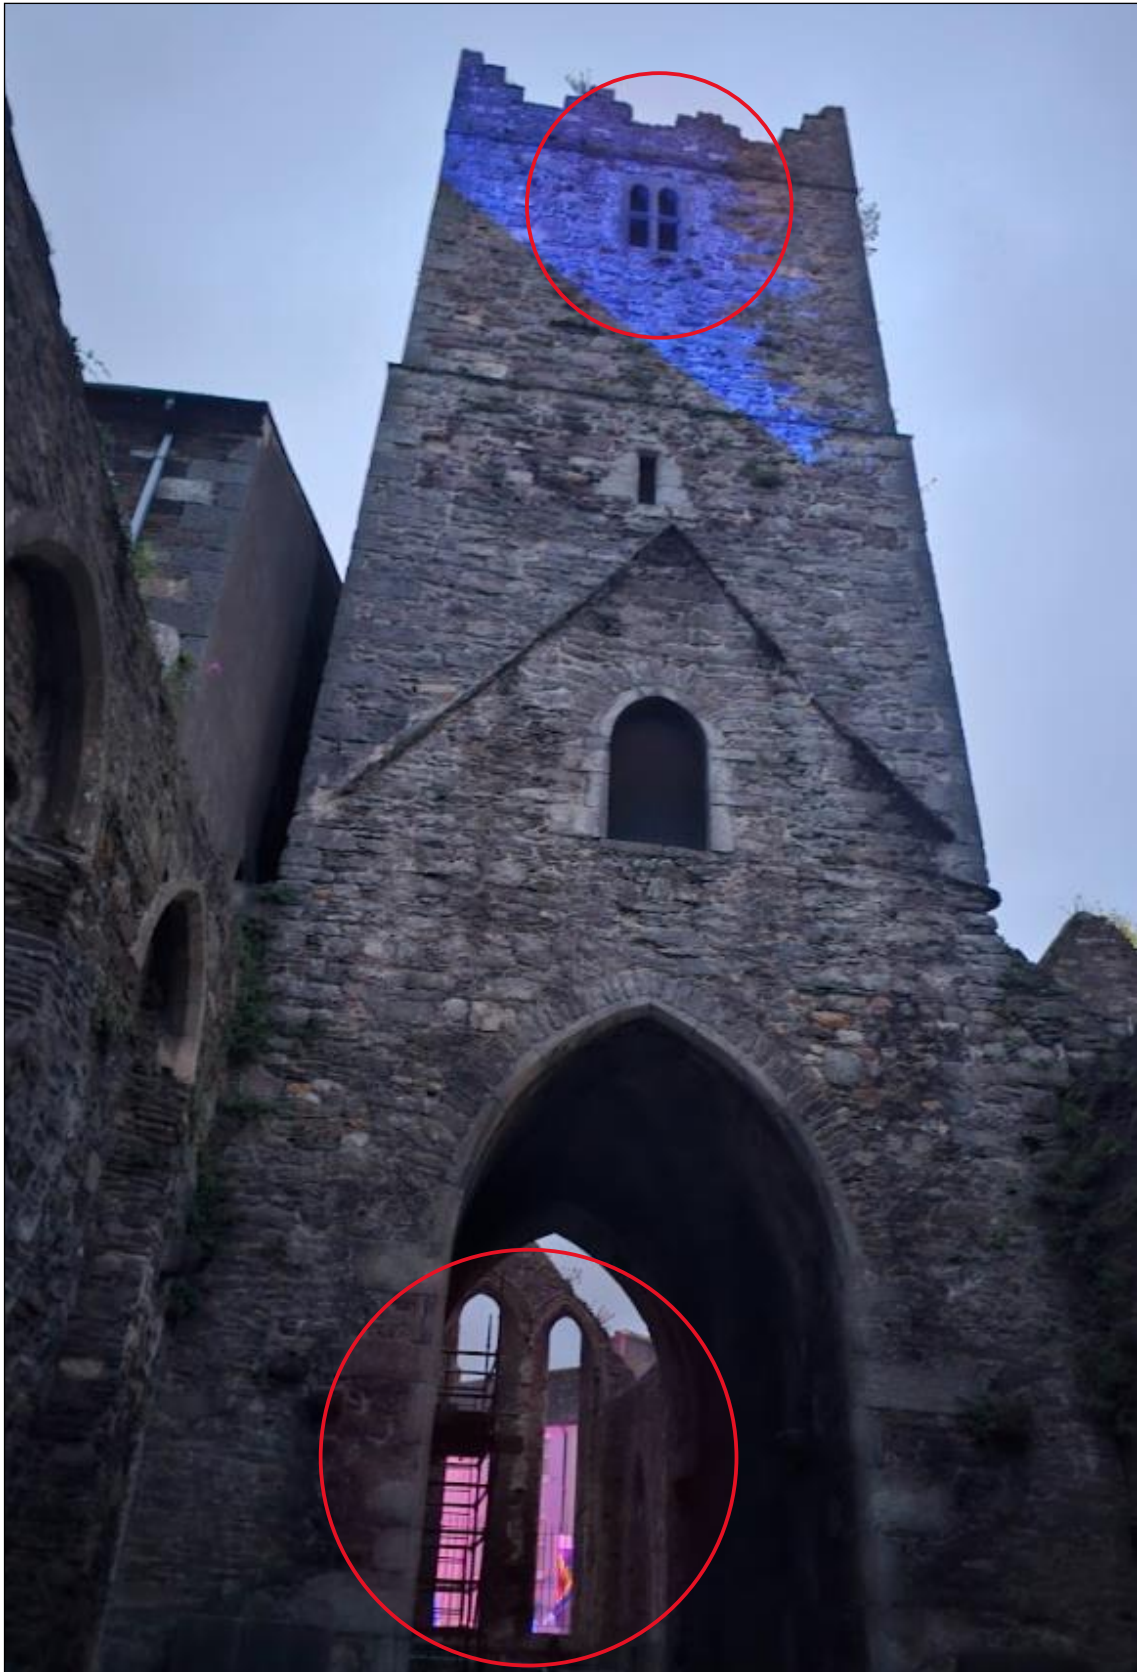
Plate 13. Light pollution from neighbouring properties shows at ground level and at the roost exit on Level 3 of the tower, circled in red.

It is recommended that as part of the works that the lighting on site is reviewed. If it is deemed that lighting of the French Church is desirable or necessary, it should be designed to be bat friendly and targeted only on the lower part of the structure avoiding illumination of the higher portions of the structure and most certainly not upwards to the upper portions of the roof and the sky.

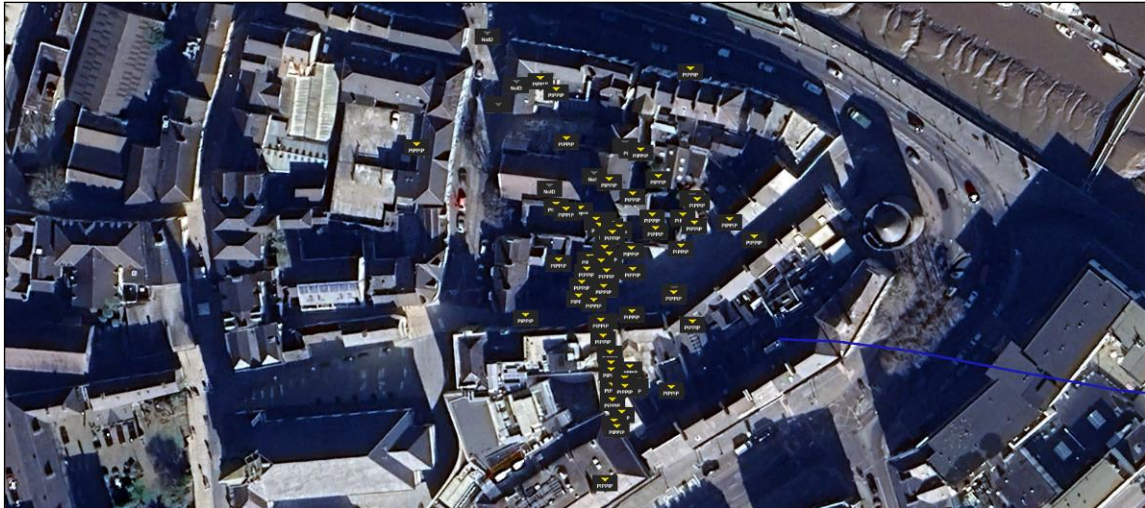
A minimum of 3-4 Common Pipistrelle bats were recorded foraging within the site after sunset as can be seen on **Figure 8**. Evidence of a bachelor roost of Common Pipistrelle bats (old droppings and feeding signs) were noted within the tower.

Figure 8. Bat activity at the French Church.

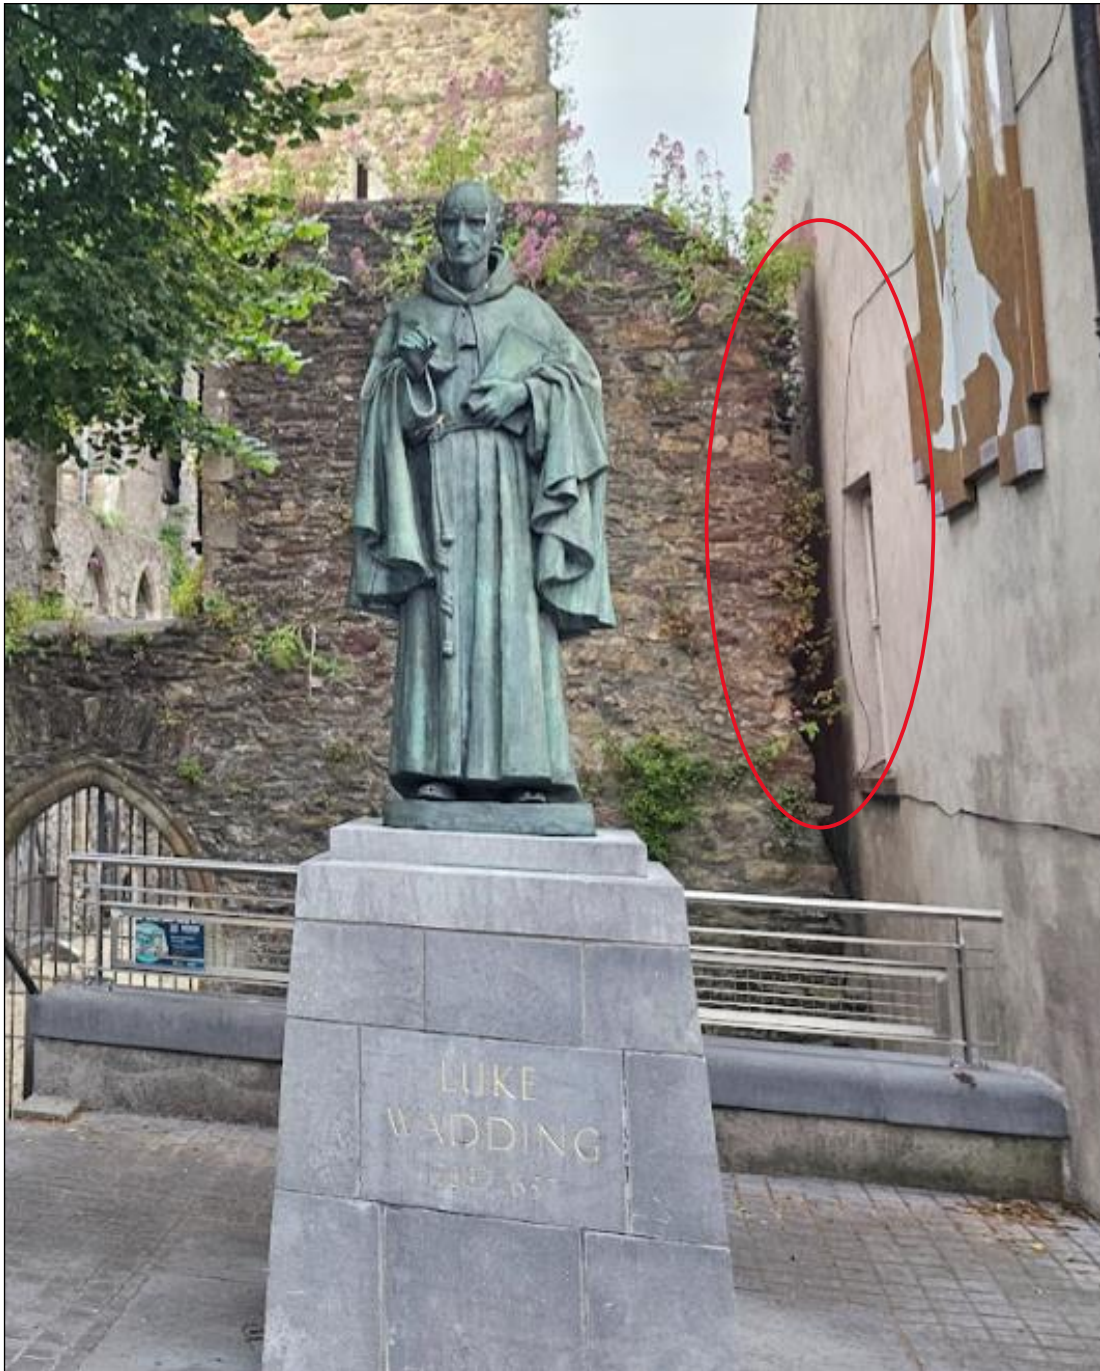
Plate 14. Gaps between the French Church perimeter walls and other buildings should be also retained as these provide protected areas free from human traffic or interference.

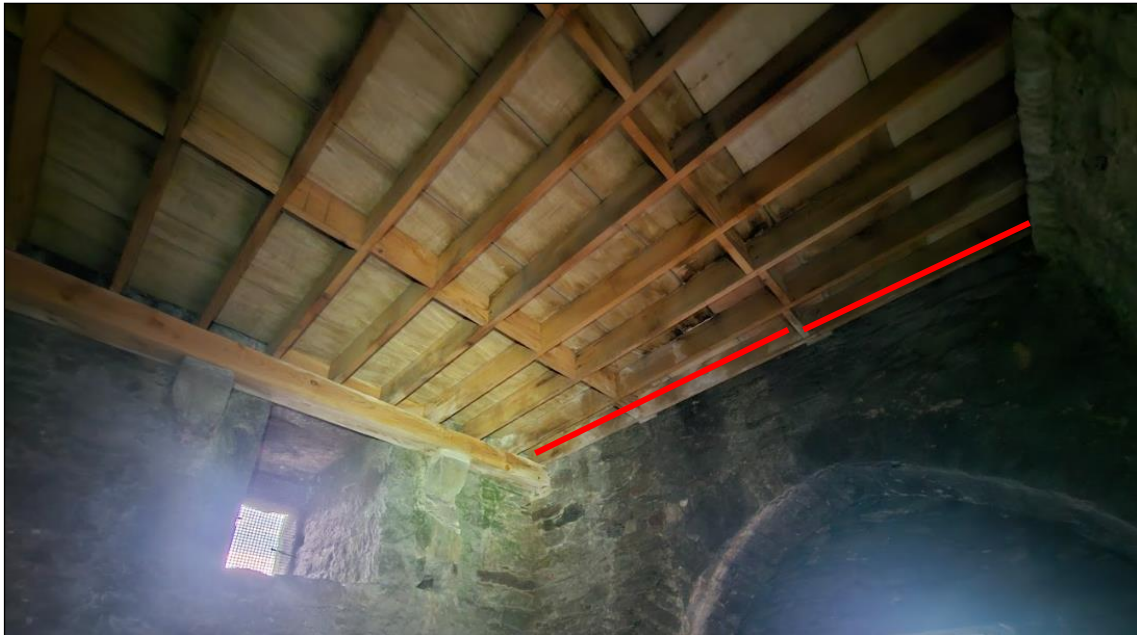
Plate 17. Level XX, showing a covered ceiling with exposed joists. This provides safe roosting opportunities for bats, without risk of entanglement in roofing membranes. Timbers here can be doubled up to create a roosting location for bats – indicative locations for timbers shown by red line.

Within the tower, there are also several areas with ceiling/roof surfaces that could be made more suitable for bat roosts amongst the joists and beams as shown on **Plate 17** below.

Doubling up some of these timbers on these joists thereby creating a gap of 18mm between them, which would offer crevice dwelling species a space in which to roost.
