The French Church, Greyfriars Street, Waterford

Ecological Survey

14th August 2024
(Amended 20th October 2024)

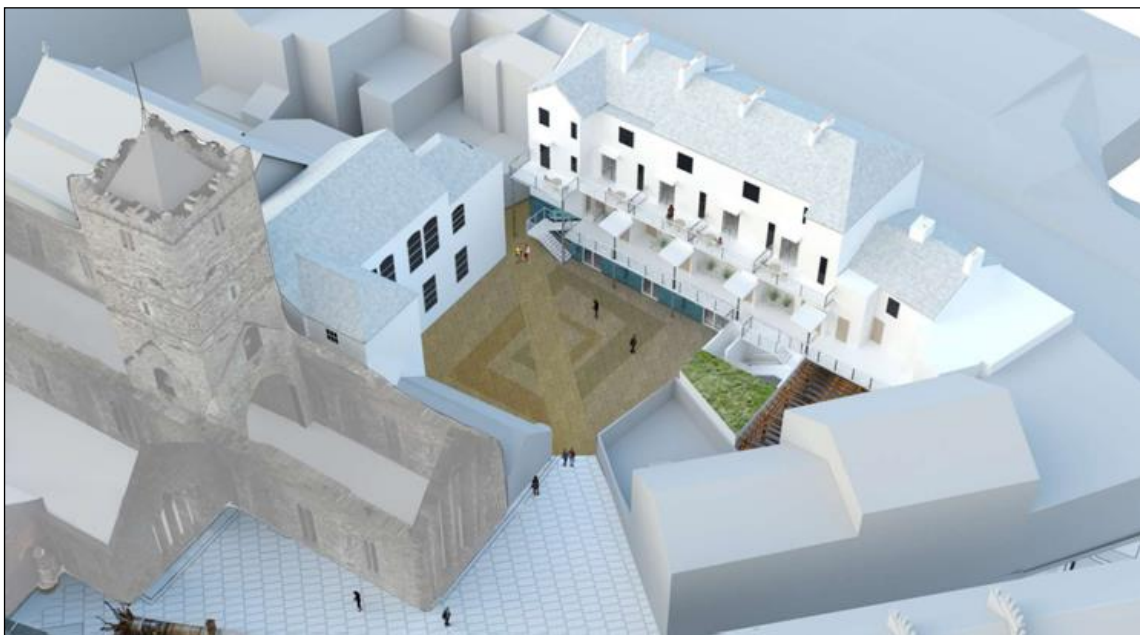
Figure 4. Aerial View of Proposed Friary Precinct / Parade Quay from the South.

Development of the surrounding area is also proposed as part of an urban regeneration project by Waterford City & County Council to provide redevelopment of vacant buildings for residential and retail units, a public plaza beside French Church and improved access links (**Figure 4**).

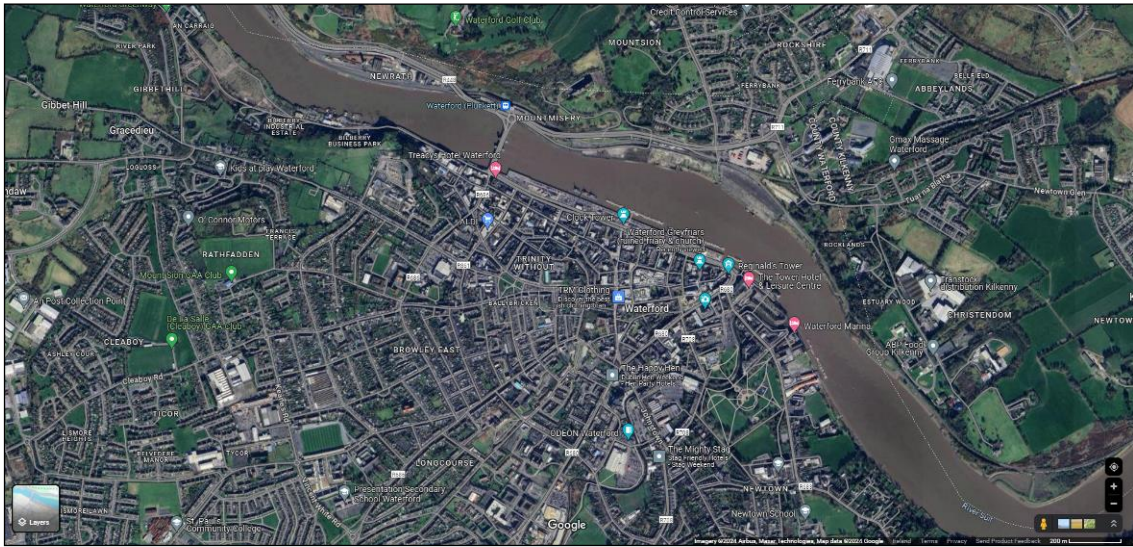
Figure 5. The urban nature of the lands surrounding the French Church in Waterford.

The church is surrounded by other buildings with no natural vegetation present in the wider landscape as can be seen on **Figure 5** and **Plate 1** below.

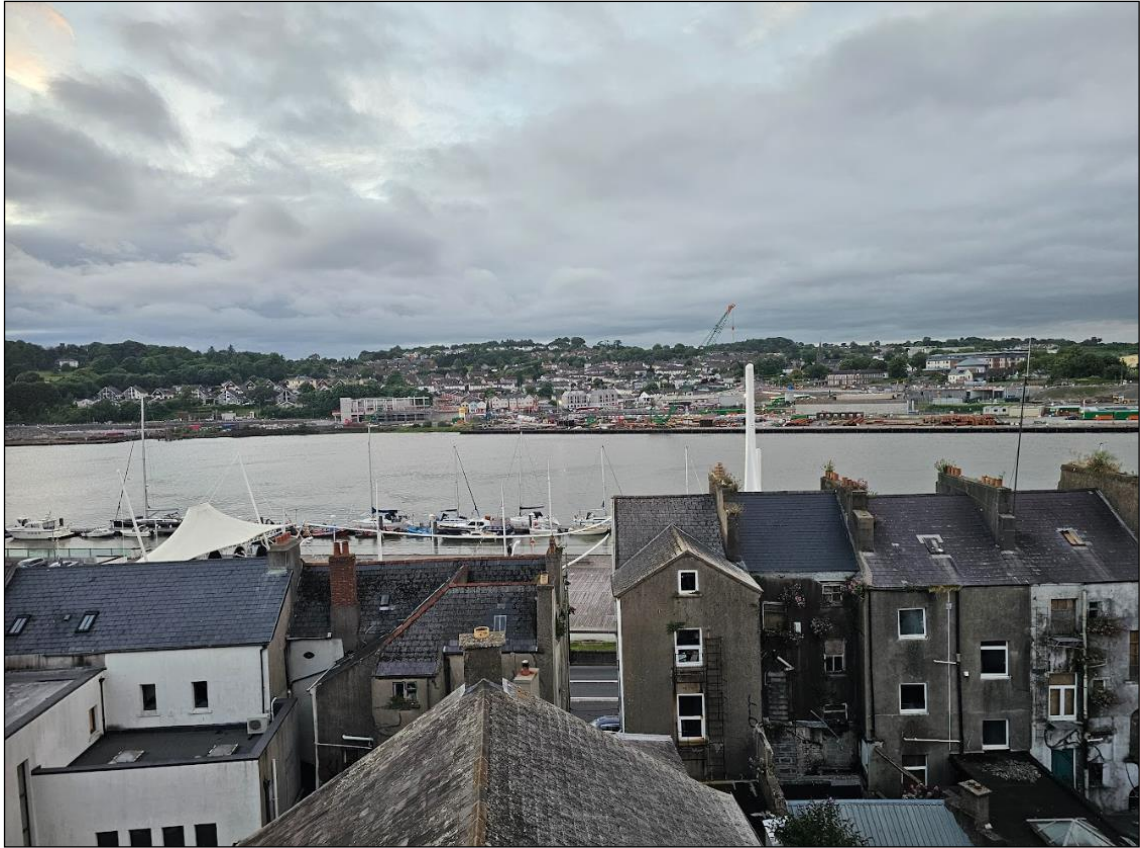
Plate 2. The River Suir to north of the French Church.

A mature Lime tree (*Tilia cordata*) is located at the entrance to the church grounds (**Plate 2**). The River Suir is located to the north of the church (**Plate 3**).

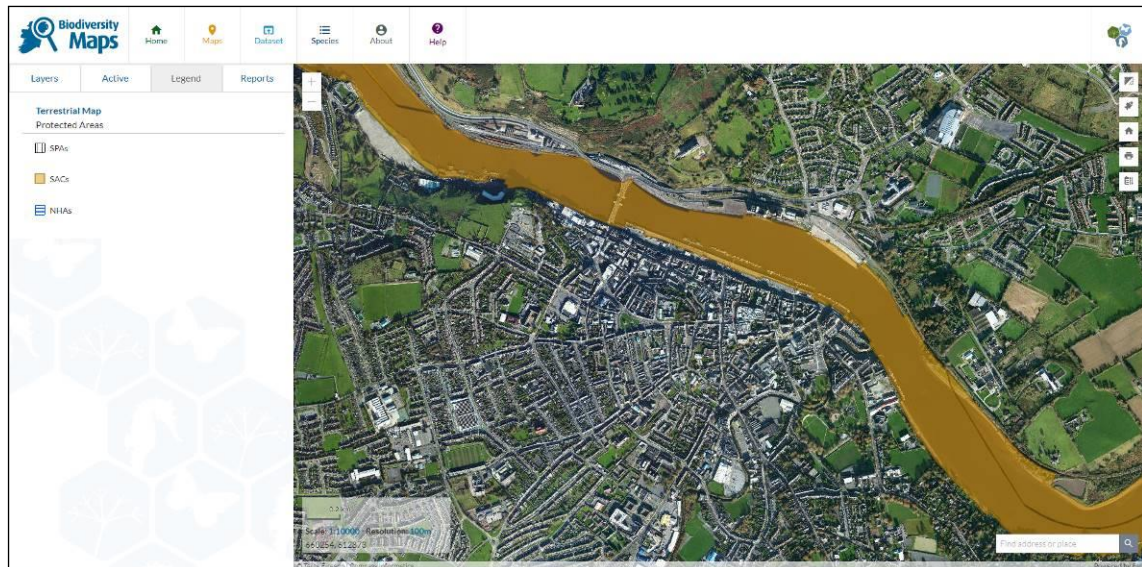
The French Church is not currently designated for the purposes of nature conservation. The closest designated site is the Lower River Suir SAC (Site Code: 002137). The boundaries of this site can be seen on **Figure 6** below.

Figure 6. The Lower River Suir SAC (Site Code: 002137) is located to the north of French Church.

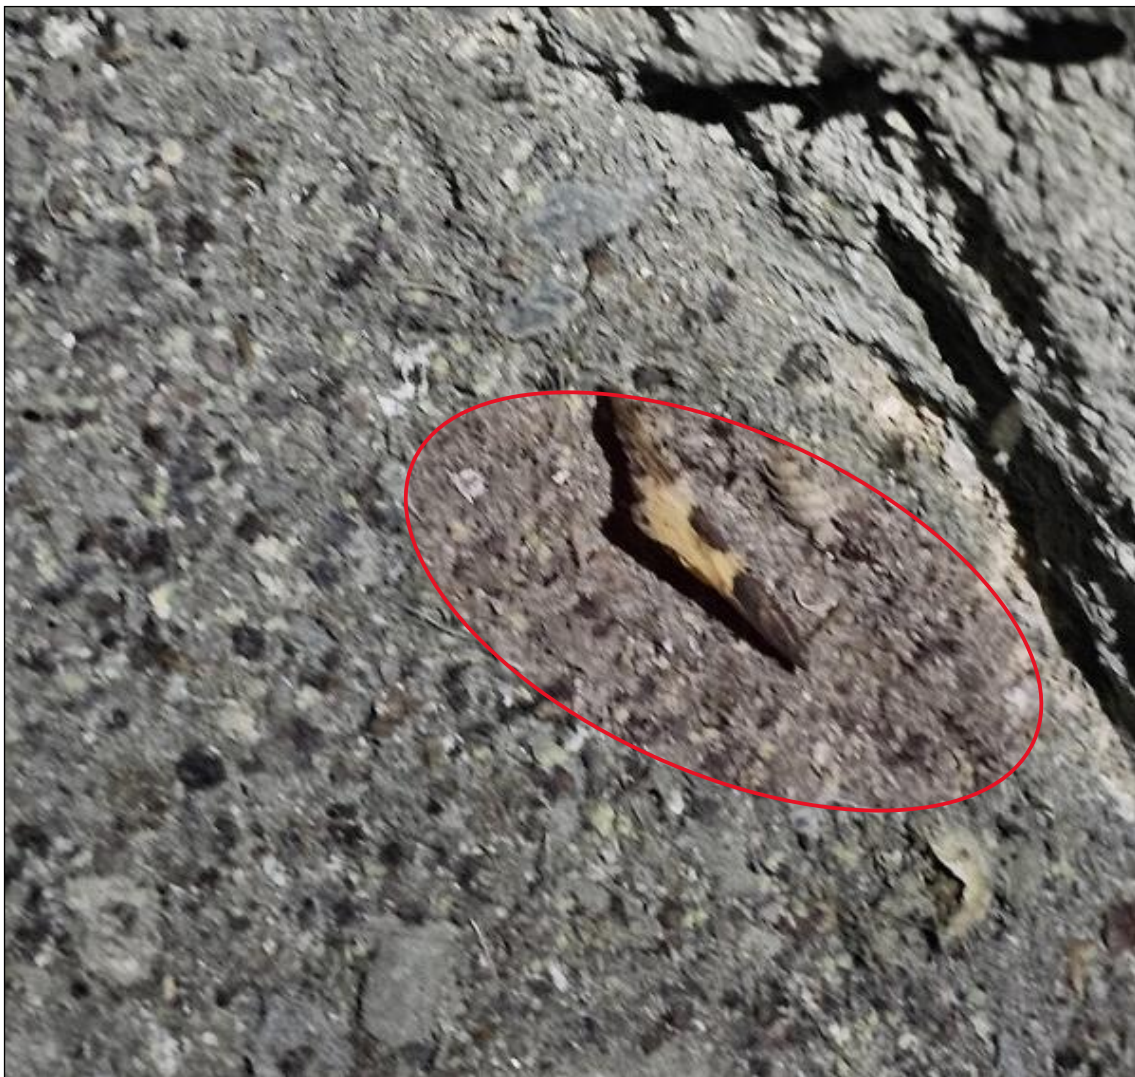
There was evidence of discarded Small Tortoiseshell butterfly wings which exhibits predation and feeding within the tower (**Plate 4**).

Plate 4. Small Tortoiseshell butterfly wings discarded during feeding (circled in red).

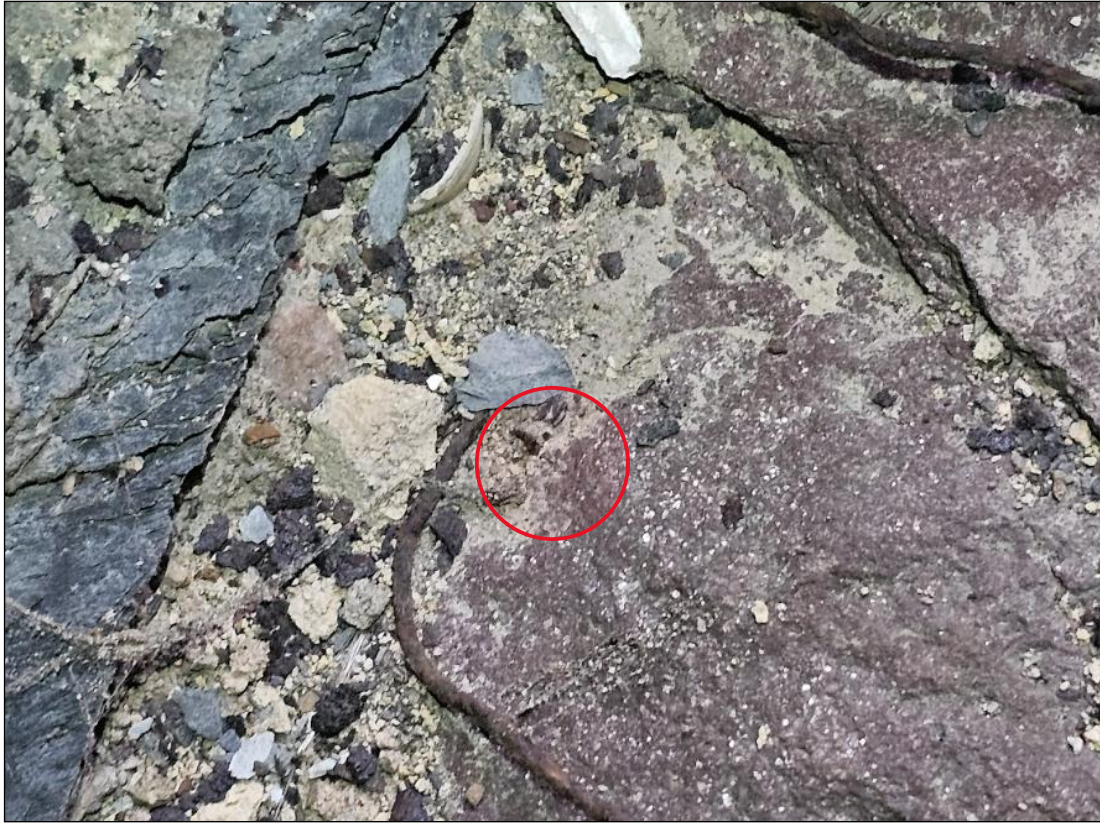
Evidence of old bat droppings were also found during investigations within the tower (**Plate 5**).

Plate 5. Bat droppings found in on the window sill (circled in red).

The small number and scattered nature of the droppings are indicative of use by a small number of bats (likely to be a bachelor roost) as opposed to a maternity roost.

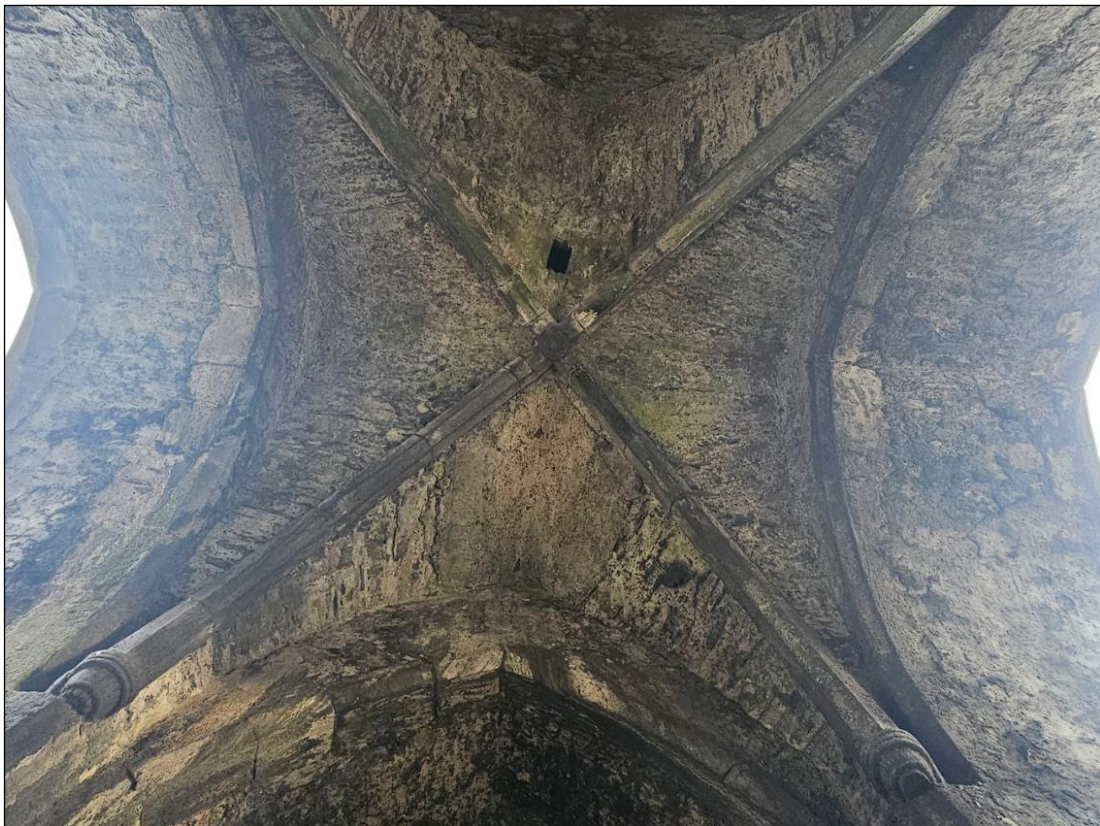
Plate 6. Level 0, Transept archway. There are many suitable locations in the stonework here that bats could avail of for roosting purposes.

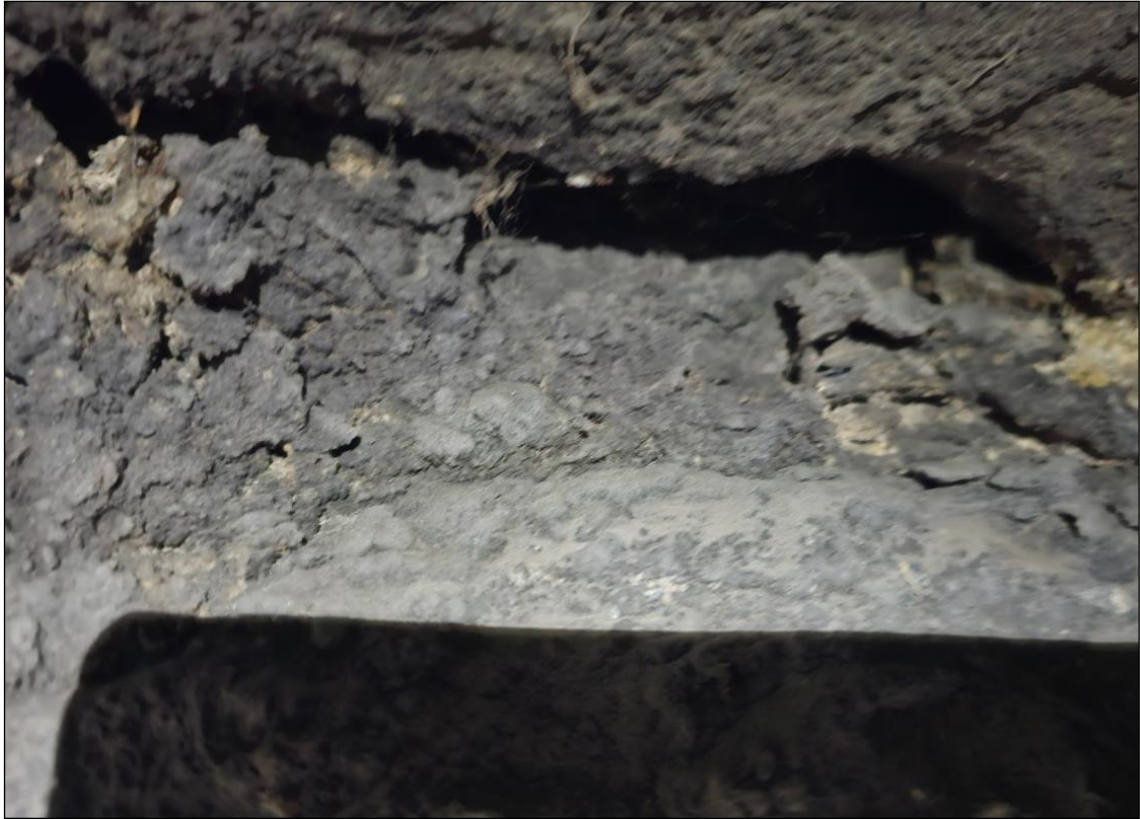
Plate 7. Tower walls above the windows. Note the crevices and ledges in the rough mortar finish, providing bat roosting shelter in the walls and stonework.

There are a series of suitable crevices and holes that were noted internally in the stonework of the church tower. These offer roosting potential for bats and should not be refilled, repointed or otherwise repaired or restored without consultation with a suitable qualified bat specialist.

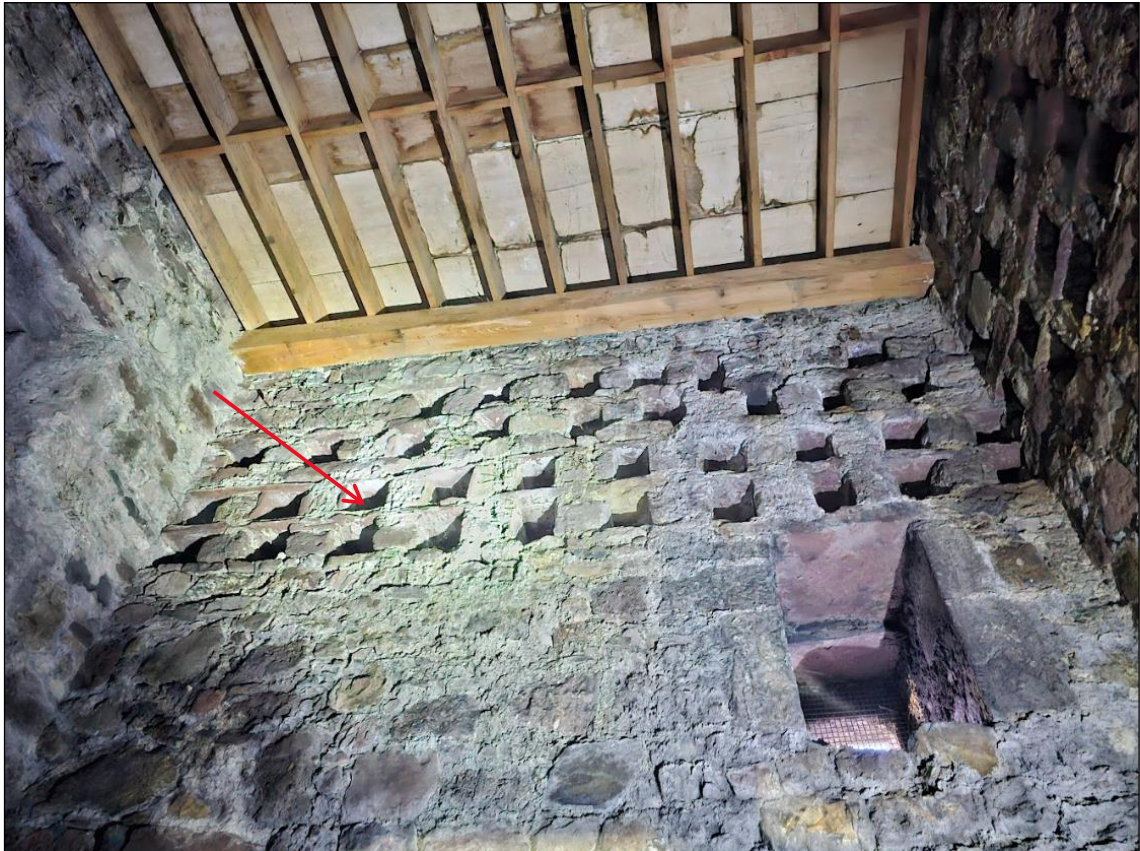
Plate 8. Historic dove nesting locations in the tower.

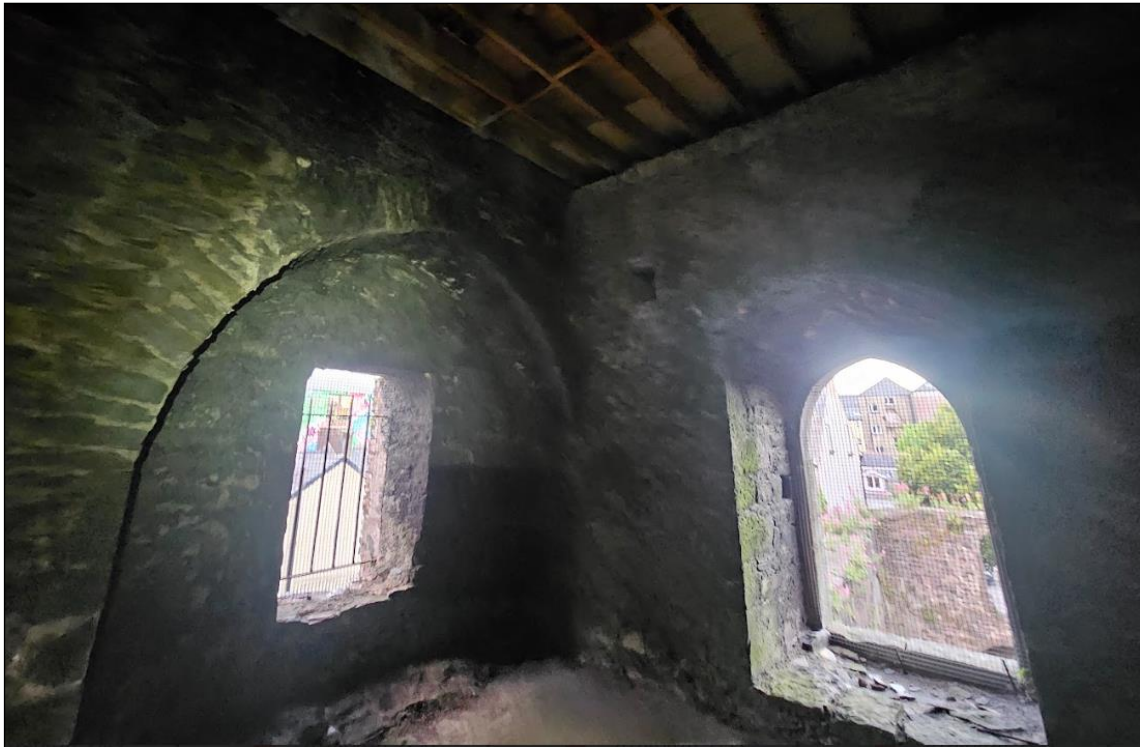
Plate 9. Windows in the tower are covered with a 1cm grating to prevent access by birds. This also limits bat access to roosting spaces within the tower.

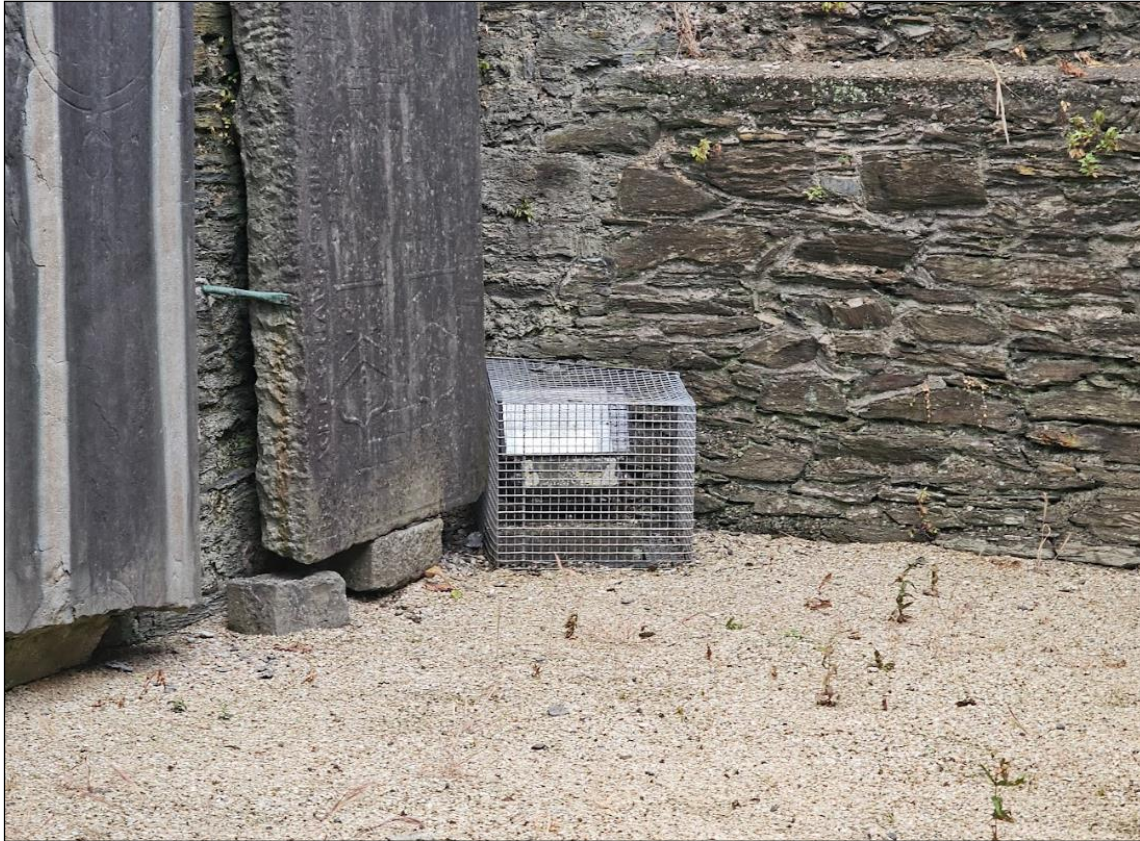
Within the grounds of the church, ground-level floodlights (**Plate 10**) were located so as to illuminate the structure's brickwork and features. In addition, the neighbouring pub has a number of high-powered lights pointing in different directions and angles (**Plate 11**). These light sources increase levels of light disturbance for bats roosting and hunting in this location and the surrounding area.

Plate 10. Level 0, ground level floodlight within the church grounds.

It is recommended that as part of the works that the lighting on site is reviewed. If it is deemed that lighting of the French Church is desirable or necessary, it should be designed to be bat friendly and targeted only on the lower part of the structure avoiding illumination of the higher portions of the structure and most certainly not upwards to the upper portions of the roof and the sky.

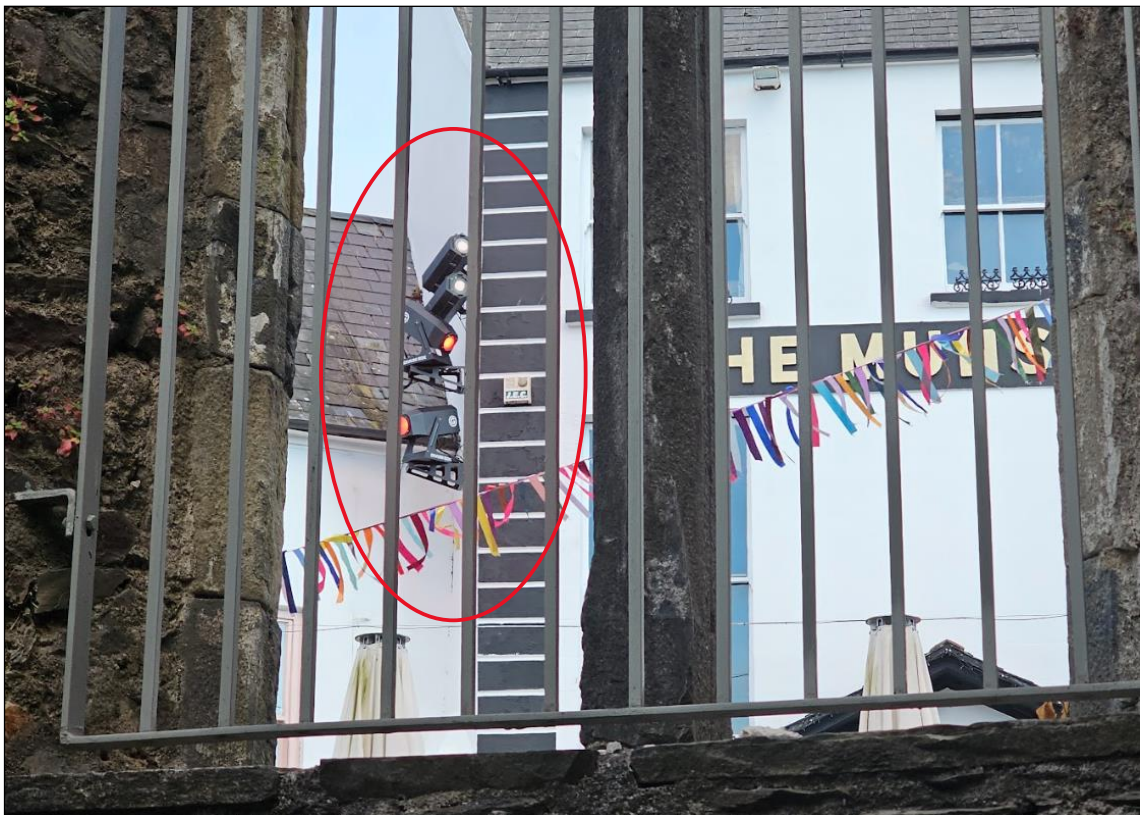
Plate 11. Level 0, multiple lights from neighbouring property, circled in red.

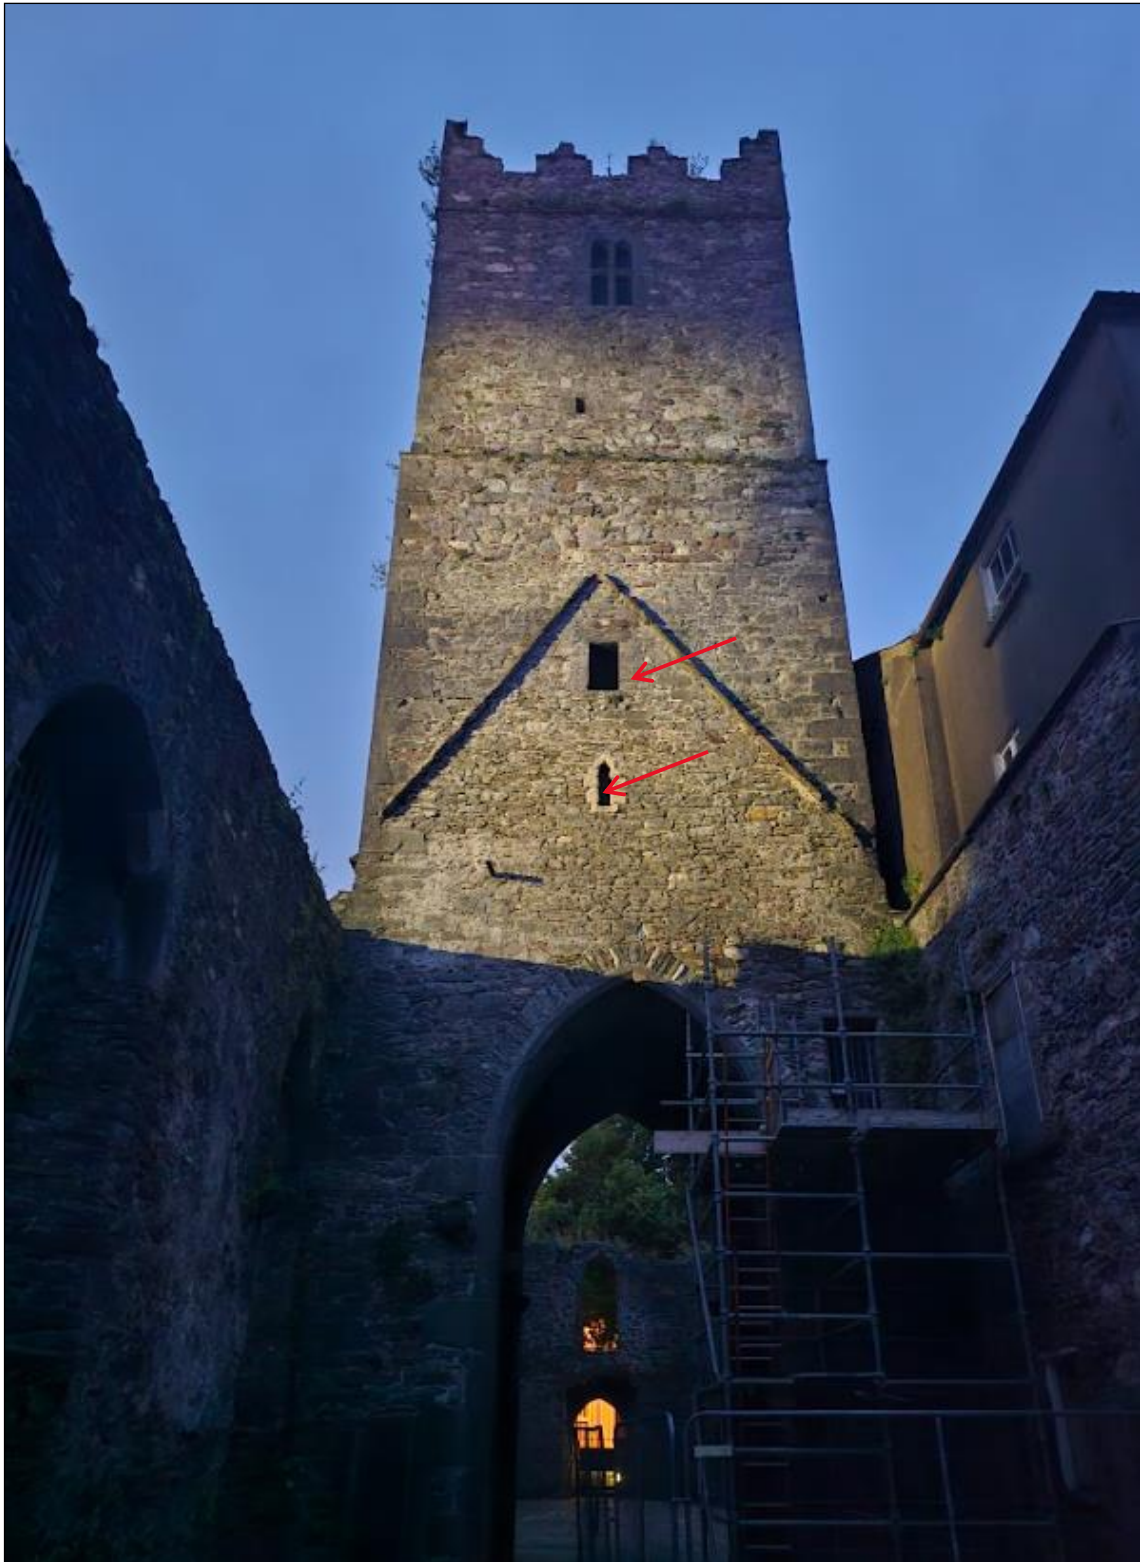
It was noted from dusk that on both sides of the church tower, the windows and therefore the majority of potential roost exits, are illuminated by artificial light (**Plates 12 and 13**). This light can affect bat emergence, and therefore interfere with important evening feeding times.

Plate 12. Light pollution from neighbouring properties shines directly on potential roost exit points.

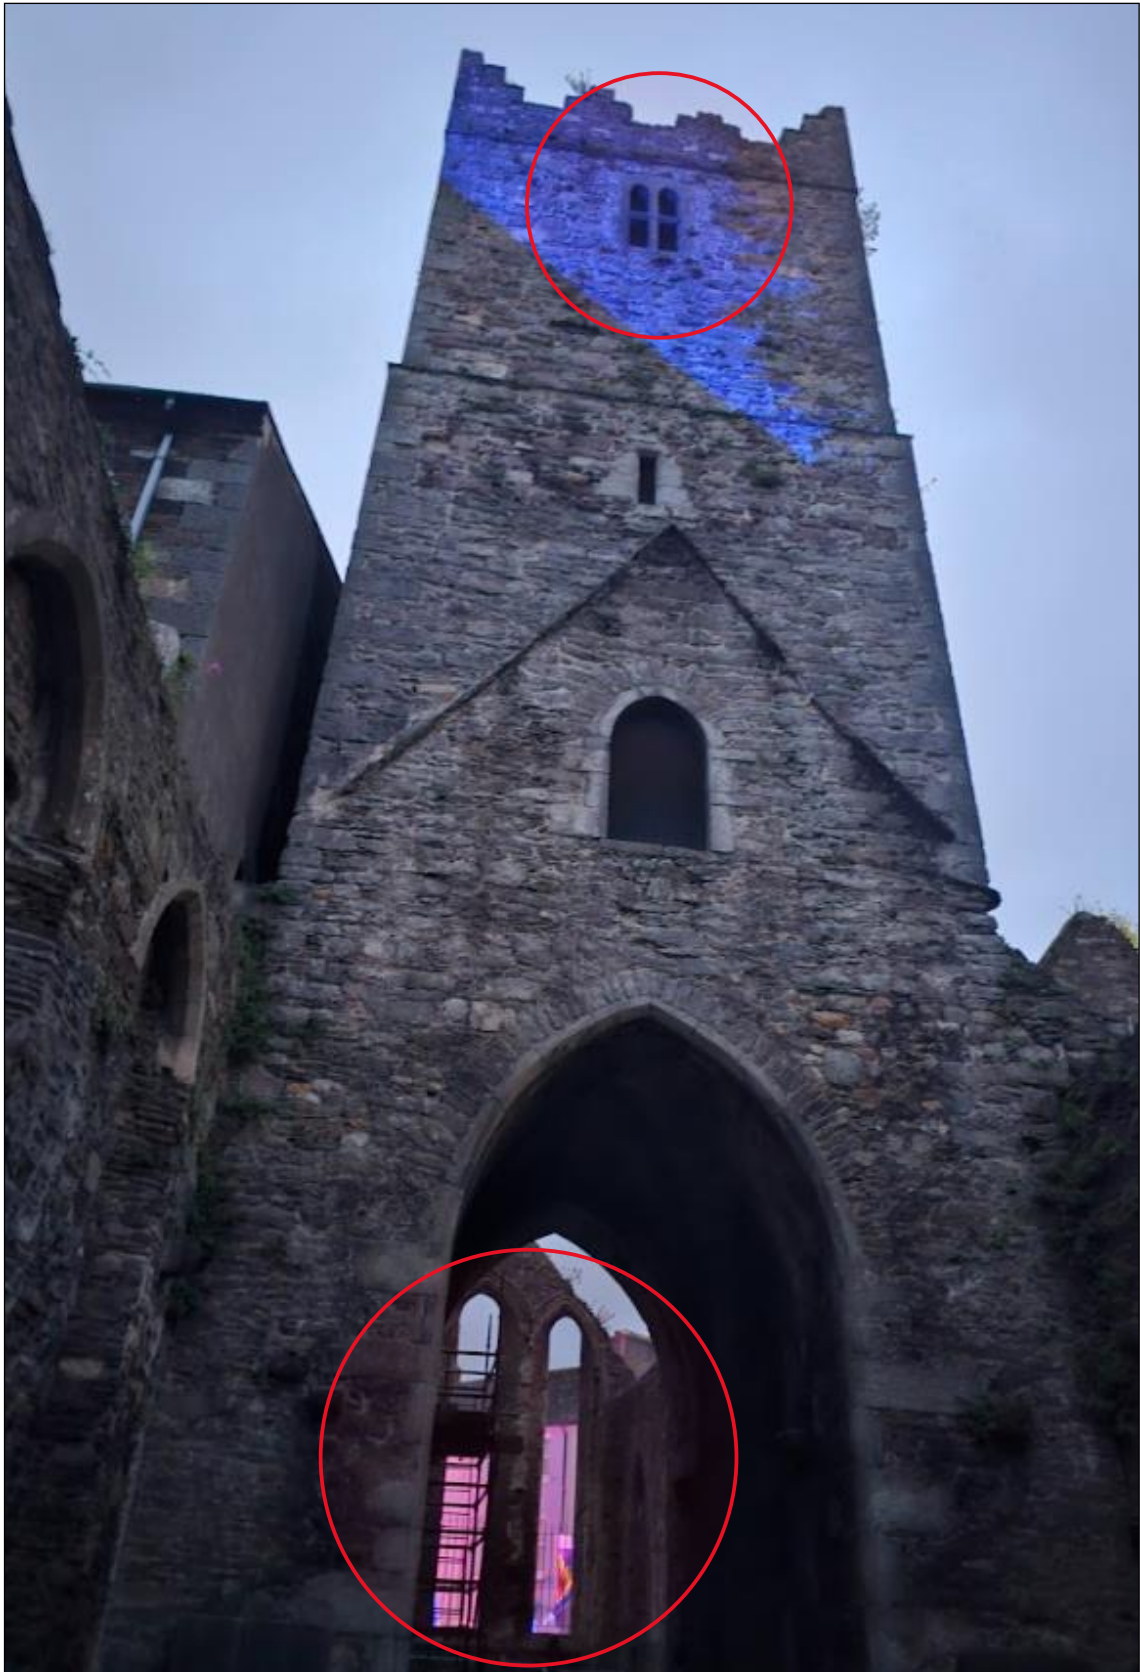
Plate 13. Light pollution from neighbouring properties shows at ground level and at the roost exit on Level 3 of the tower, circled in red.

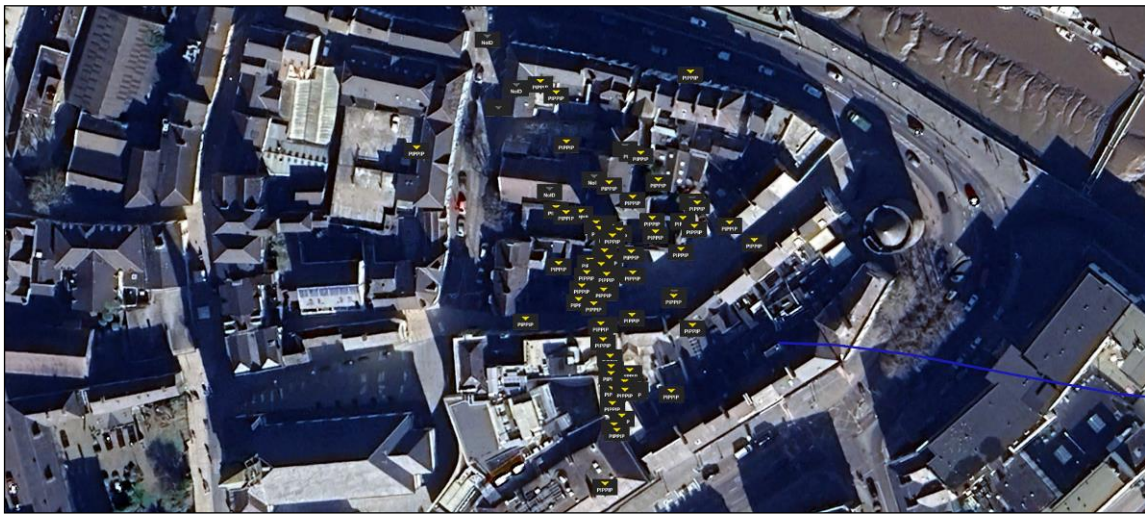
A minimum of 3-4 Common Pipistrelle bats were recorded foraging within the site after sunset as can be seen on **Figure 8**. Evidence of what is deemed a bachelor roost of Common Pipistrelle bats (old droppings and feeding signs) were noted within the tower.

Figure 8. Bat activity at the French Church.

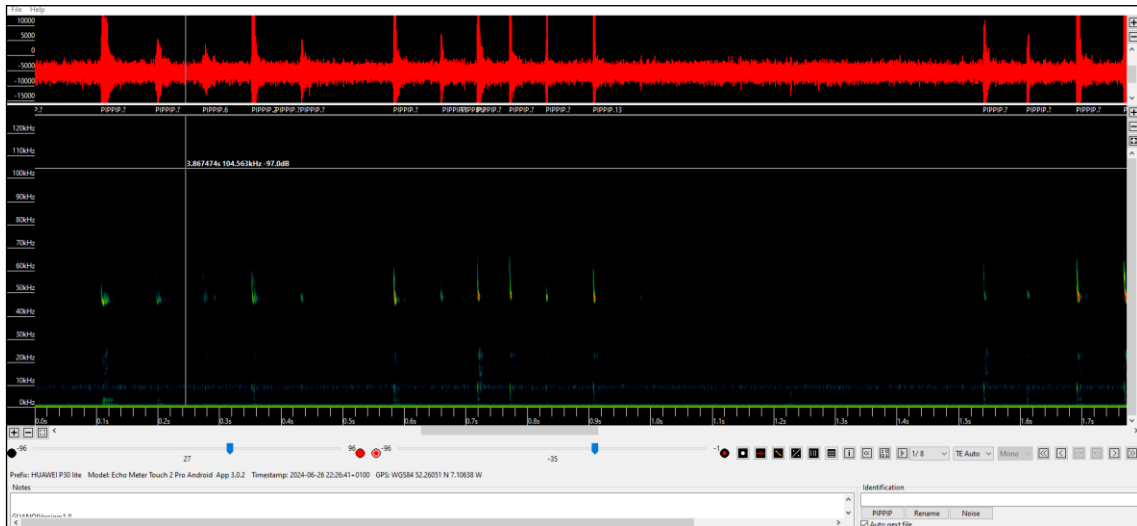
Figure 9. Sonogram of Common pipistrelle bat hunting in the French Church.

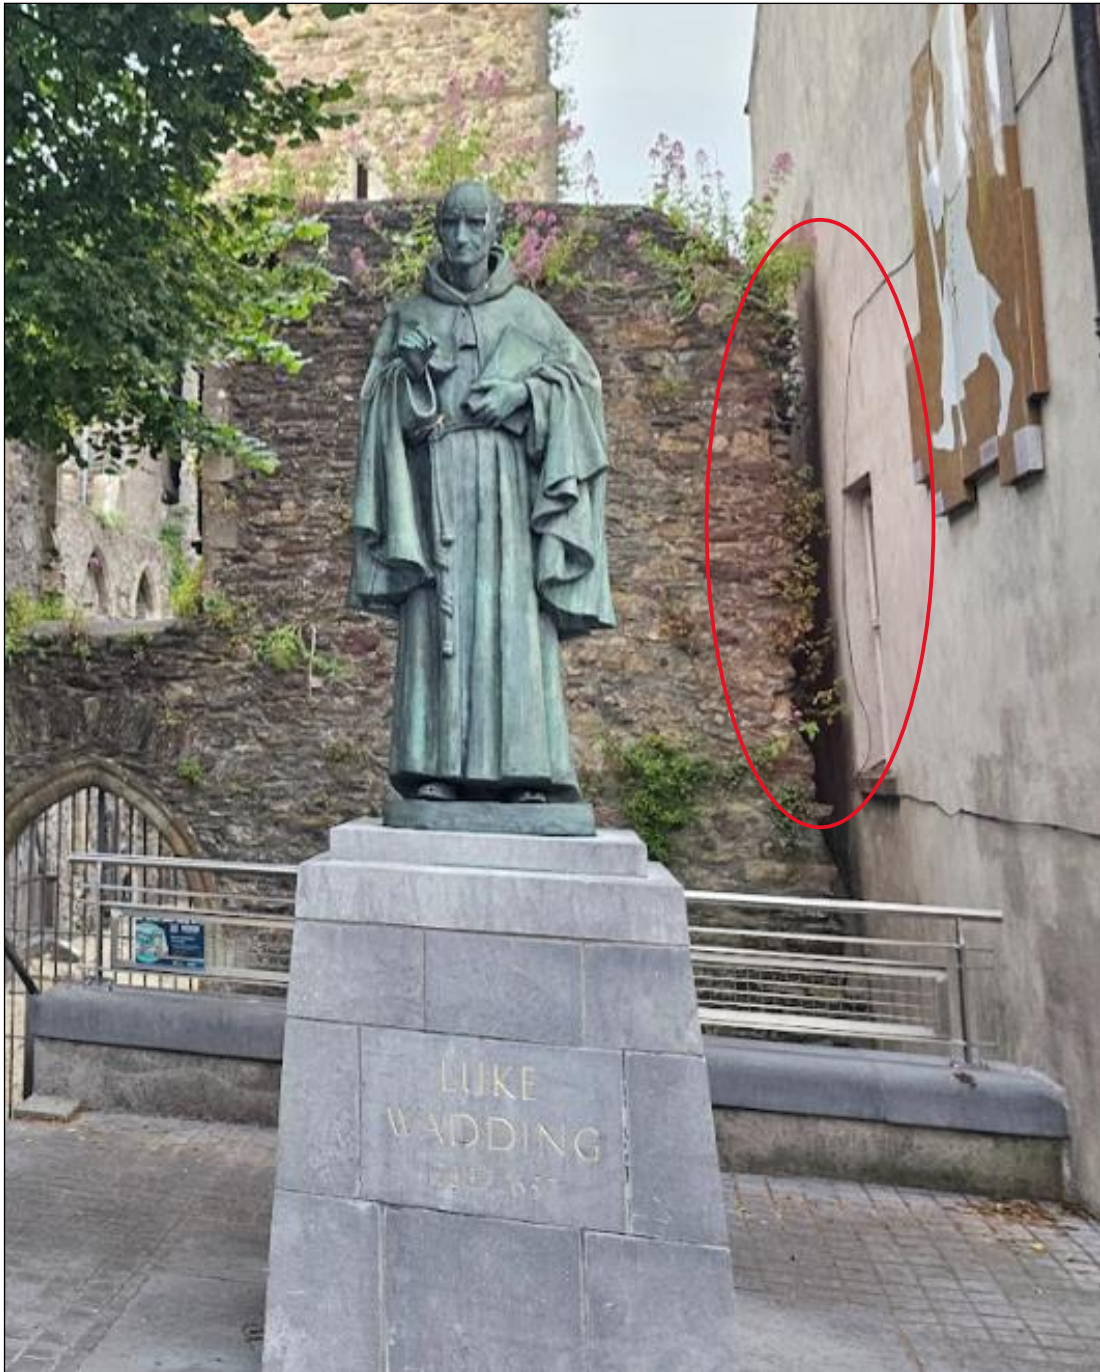
Plate 14. Gaps between the French Church perimeter walls and other buildings should be also retained as these provide protected areas free from human traffic or interference.

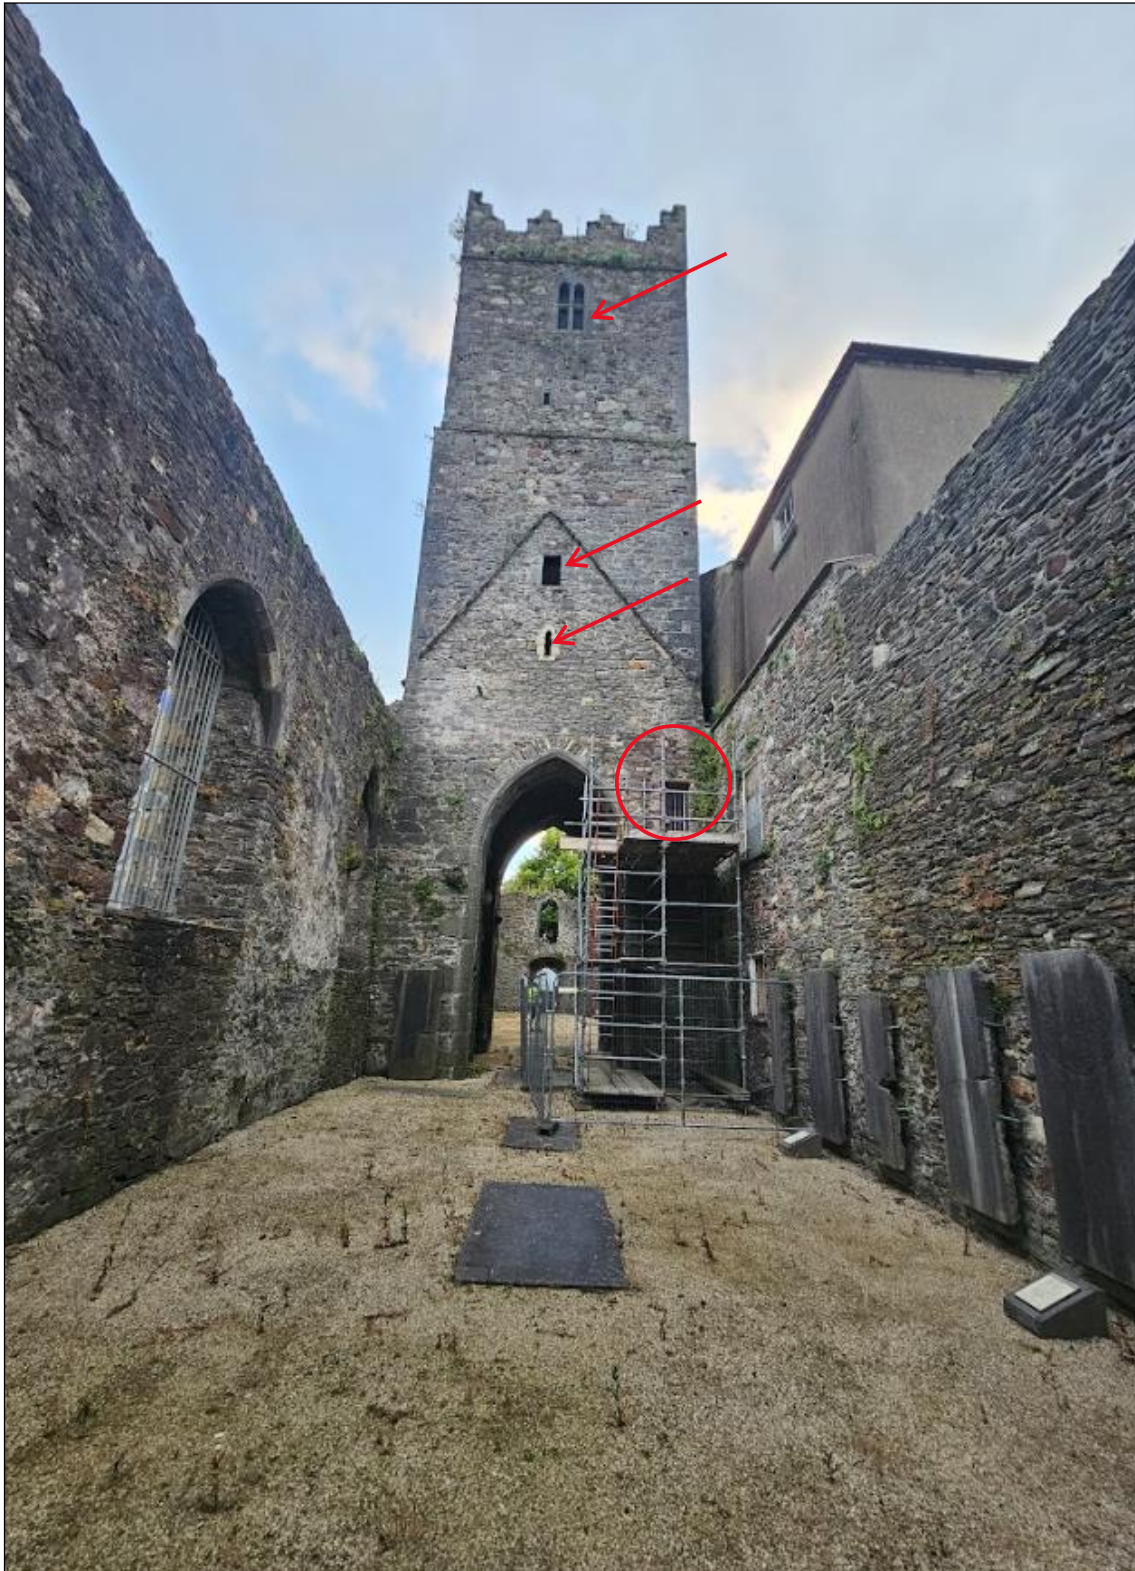
Plate 15. Level 0, showing the length of the chancel, the transept and tower with the nave and entrance beyond. The red arrows highlight openings that provide potential access points for bats, if the grating is appropriately modified. Access door circled in red.

It is recommended that access to the main tower in the church is retained and modified to allow continued access by bats.

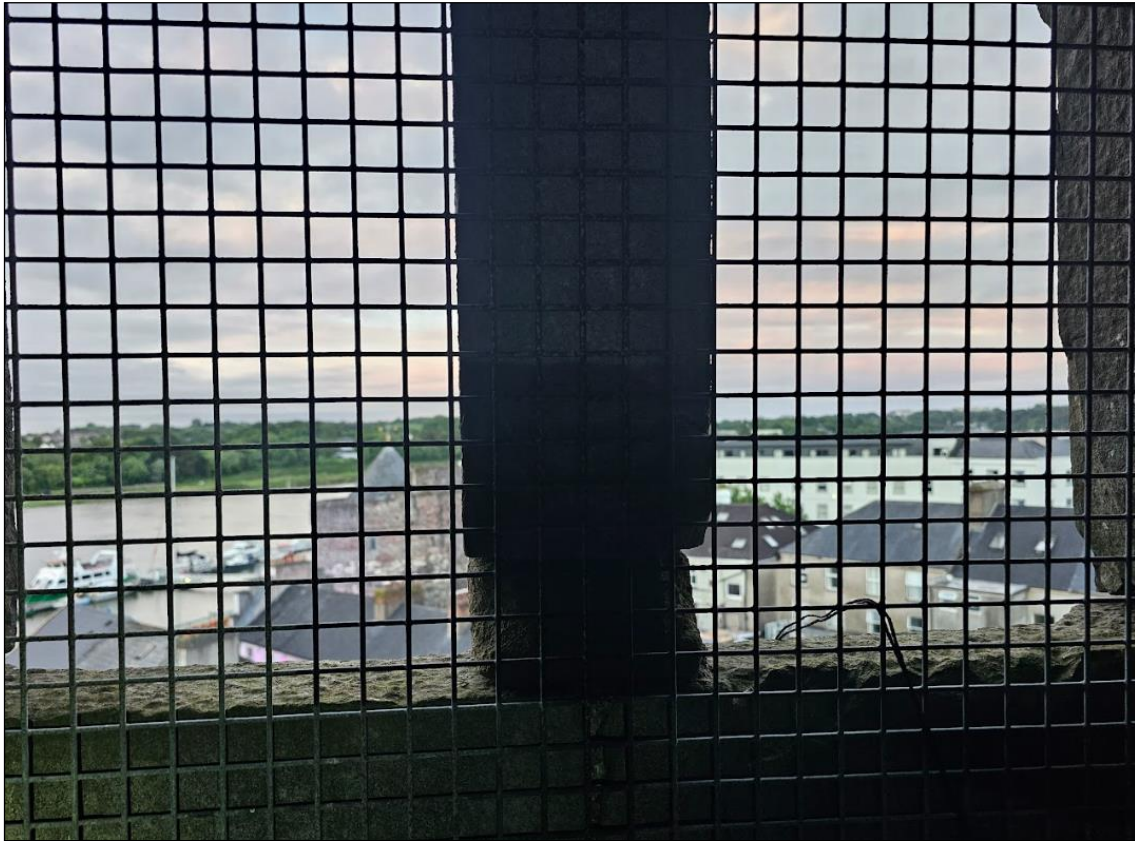
Plate 16. Removing a single row or creating an access space within the grating at the top of each of the windows will provide bat egress to the tower, without allowing other larger animals and birds such as pigeon to enter.

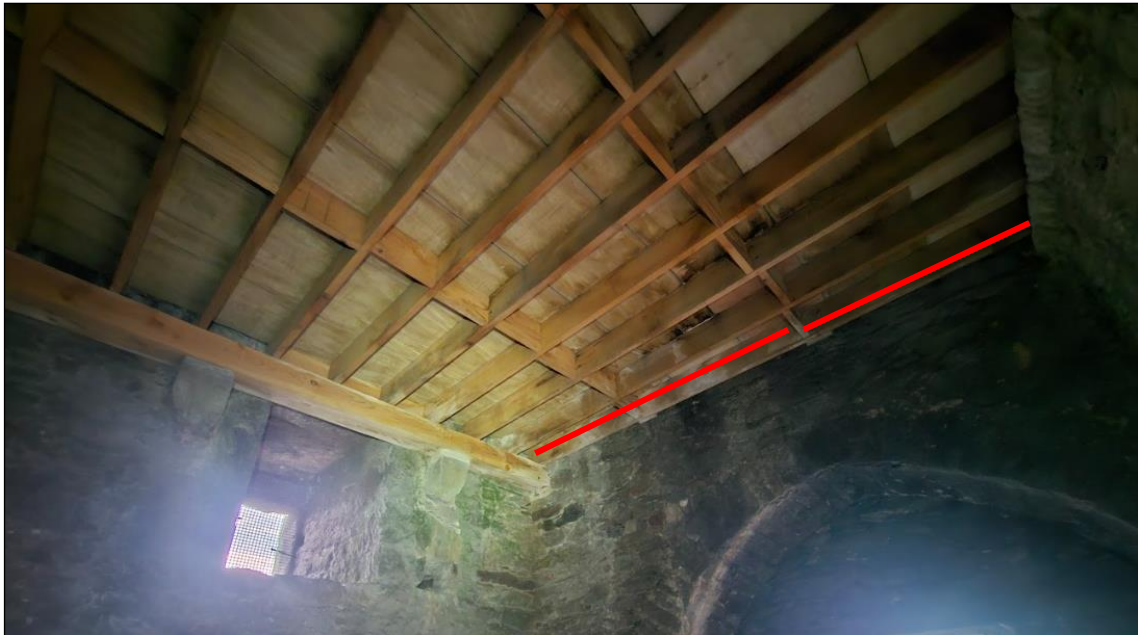
Within the tower, there are also several areas with ceiling/roof surfaces that could be made more suitable for bat roosts amongst the joists and beams as shown on **Plate 17** below.

Plate 17. Level XX, showing a covered ceiling with exposed joists. This provides safe roosting opportunities for bats, without risk of entanglement in roofing membranes. Timbers here can be doubled up to create a roosting location for bats – indicative locations for timbers shown by red line.

Doubling up some of these timbers on these joists thereby creating a gap of 18mm between them, which would offer crevice dwelling species a space in which to roost.

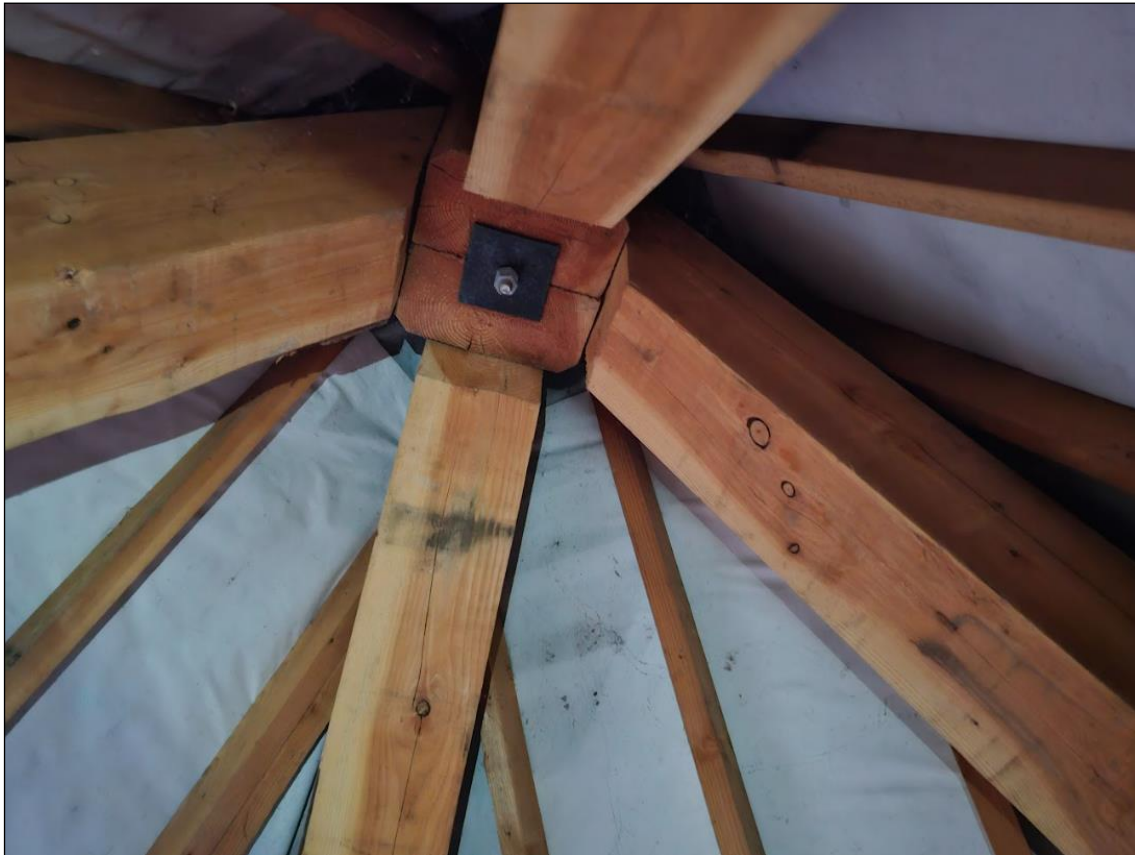
The attic/upper floor of the tower contains an exposed timber roof structure. The slates on the roof here are underlain by a breathable membrane – Tyvek or similar.

Plate 18. Level 3, Attic of the tower. By covering the roofing membrane with rough wood panels, the risk of entanglement in these roosting areas can be reduced.

In this instance the addition of rough sawn timber boards to the apex of the roof where bats are most likely to roost is recommended to reduce snagging and entanglement potential. The building contractor will ensure that only bat safe, pre-treated timbers are used. The bat specialist will advise on same.
