The French Church, Greyfriars Street, Waterford

Ecological Survey

14th August 2024
(Amended 20th October 2024)

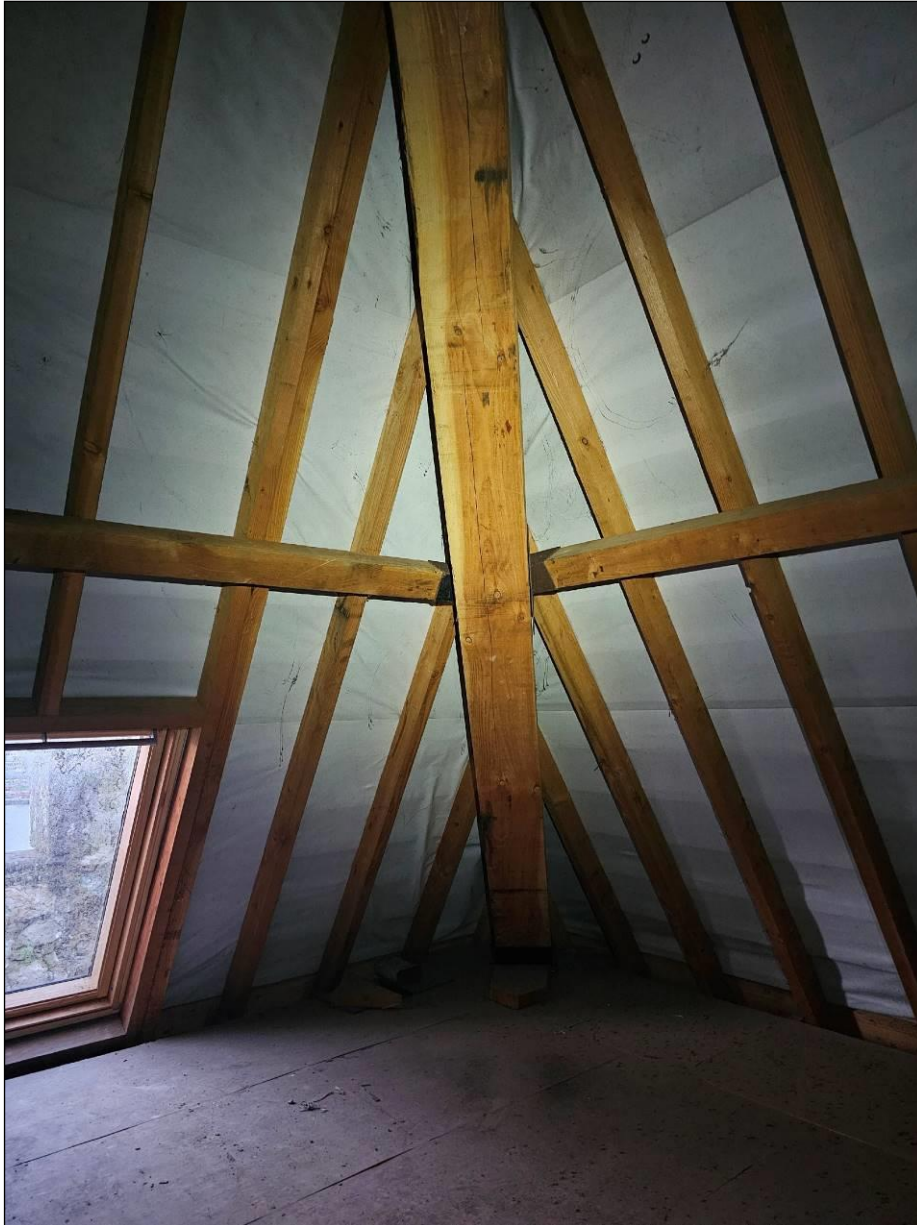
Plate 19. Darkening this skylight would improve the roof space of the tower for roosting bats.

This attic area can also be made more favourable to roosting bats by blocking out the day light from the skylight on the roof. This skylight provides access to the roof

perimeter. It could be darkened with black card/thin sheet of plywood cut to fit the glass and pinned into place with panel pins to the frame or the glass could be painted with black out paint.

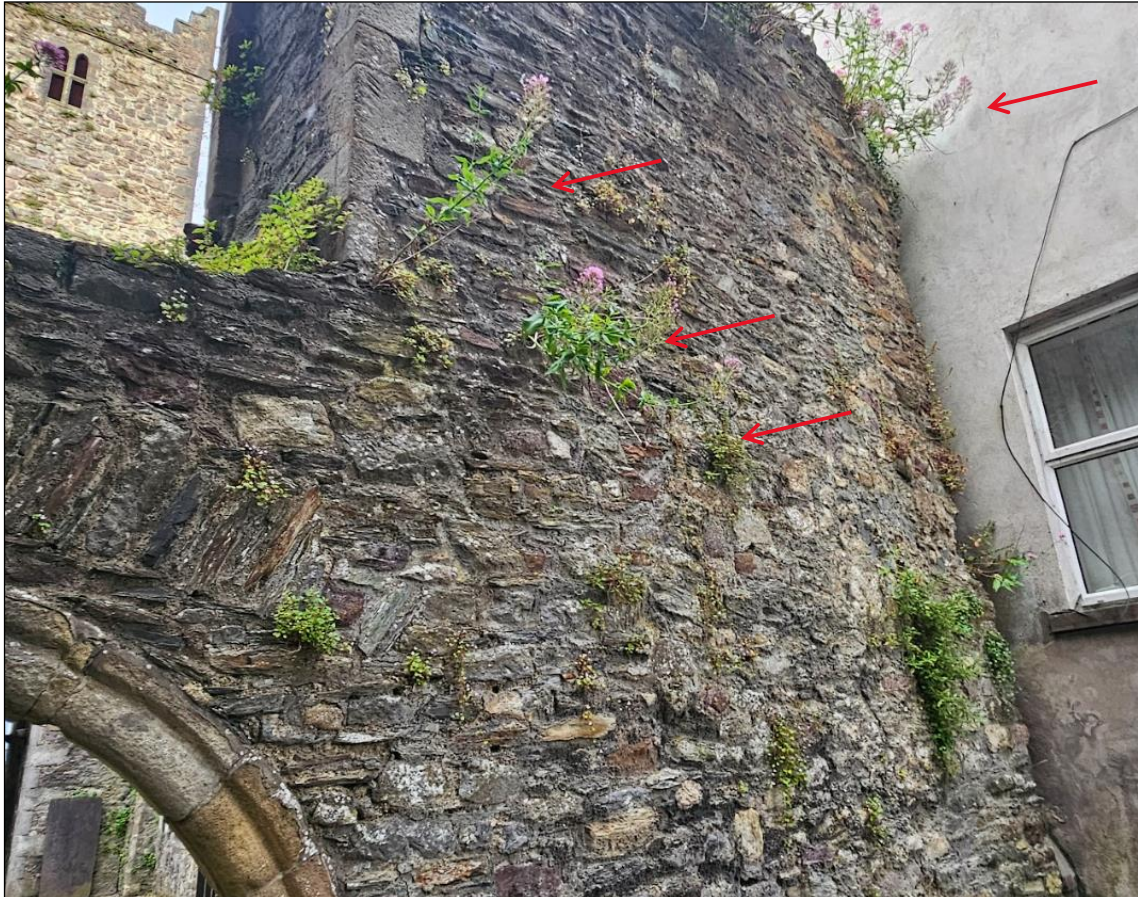
Plate 20. Examples of Red Valerian growing on the perimeter walls of the entrance to the French Church (circled in red).

Red Valerian (**Plate 20**) is an invasive plant and should be carefully removed throughout the site during maintenance and restoration works.

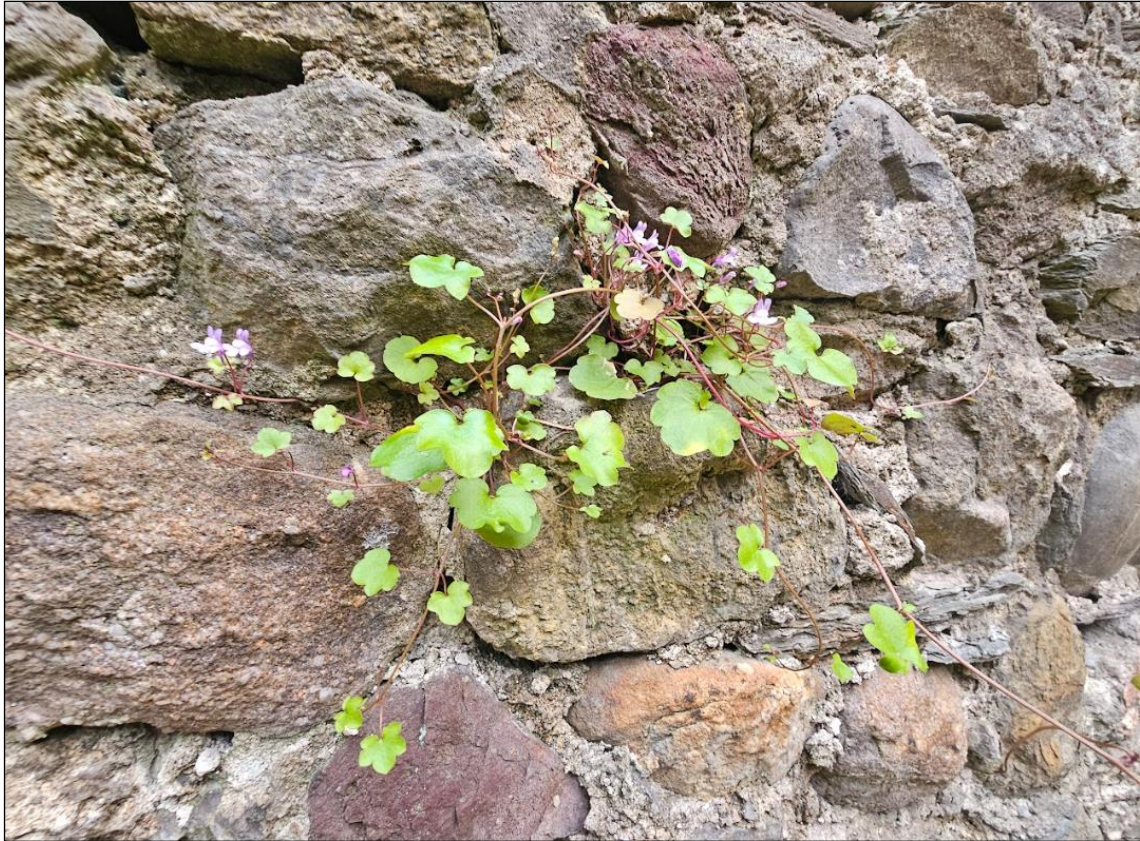
Plate 21. Some areas of the walls have significant vegetation such as this cover of ivy leaved toadflax. Vegetation such as this does not compromise the building in comparison to species such as trees and dense ivy whose roots can work their way into the wall structure.
