Menlo Castle Phase 4

Project reference	191204
Date and time	26/08/2024
Subject	Menlo Castle Ecology Phase 4
Author(s)	KG

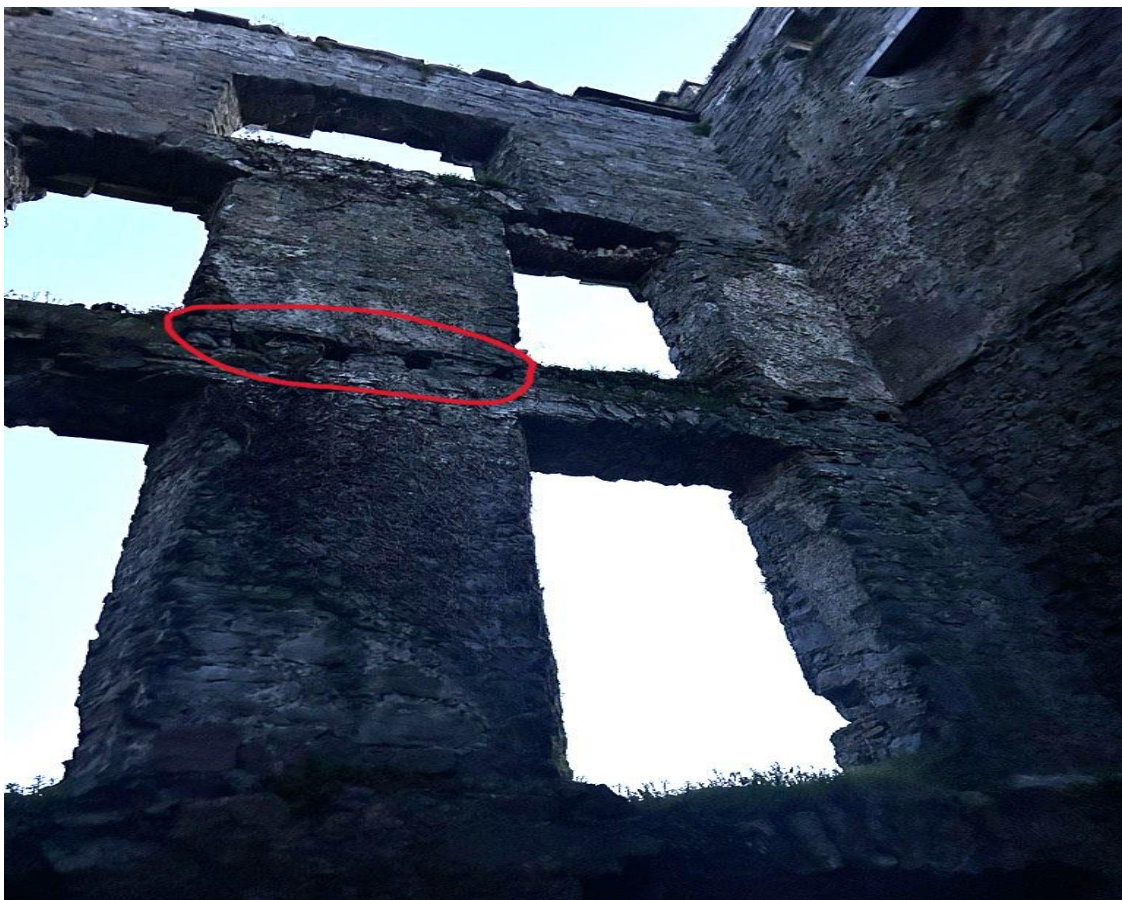
Lesser horseshoe bats were recorded emerging from the known main roost and using several other cavities for night roosting but none were observed in the area of the Phase 4 works. Five bats, confirmed to be a mixture of Soprano pipistrelle and Nathusius' pipistrelle bats were seen to be emerging from cavities on the interior, southern wall. This roosting location has been highlighted in the photo below.

Plate 1 Pipistrelle spp. Roosting locations.

7. The confirmed pipistrelle roosts will be marked for retention and avoided throughout the works.
8. All works will be undertaken outside the main period of bat activity (May to August inclusive).

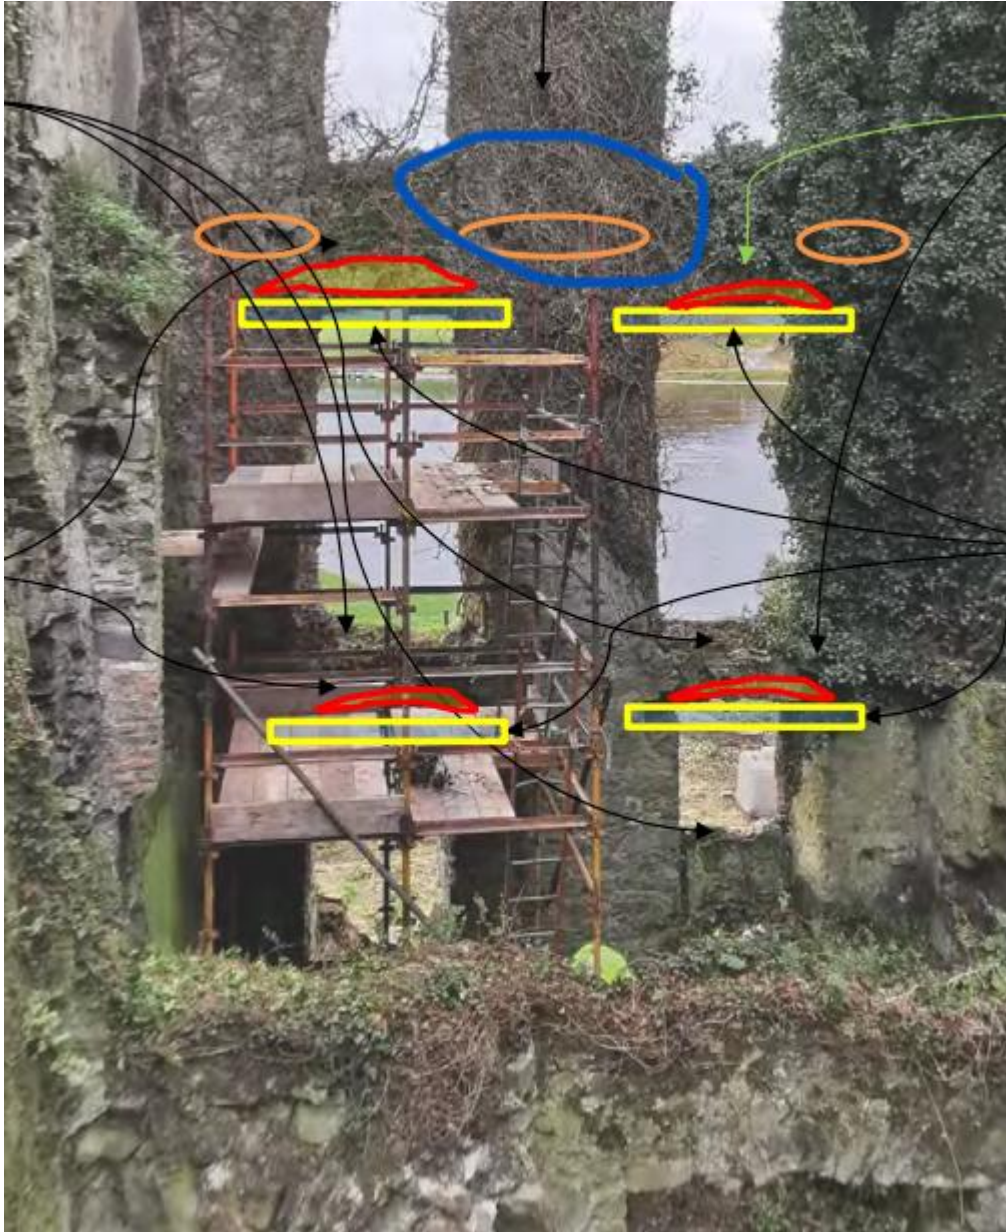
Plate 2 Confirmed pipistrelle spp. Roosting locations circled in blue
