Monitoring of purpose built bat house at Bective Demesne, Bective, Co. Meath.

Client: Bective Stud Ltd.

Project Name & Location: Bective Demesne, Bective, Navan, Co. Meath

Proposed work: Monitoring of purposed built bat house (Bective Bat House)

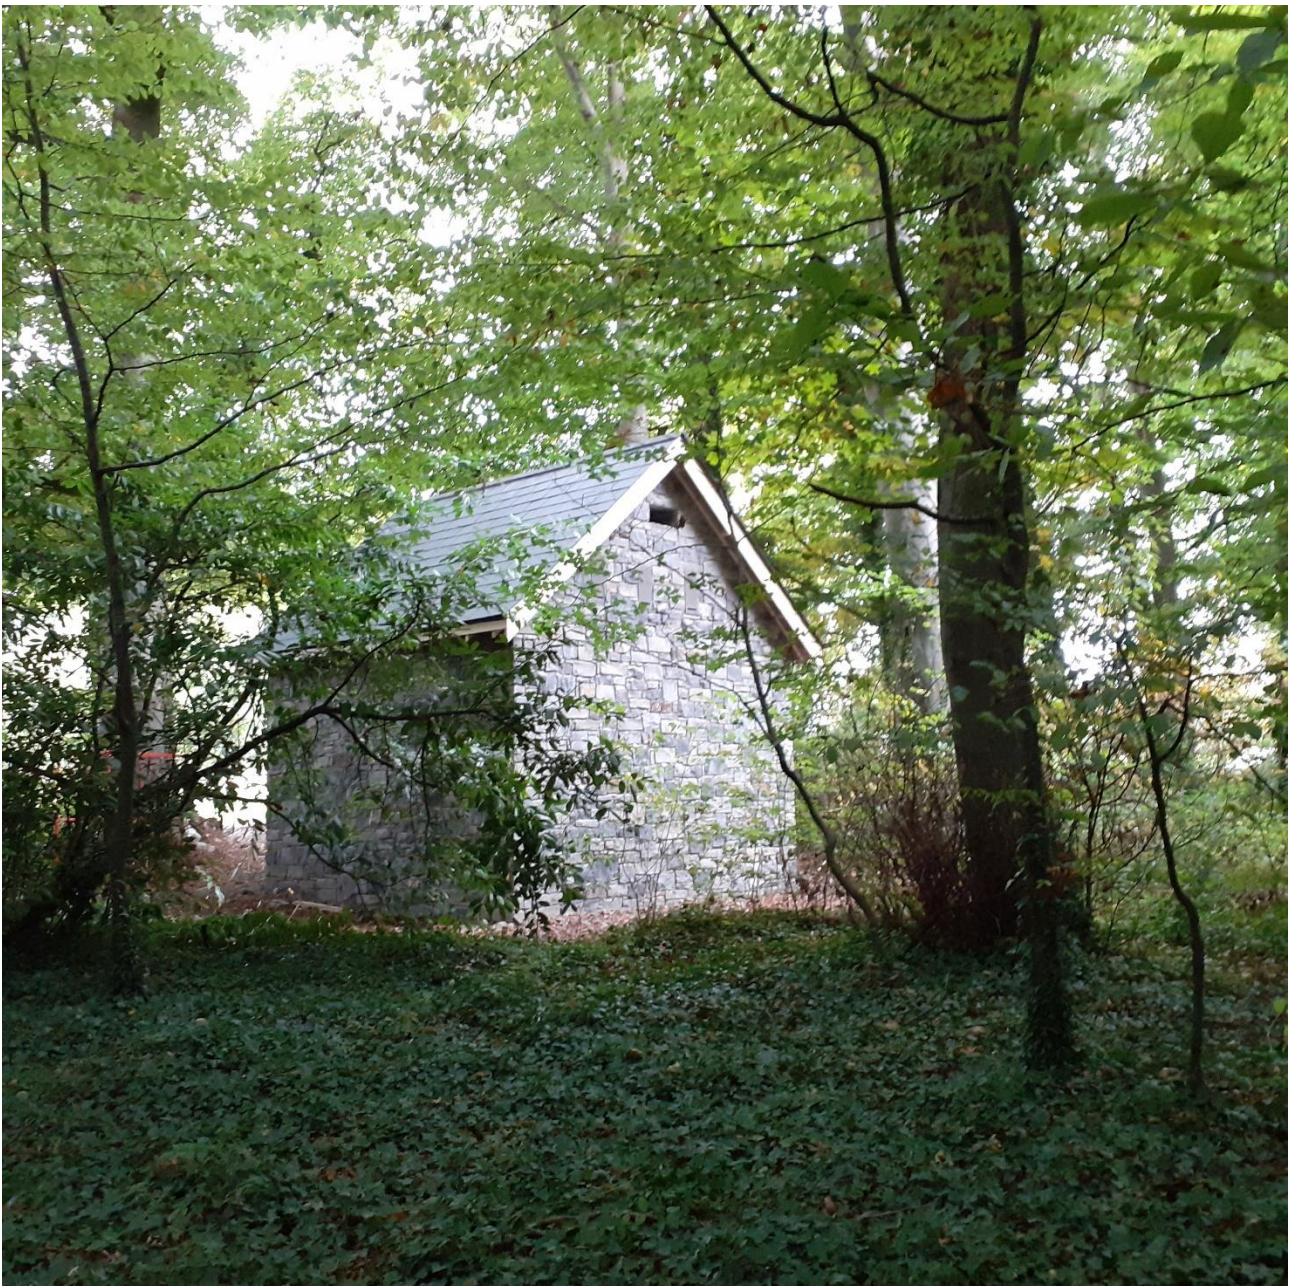
Plate 1: Bat house (rear view).

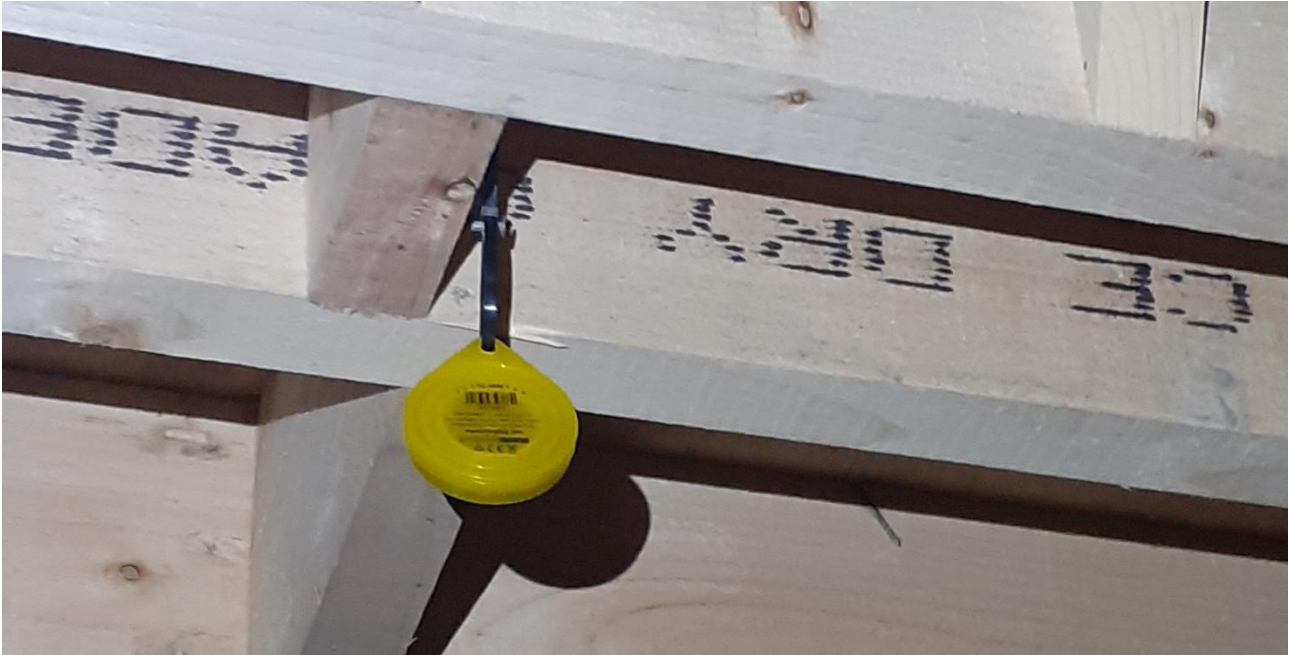
Plate 2: Temperature data logger installed in Bat House.

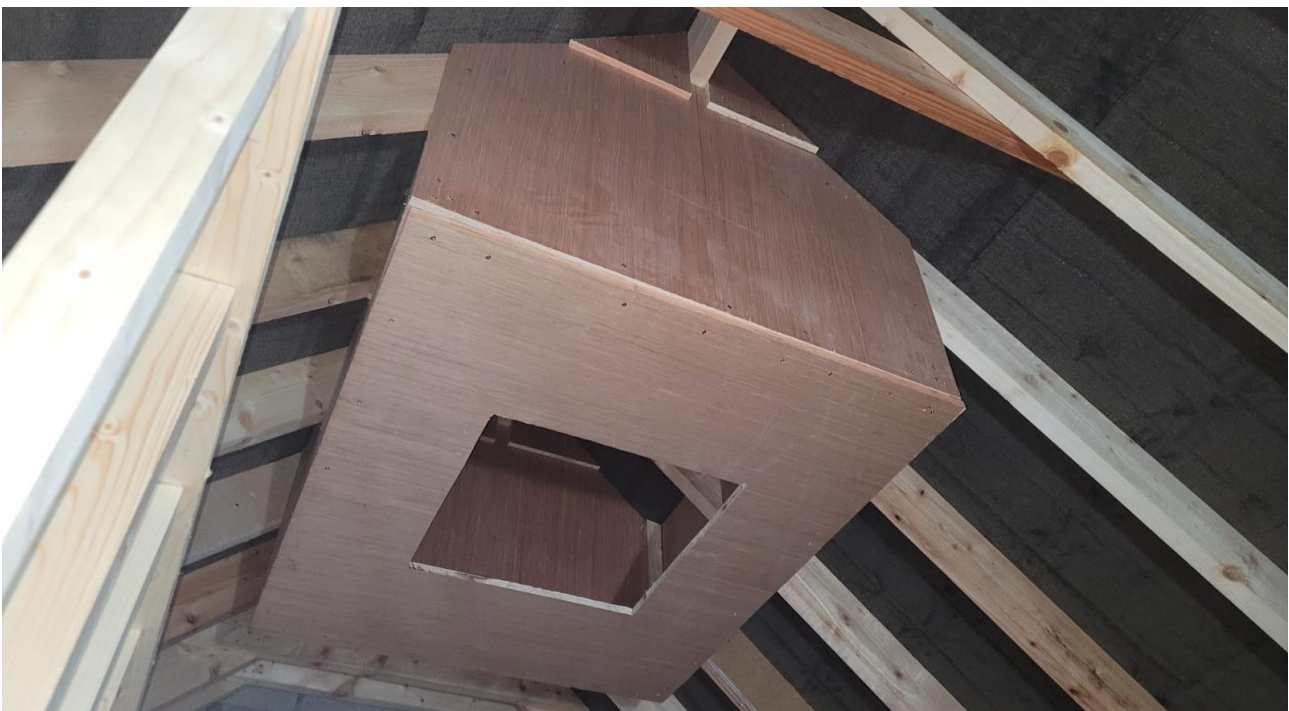
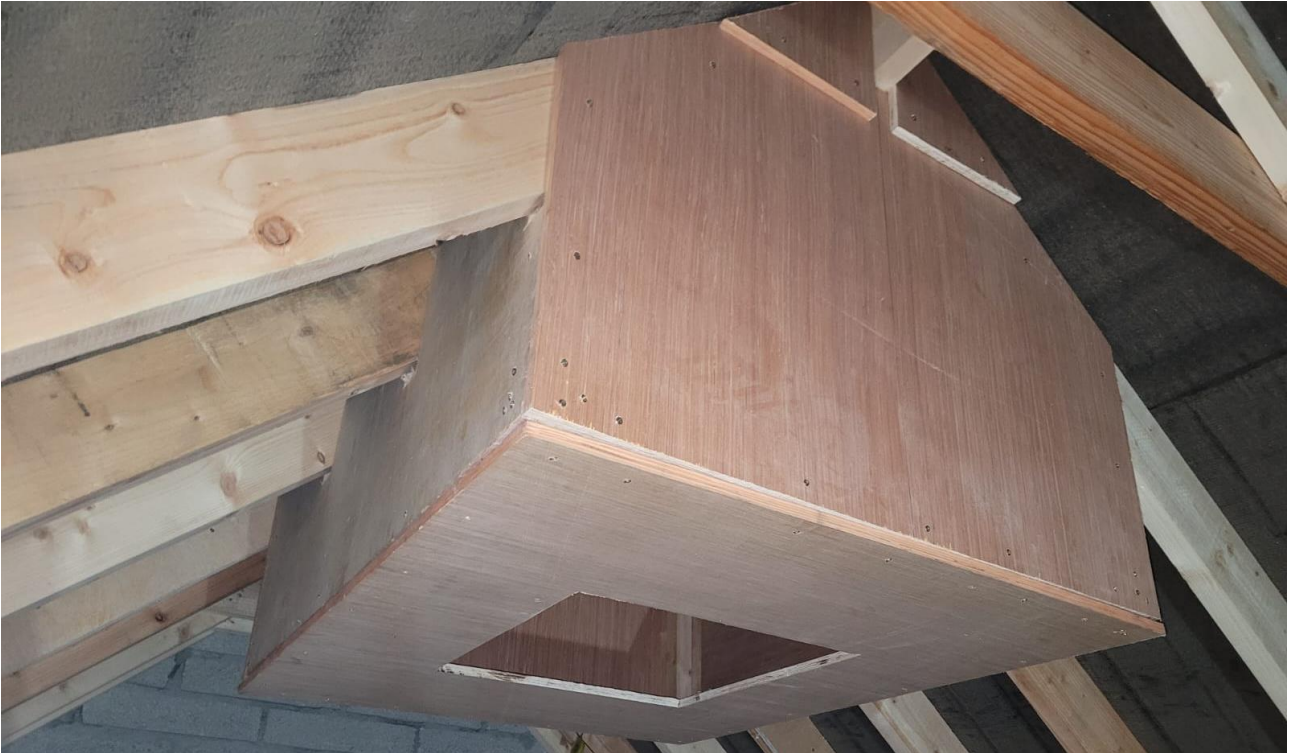
A hot box was installed on 19th July 2022. The dimensions of the hot box is 100cm x 120xm x 90cm.

Plate 3a: Hot box installed in roof of bat house.

Plate 3b: Hot box installed in roof of bat house.

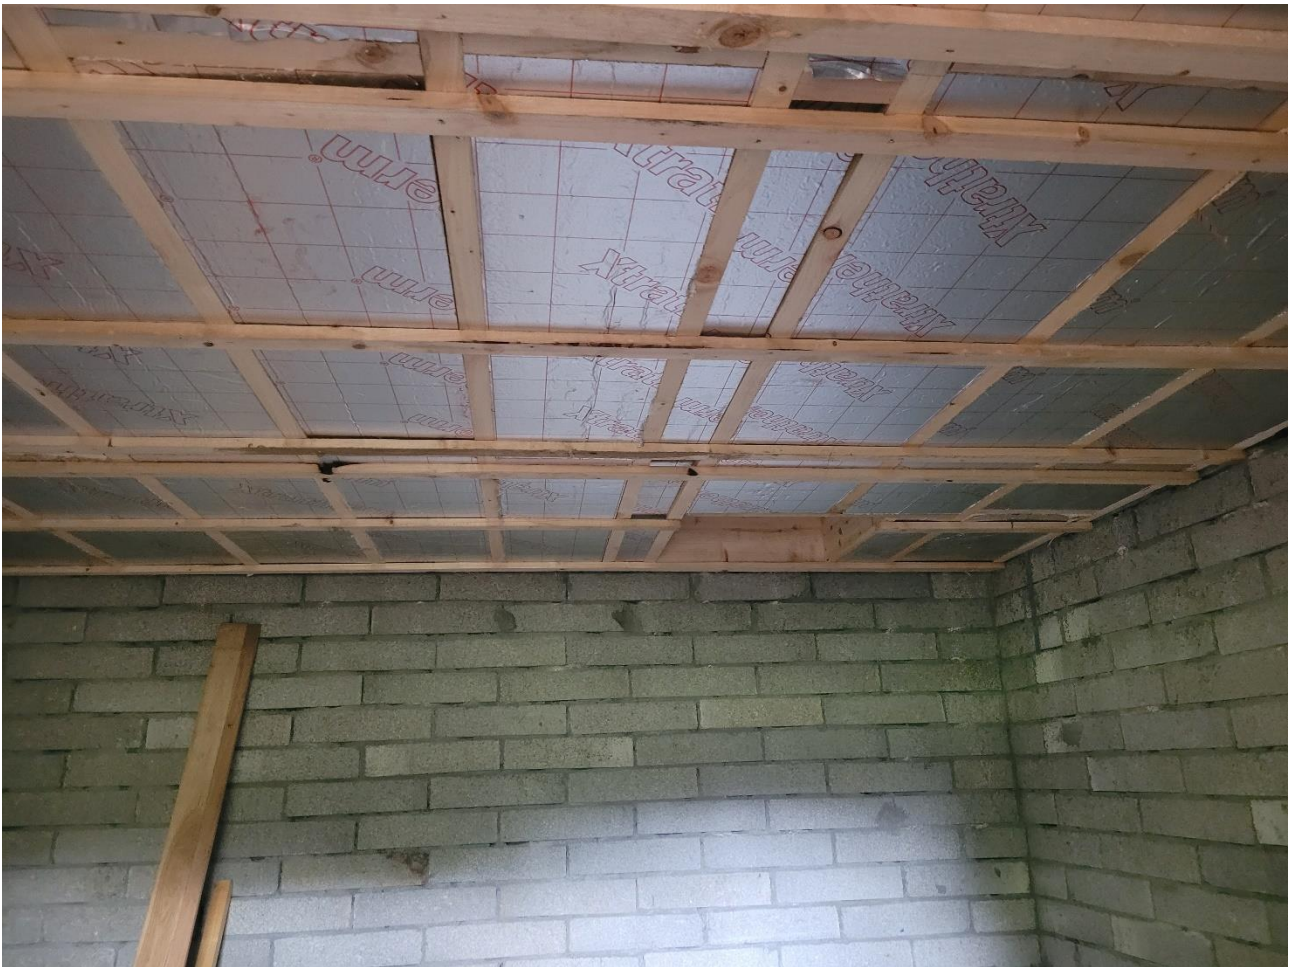
The loft floor was installed on 31st August 2022. This consisted of a full floor, insulated on the underside and a entrance hole (with trip boards) of 500mm square. A ladder is required to access the loft space from the ground floor.

Plate 4: New insulated loft floor – showing underside of loft floor.

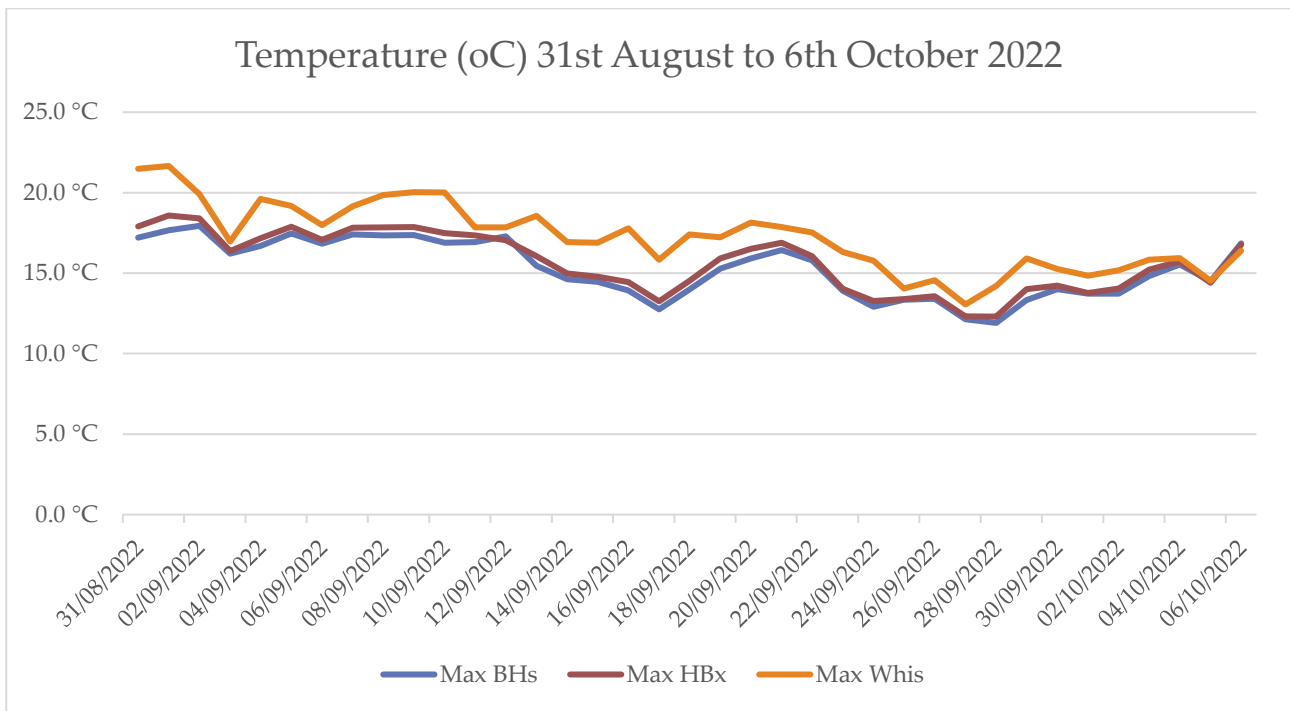
The graph below displays the temperature data collected. The average daily maximum temperature for this monitoring period in the Whiskered Bat Roost (stable courtyard loft – Bective Courtyard) was 17.2 °C with a range of 13.1 to 21.7 °C. In comparison, the average daily maximum temperature for the same period for the Bat House (general attic space) was 15.3 °C with a range of 11.9 to 17.9 °C. In relation to the hotbox, the average daily maximum temperature for the same period was 15.7 °C with a range of 12.3 to 18.6 °C. Therefore the maximum daily temperature in the Bective Bat House is on average 1.5 °C cooler than the Whiskered Bat Roost. Comparing this to the average temperatures recorded in Monitoring Period 1, there is a less temperature difference between the Whiskered Bat Roost and the Bat House as a result of the works undertaken.

Figure 4: Daily maximum temperature recorded in the stable courtyard loft of Bective Courtyard (Whiskered Roost) and Bective Bat House from 11/7/2022 to 28/7/2022.

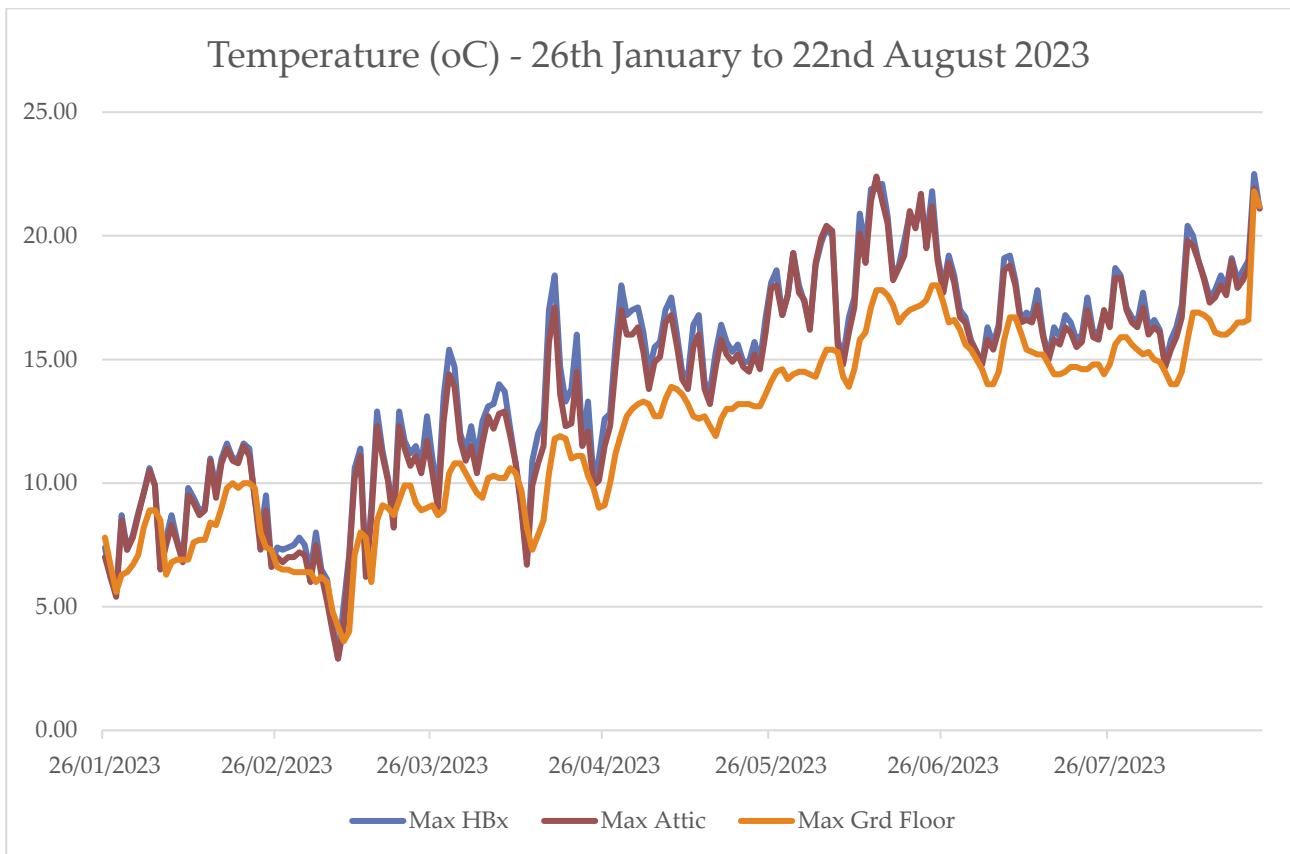
Temperature data loggers continued to be located inside the loft space of the bat house and inside the hot box (bat house) while a third unit was located within the ground floor of the bat house to monitor temperature hourly from 26th January to 22nd August 2023. The temperature records are presented on the graph below. The daily maximum temperature for the ground floor of the bat house was consistently lower than the temperatures within the loft and hotbox of the bat house. Therefore the new “full” floor was ensuring that there was a higher temperature in the loft space.

Figure 5: Daily maximum temperature recorded in Bective Bat House from 26th January to 22nd August 2023.

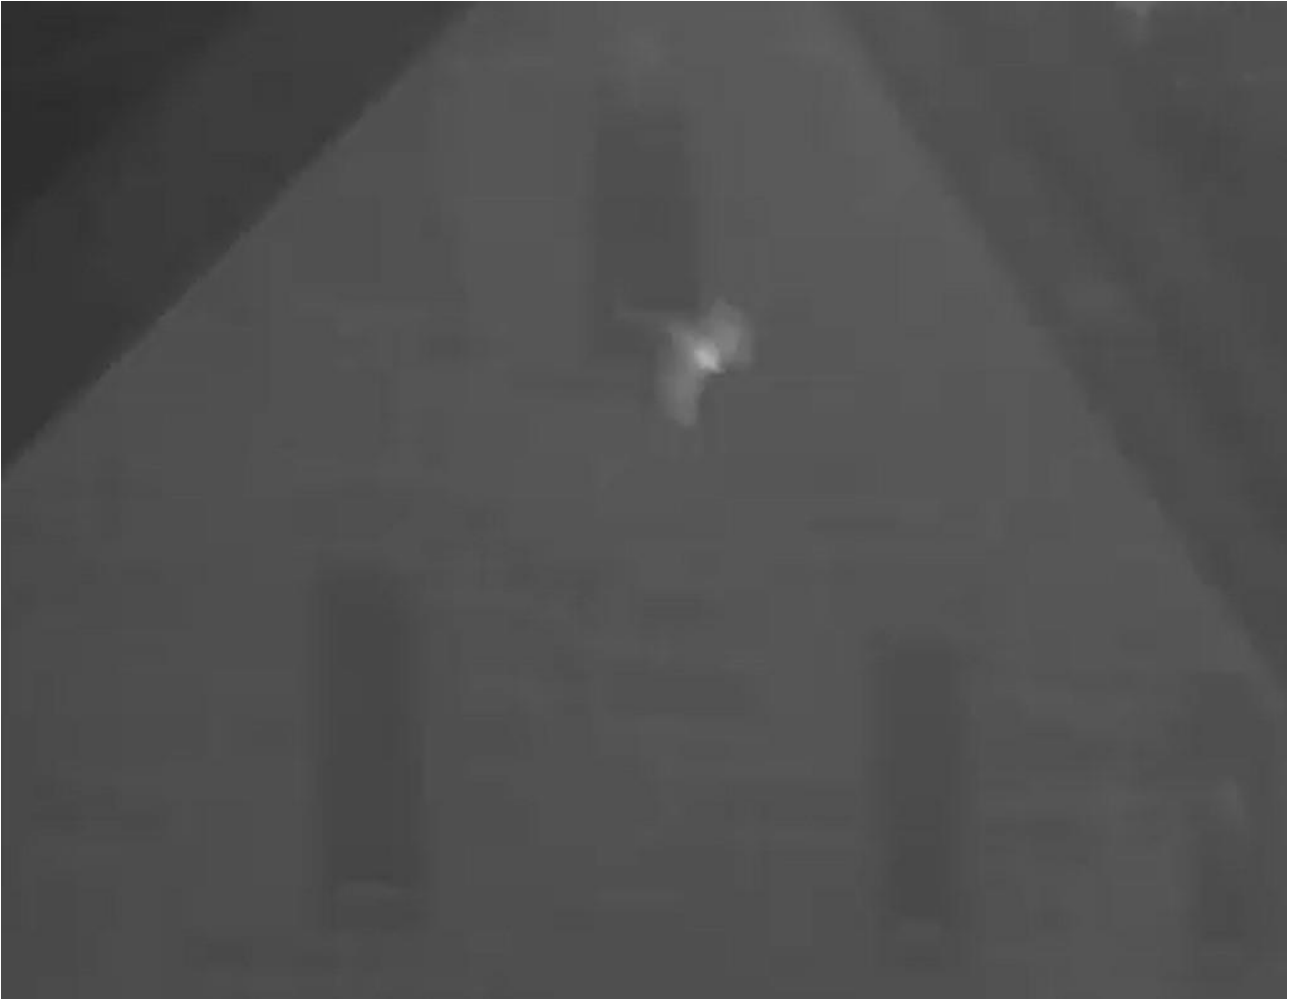
- Three whiskered bats were confirmed emerging from the eaves of the bat house at 21:21 hrs, 21:30 hrs and 21:38 hrs.
- Six brown long-eared bats were confirmed emerging from the eaves (5 individuals) and one from a bat tube (rear wall of bat house) at 21:01 hrs, 21:02 hrs, 21:04 hrs (2 individuals), 21:07 hrs and 21:11 hrs.
- 10 soprano pipistrelles were recorded emerging from the bat tube located on the front wall of the bat house (Plate 5a) while one additional individual was recorded emerging from a bat tube located on the rear wall of the bat house.

Plate 5a: Soprano pipistrelle emerging from bat tube (front of bat house).

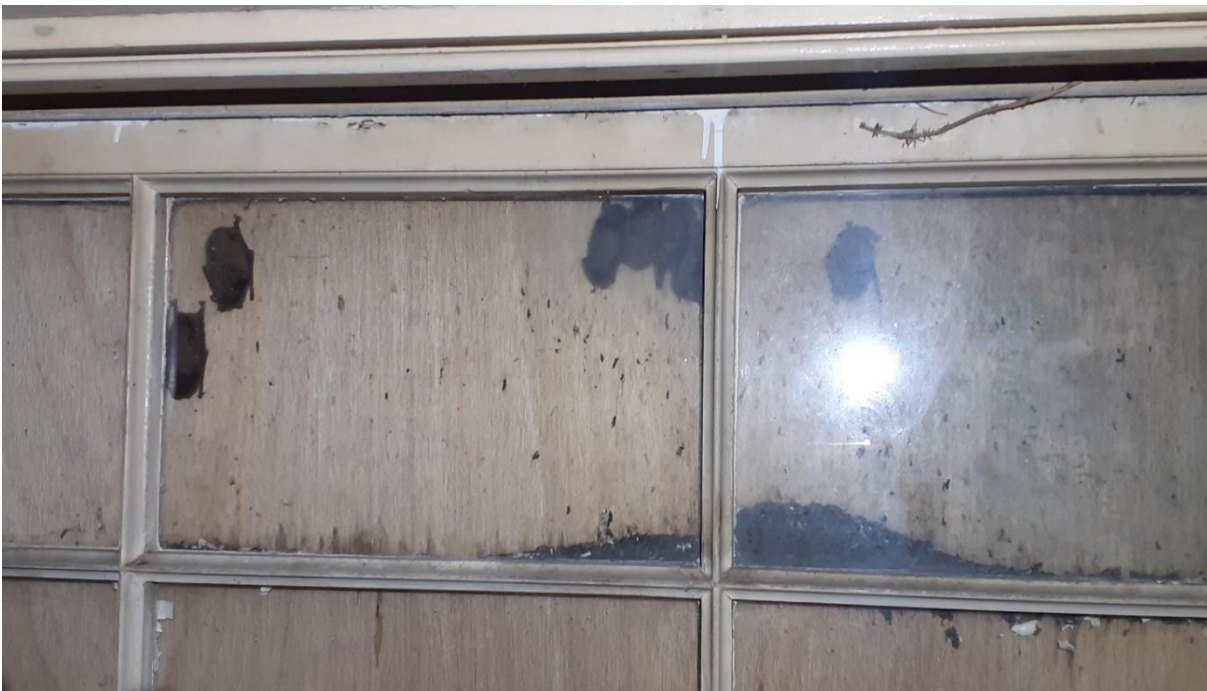
During this survey, seven soprano pipistrelles were also recorded roosting between the window pane and ply wood sheeting located in the room where brown long-eared bats were recorded emerging from the attic space. A collection of bat droppings was also noted in this tight space indicating that the bats roost here regularly. This additional bat roosting information will inform bat mitigation steps required in relation to proposed development works.

Plate 6: Soprano pipistrelles roosting between window pane and ply wood sheeting

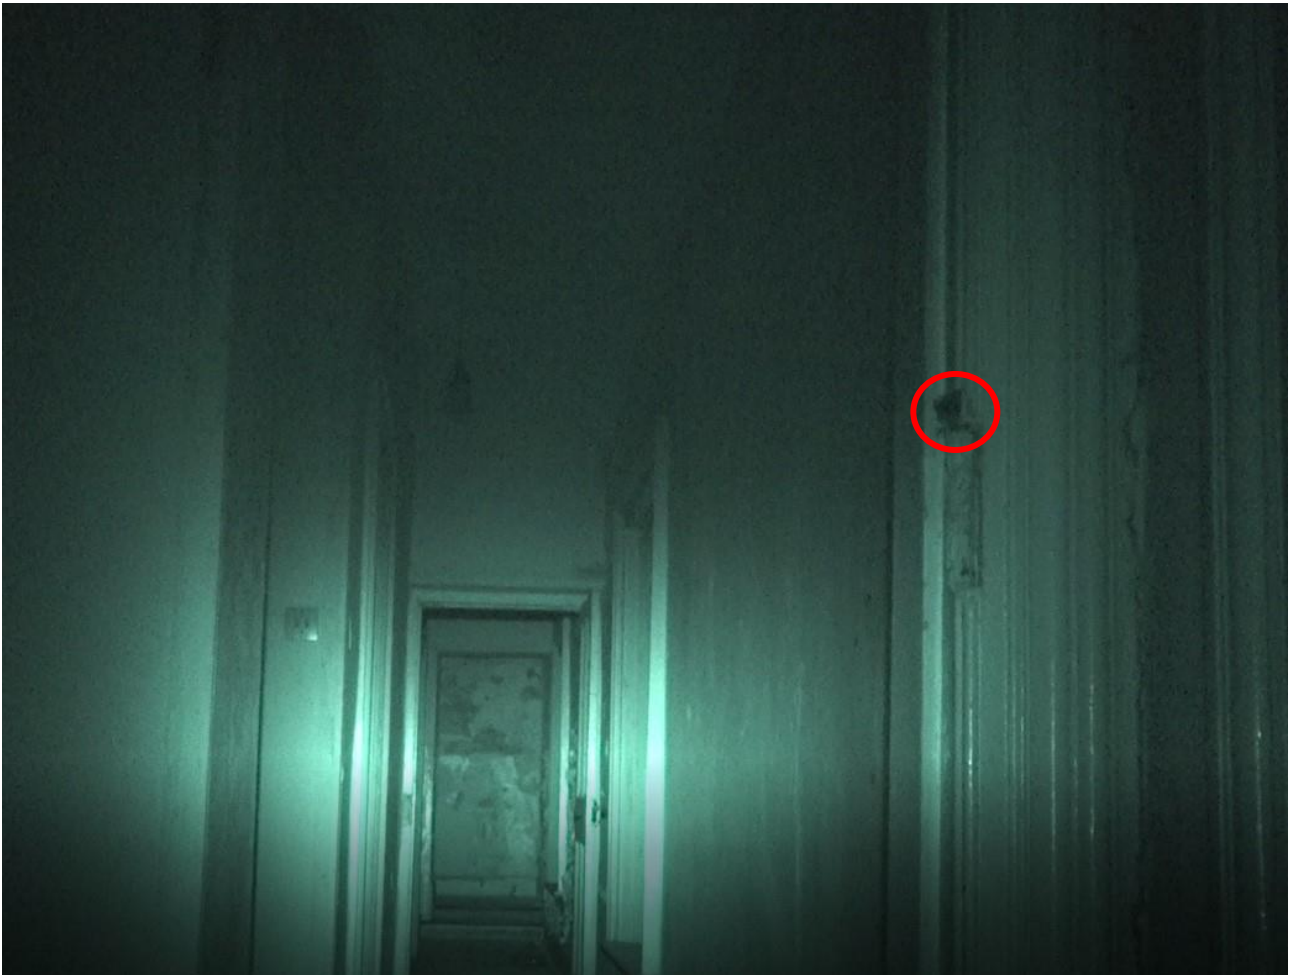
In addition, a single bat (likely to be a *Pipistrellus* species) was recorded emerging from timber frame around the doorway.

Plate 7: Bat emerging from timber door frame during filming – Red Circle.

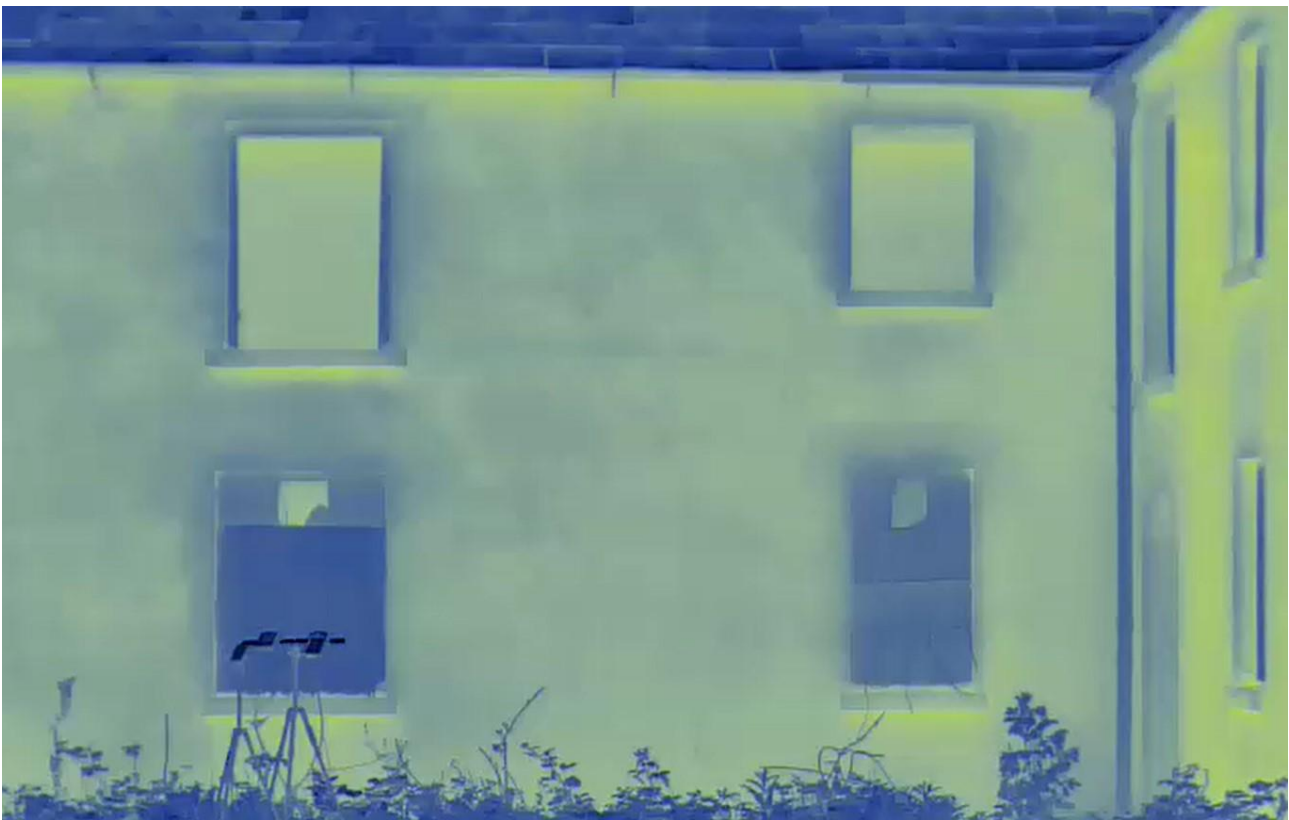
Plate 8: Thermal imagery filming of access points to loft room (two windows on the 1st floor) of stable courtyard (i.e. Whiskered bat roost)

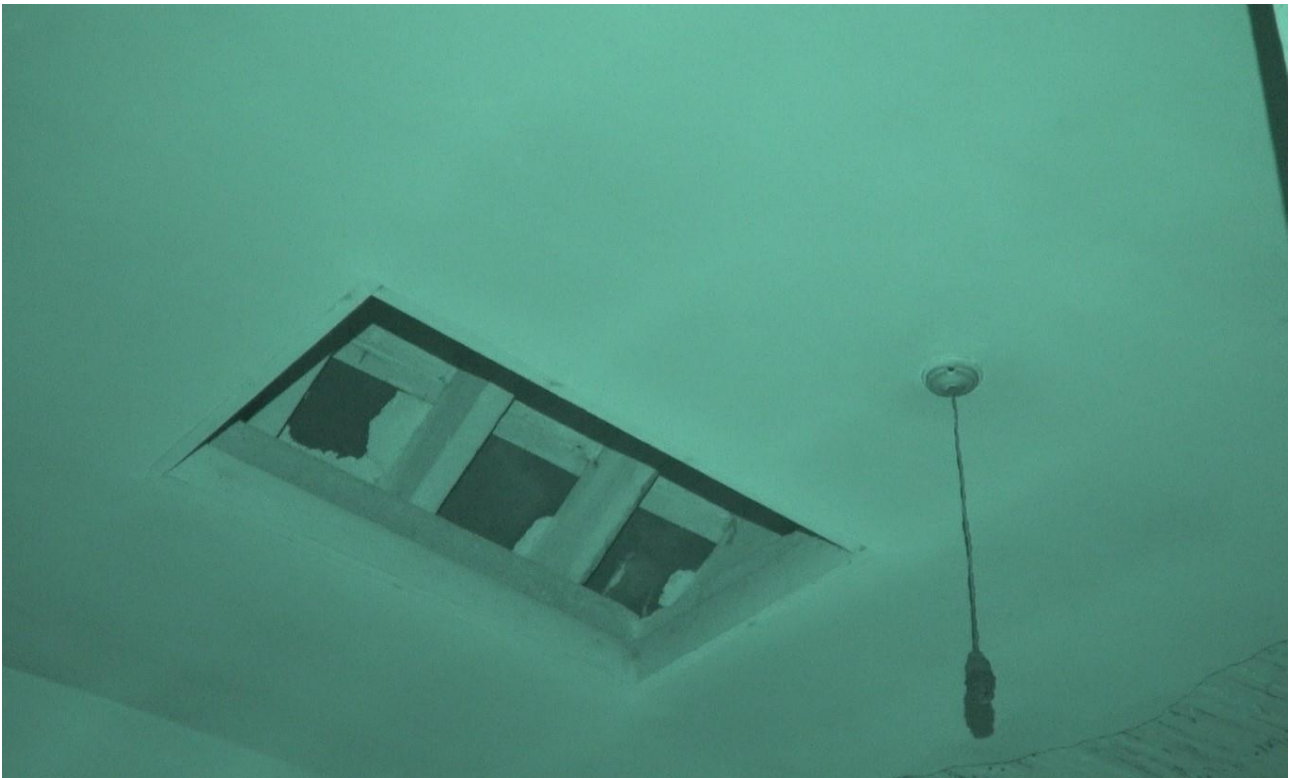
Plate 9: Image of loft entrance where brown long-eared bat activity was recorded using IR filming.

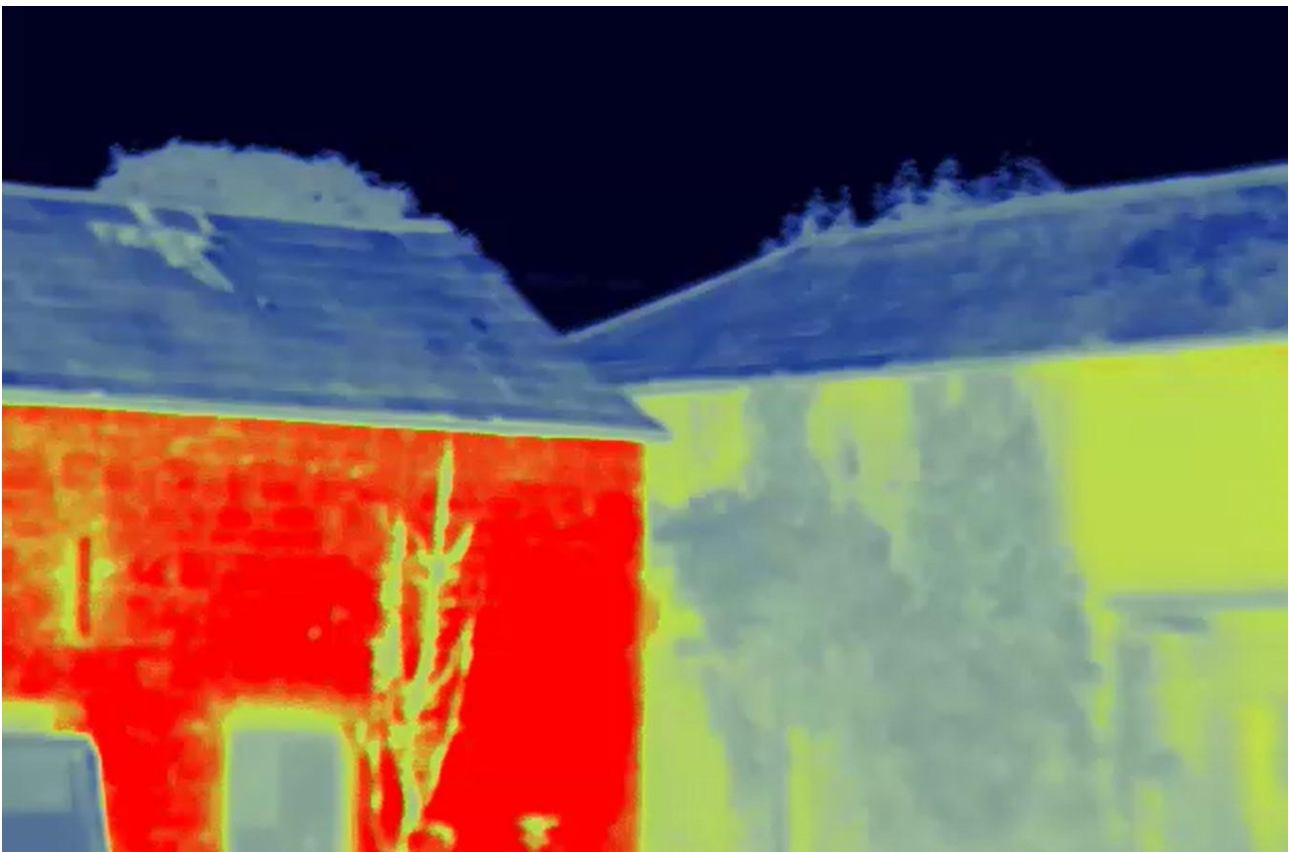
Plate 10: Additional thermal imagery filming of the rear section of stable courtyard building to determine if bats were exiting from the gaps in the slates of the roof – building to right hand-side of screen shot.

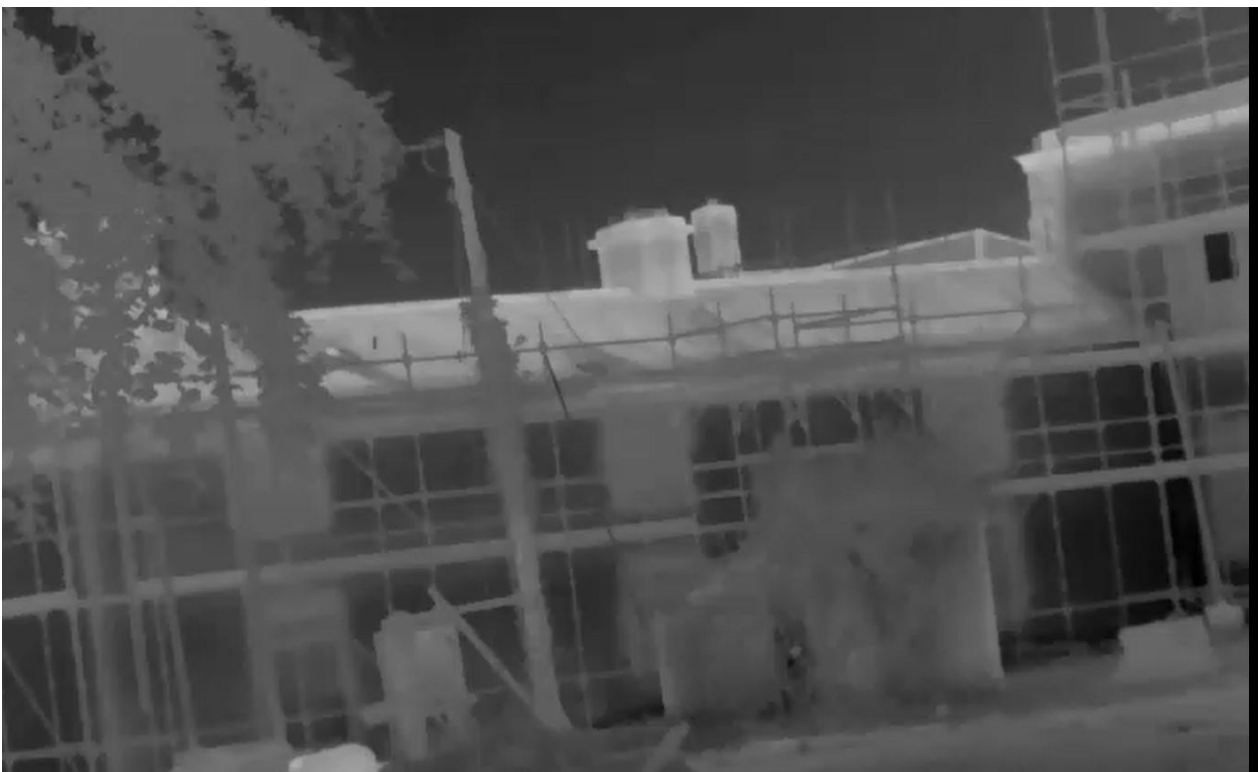
Plate 11: Thermal imagery filming of front of Bective House.

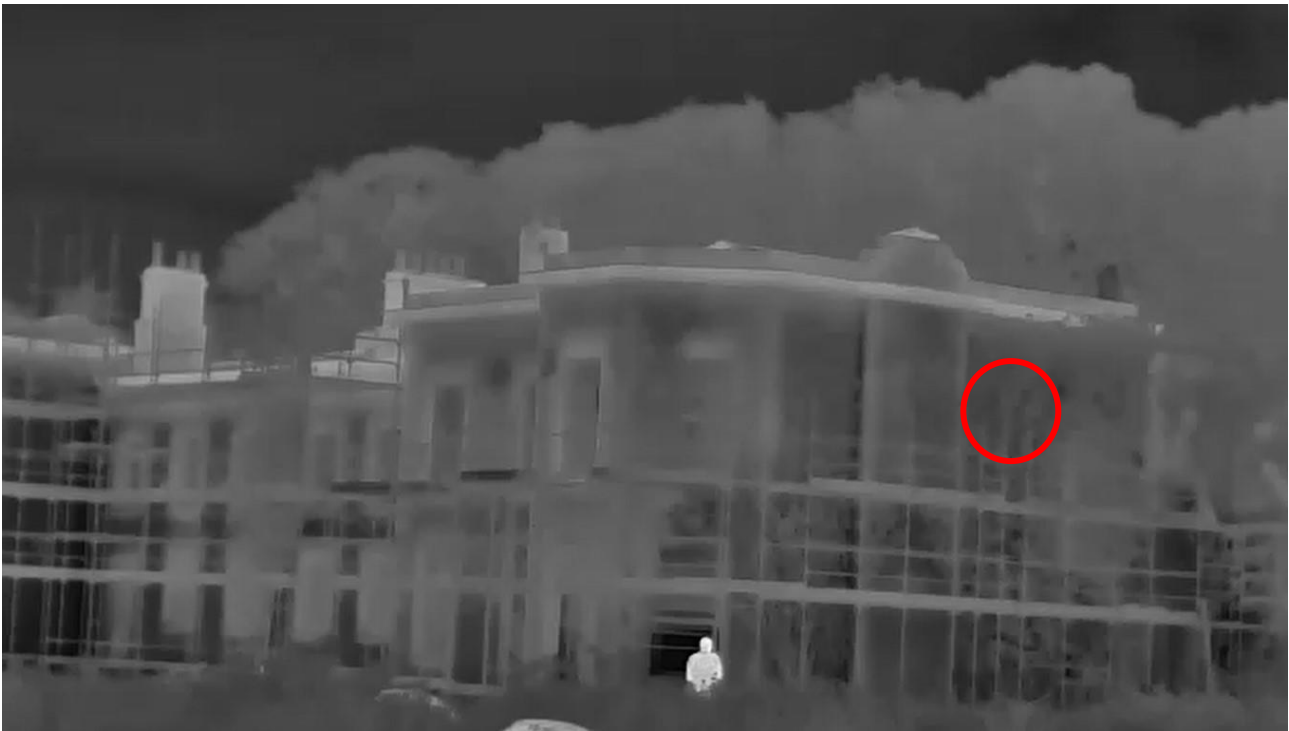
Plate 12: Thermal imagery filming of rear of Bective House. Red circle – window (exit point).

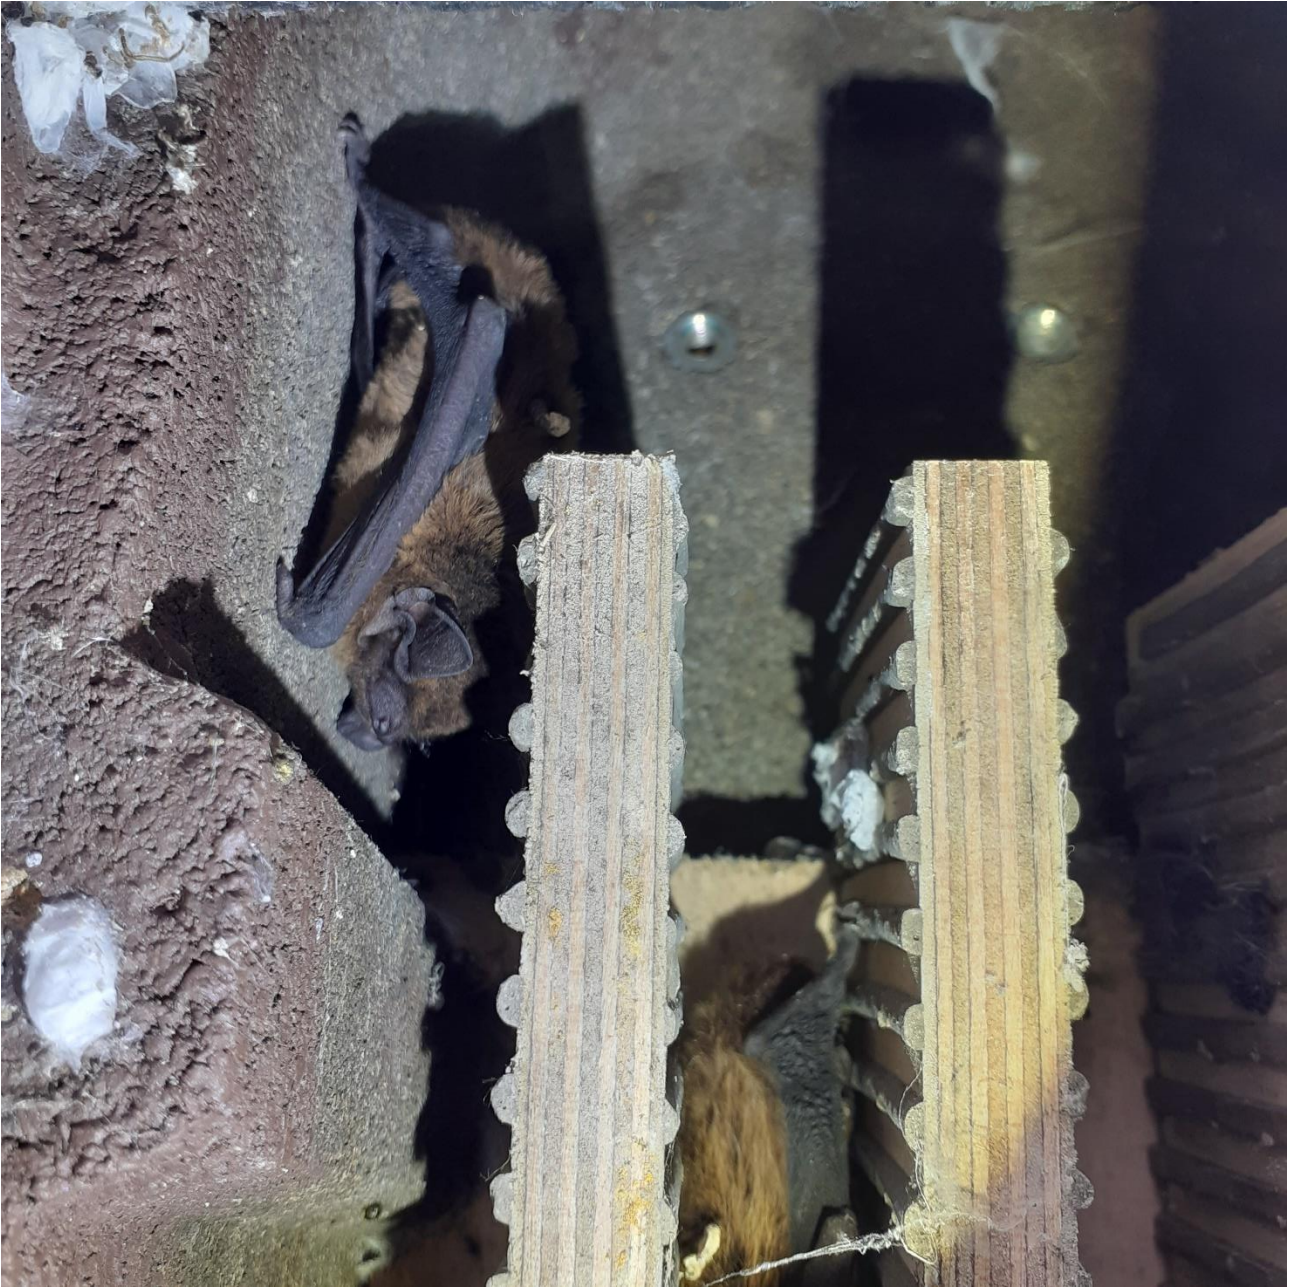
A bat box inspection was undertaken on 19th March 2023. Of the 19 bat boxes checked, eight had evidence of bat usage. The bat species primarily using the bat boxes are Leisler's bats (Plate 13). The results of this inspection is present in Table 4.

Plate 13: Two Leisler's bats recorded roosting in a bat box during inspection.
