Derogation Licence Application and Bat Survey Report

Newhall Estate Stables
Redevelopment,
Co. Clare.

Prepared for:
Transmoor Limited

Project: Proposed redevelopment of Newhall Estate stables, Co. Clare.

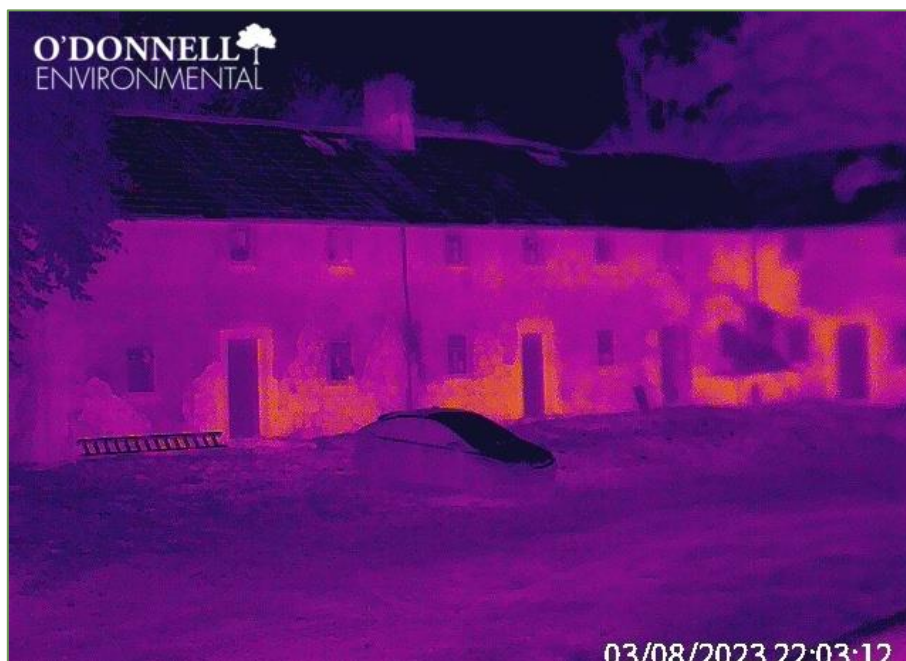
Plate 2.1 Example image of thermal camera covering the former stables complex containing the original roosting location of Lesser Horseshoe Bat (Roost ID: 44).

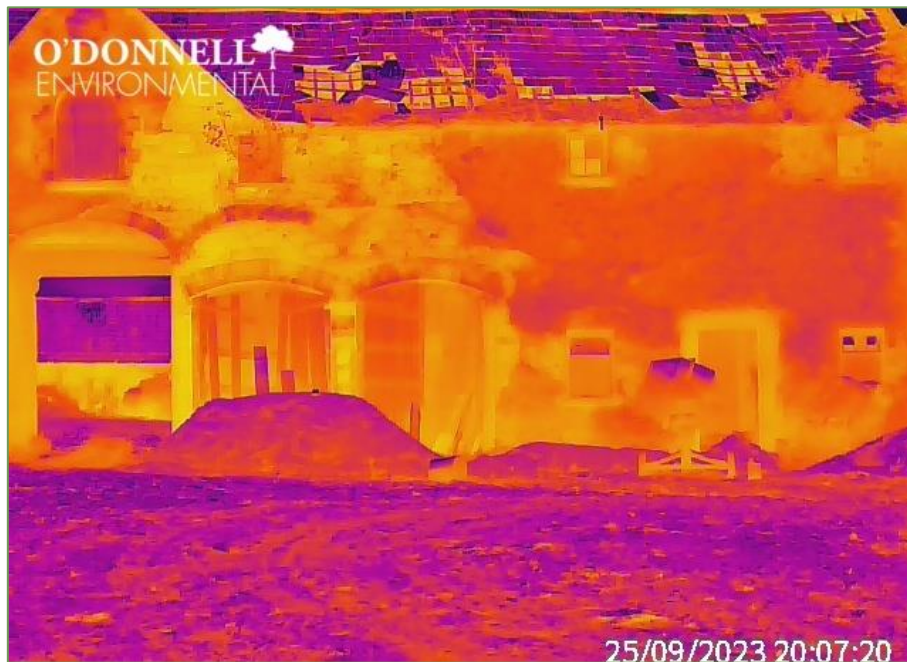
Plate 2.2 Example image of thermal camera covering the western aspect of the former stables complex adjoining the main courtyard.

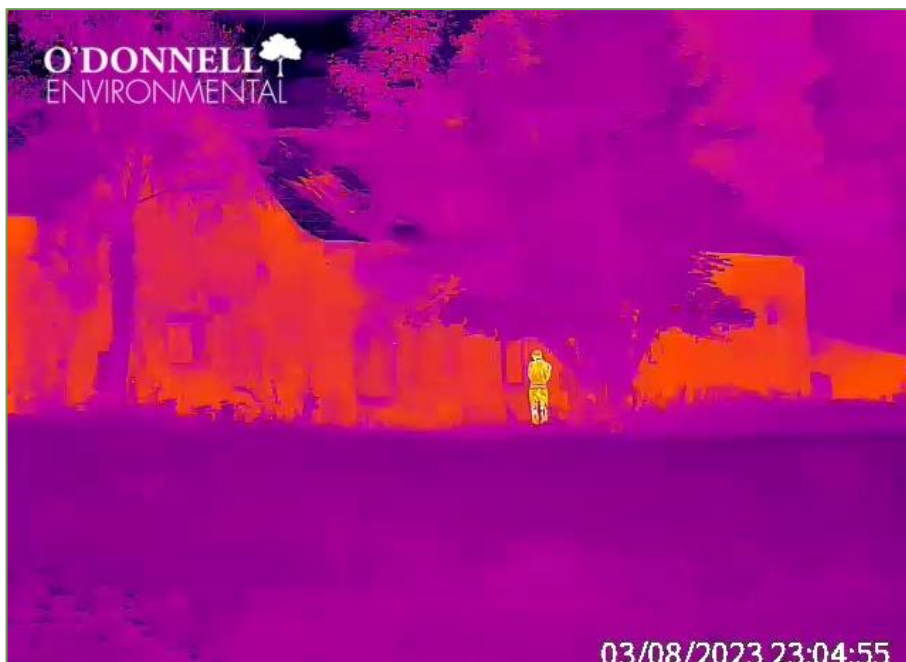
Plate 2.3 Example image of thermal camera covering the northern aspect of the former stables complex (Roost ID: 44) adjoining mature woodland with surveyor positioned adjacent to egress point.

Multiple potential emergence points were identified within the two-storey outbuilding (Roost ID: 44), primarily due to the advanced state of dereliction of the building (see **Plate 3.2**). The primary access/egress route was historically, and remains so, the unglazed windows at the rear/northern aspect of the building on the ground floor which leads directly into the woodlands/former gardens (McAney and Fairly, 1989; Elaine Keegan pers. comm.; see **Plate 2.3**). No emergence of any bat species was noted along the front of the building leading directly into the courtyard.

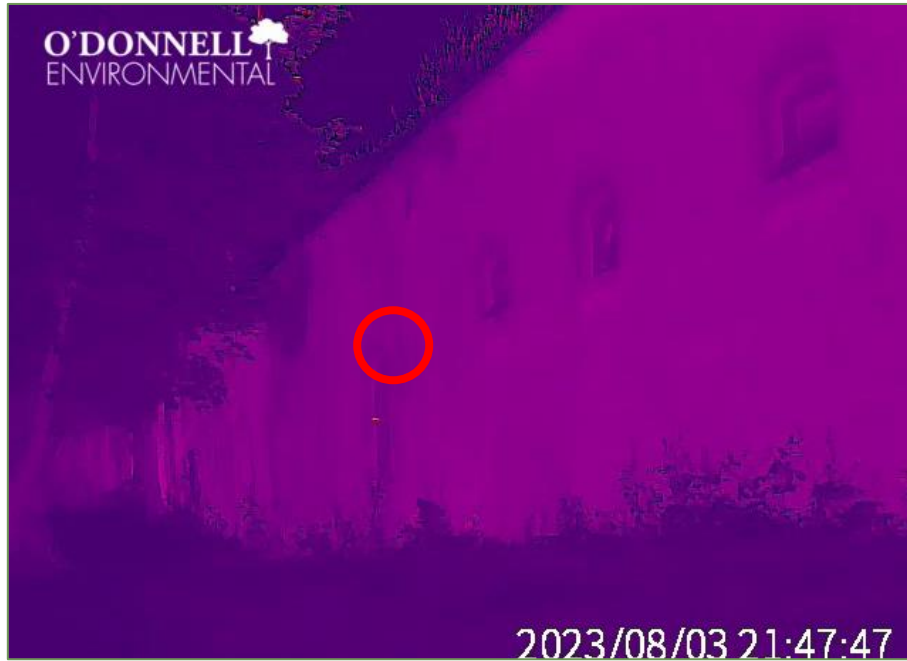
Plate 2.4 Example image of thermal camera covering the northern aspect of the former stables complex (Roost ID: 44) adjoining mature woodland with Lesser Horseshoe Bat emerging (red) and travelling north.

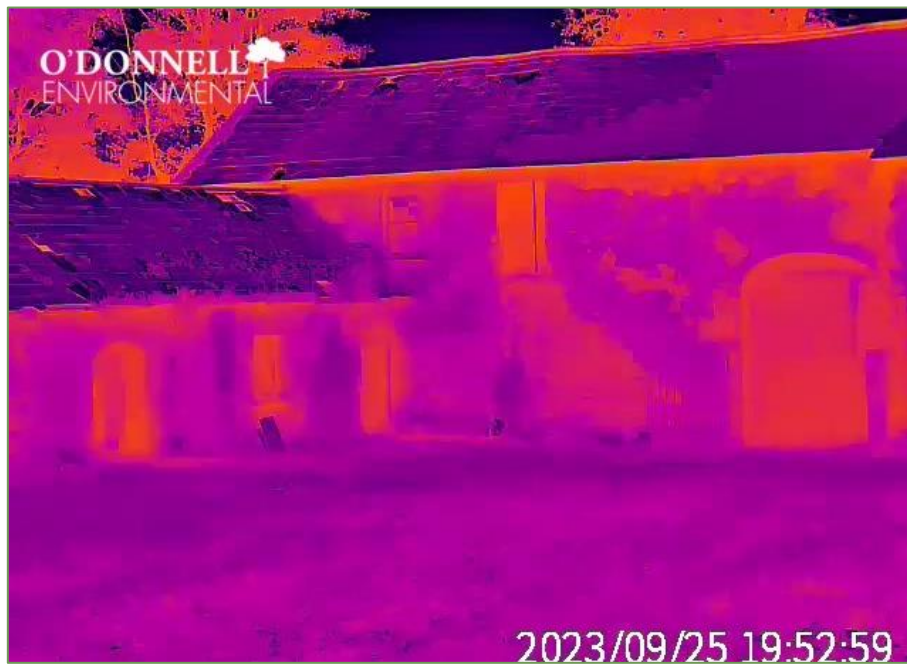
Plate 2.5 Example image of thermal camera covering the eastern aspect of the former stables complex adjoining the eastern courtyard.

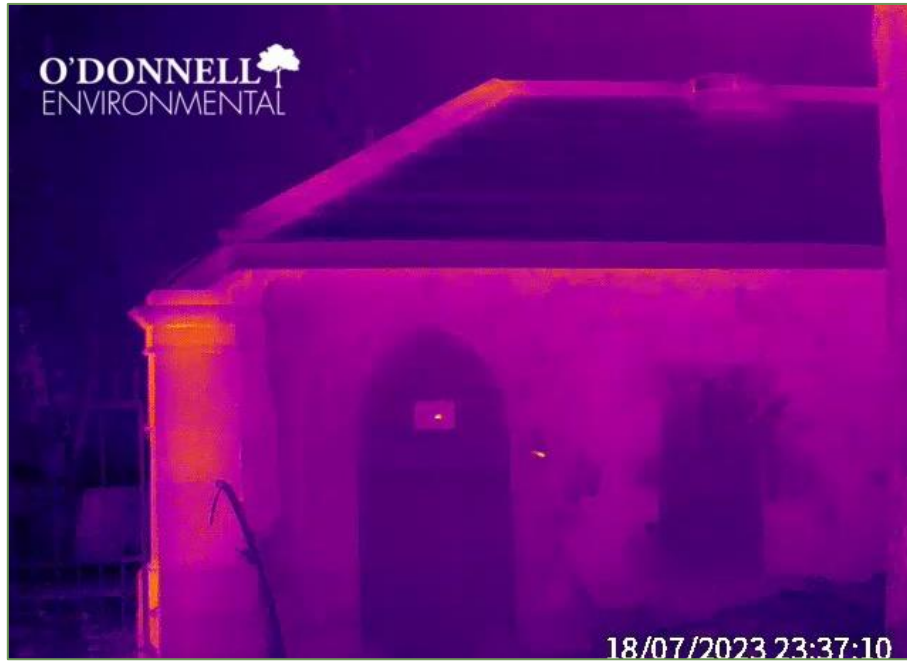
Plate 2.6 Example image of thermal camera covering the northern gate lodge housing the newly discovered Lesser Horseshoe Bat maternity roost with bats emerging (red) and travelling north.

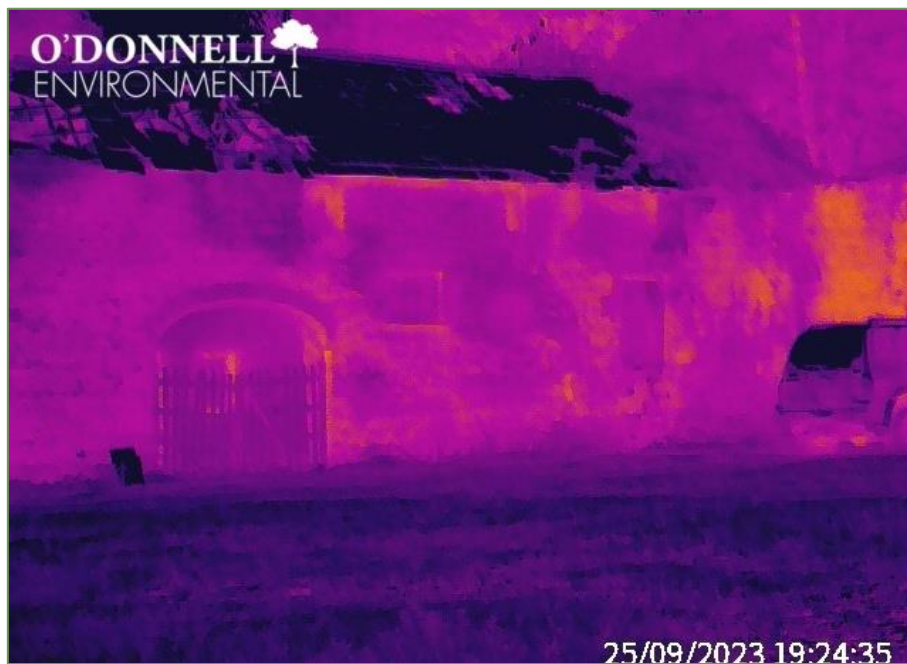
Plate 2.7 Example image of thermal camera covering the eastern aspect of the two-storey outbuilding adjoining the eastern courtyard

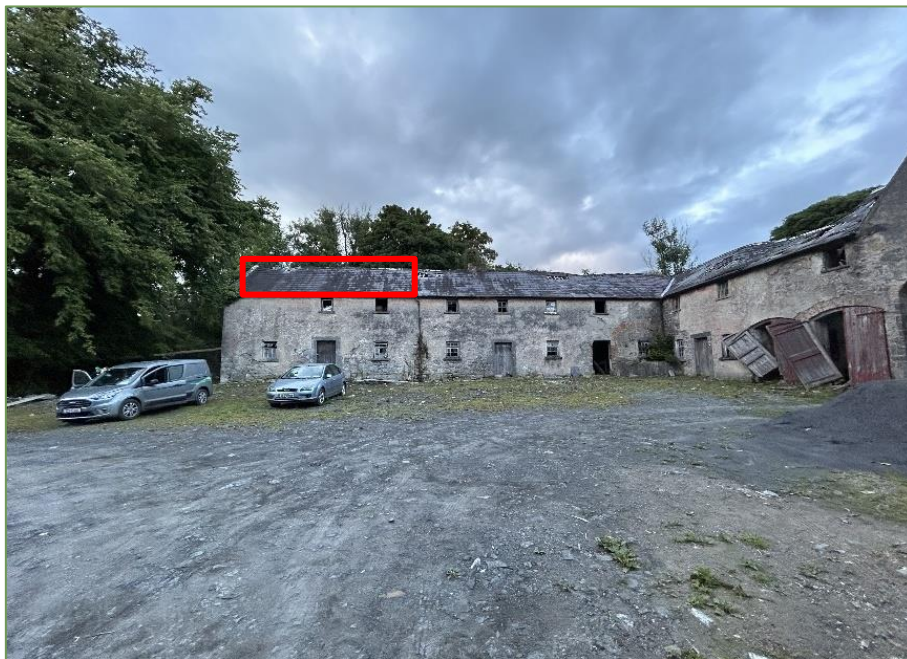
The entirety of the exterior structures were accessible when viewed from ground-level. The exterior of the house presented multiple access/egress points, mostly in the form of unglazed windows on the ground floor and collapsed portions of roofing. There was considerable damage and dilapidation present on the entirety of the outbuilding complex, with entire subsections completely open to light and water ingress following total collapses of roof portions (see **Appendix A1; A2**). The location of the original Lesser Horseshoe Bat roost (Roost ID: 44; see

Plate 3.1) remains in somewhat better condition but no bitumen felt remains underneath the natural slate and moderate light ingress is visible through loose tiles (see **Appendix A4**). The roof portions of the adjacent upper rooms have failed catastrophically in sections (see **Plate 3.2**), further exacerbating the problem light and water ingress on the colony.

Plate 3.1 Overview of the exterior structure of the two-storey building which houses a maternity colony of Lesser Horseshoe Bat (Roost ID: 44) (bounded in red).

The stables roost (Roost ID 44) will be lost entirely to roosting bats. In the absence of intervention, the roost would be lost in any event in the short term due to dereliction. The stables roosting location is in a dilapidated condition and there is evidence that it is a suboptimal roosting location and being abandoned by the colony. Two suitable, suitably large, safe roosting spaces are available locally which are in the Clients ownership and are already being used by Lesser Horseshoe Bats. These spaces will continue to be dedicated to Lesser Horseshoe Bat. Confidence is high in this instance that the mitigation proposed is appropriate and likely to be successful.

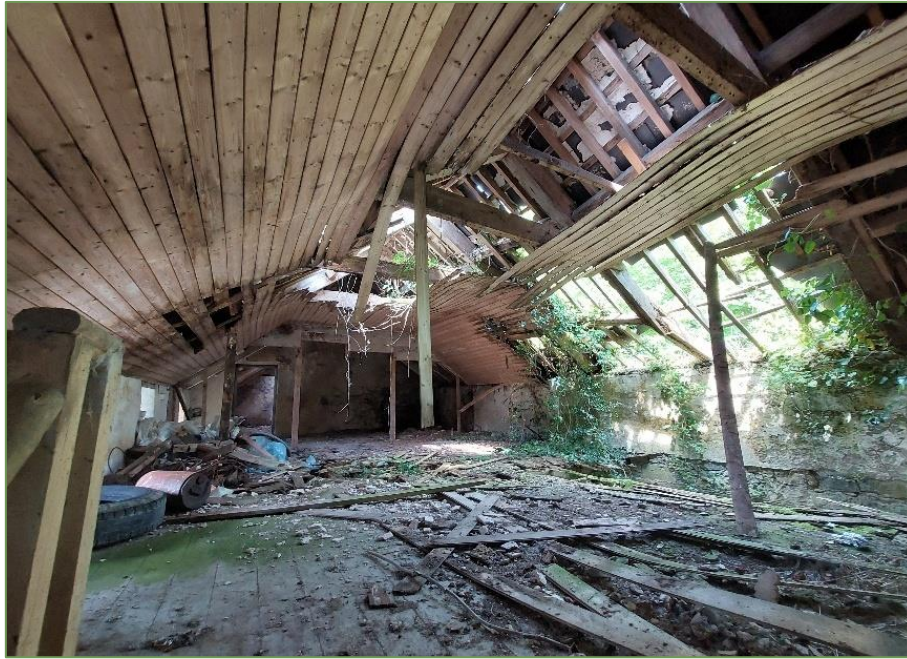
Plate 3.2 Interior view of the two-storey outbuilding (Roost ID: 44) which shows advanced state of dereliction allowing significant light and water ingress into the main roosting location of Lesser Horseshoe Bat.

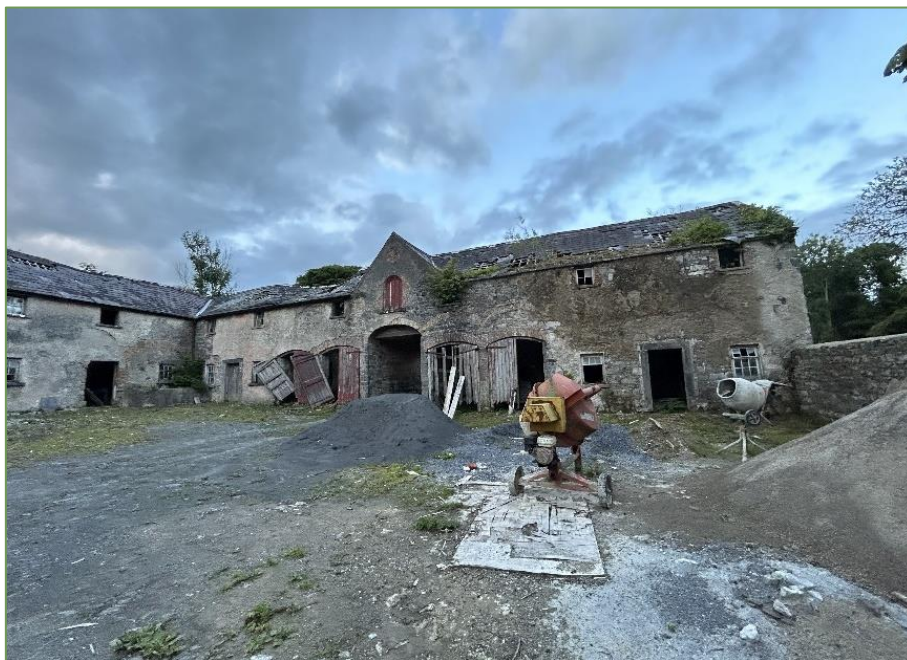
Plate 3.3 View looking east showing the associated stonework structures attached to the two-storey outbuilding containing the Lesser Horseshoe Bat maternity roost (Roost ID: 44).

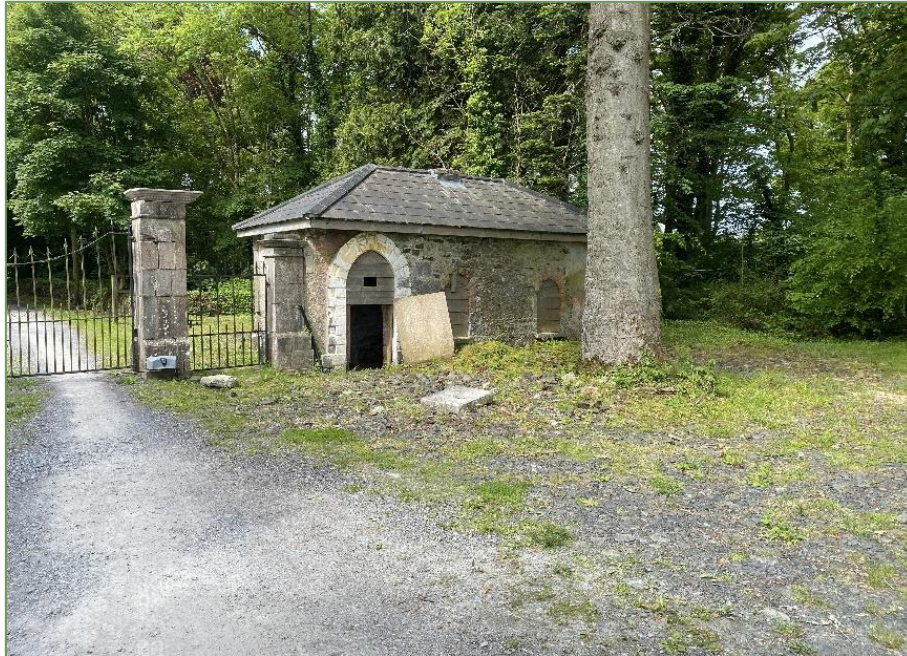
Exterior inspection of the gate lodge yielded no discernible gaps present in the roofing slates or exterior faces. A single cutout in the boarded-up door provides the only access/egress for bat species (see **Plate 3.4**). Interior inspection of the gate lodge resulted in the discovery of a maternity colony of Lesser Horseshoe Bat (Tom O'Donnell pers. comm.) which was previously thought to be solely used for night roosting (NPWS, 2013; see **Plate 3.5**). The gate lodge structure appears relatively intact and structurally sound, with a single juvenile Sycamore

Plate 3.4 View of the Newhall Estate entrance gate lodge housing the recently discovered Lesser Horseshoe Bat maternity roost (c T. O'Donnell, NPWS License Ref. 211/2023).

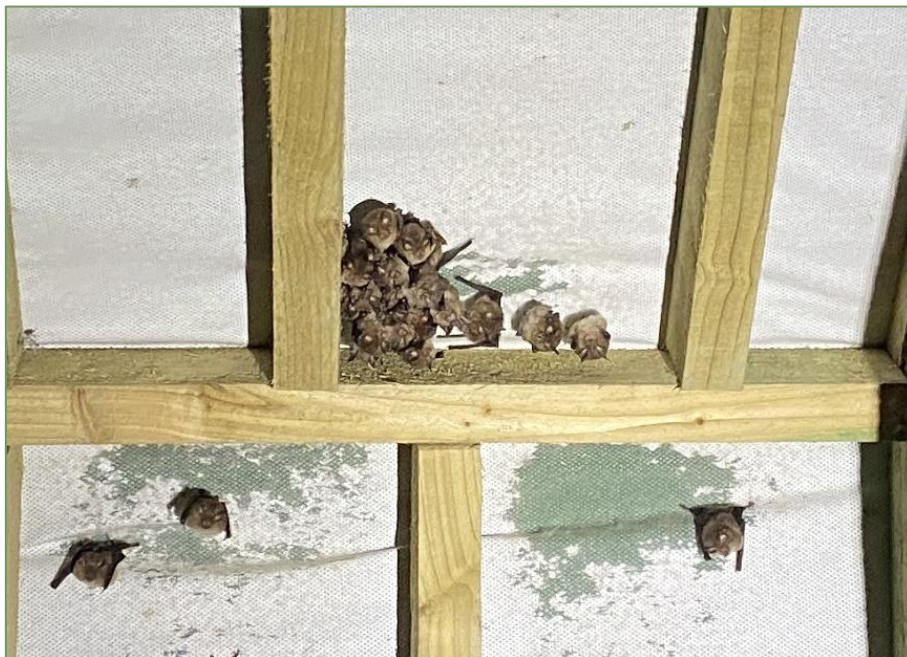
growing from the base of the northern wall which may displace the wall in future years. It should be noted that modern roofing felt is installed within the interior of this structure, which can cause bats (including Lesser Horseshoe Bat) to become entangled in loose threads and induce mortality, as opposed to traditional bitumen felt. In this instance the particular product used shows no sign of fraying although the material has become worn (see **Plate 3.5**).

Plate 3.5 View of the Lesser Horseshoe Bat maternity colony within the entrance gate lodge (T. O'Donnell, NPWS License Ref. 211/2023).

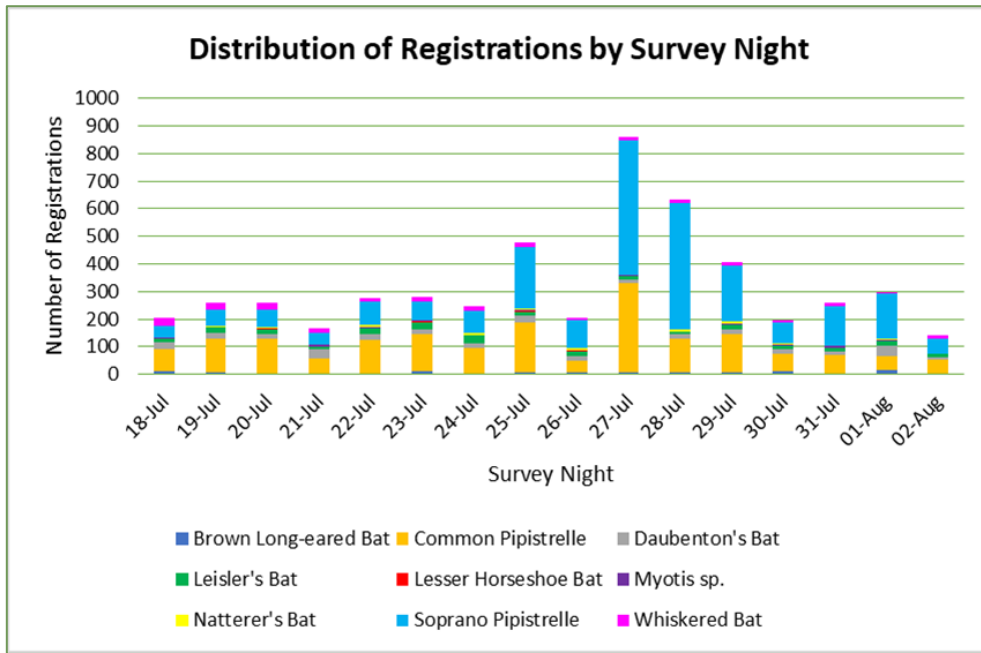
Figure 3.2 - Distribution of all bat registrations recorded by survey night and species.

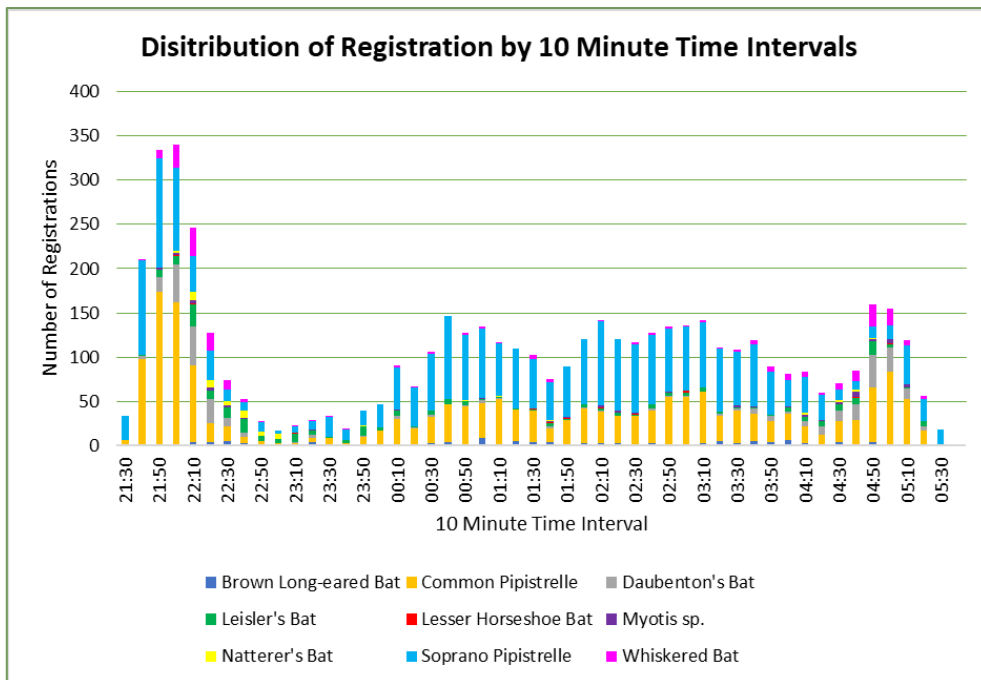
Figure 3.3 - Distribution of all bat registrations recorded by 10-minute time intervals and species (median sunset and sunrise times were 21:38 and 05:42 respectively).

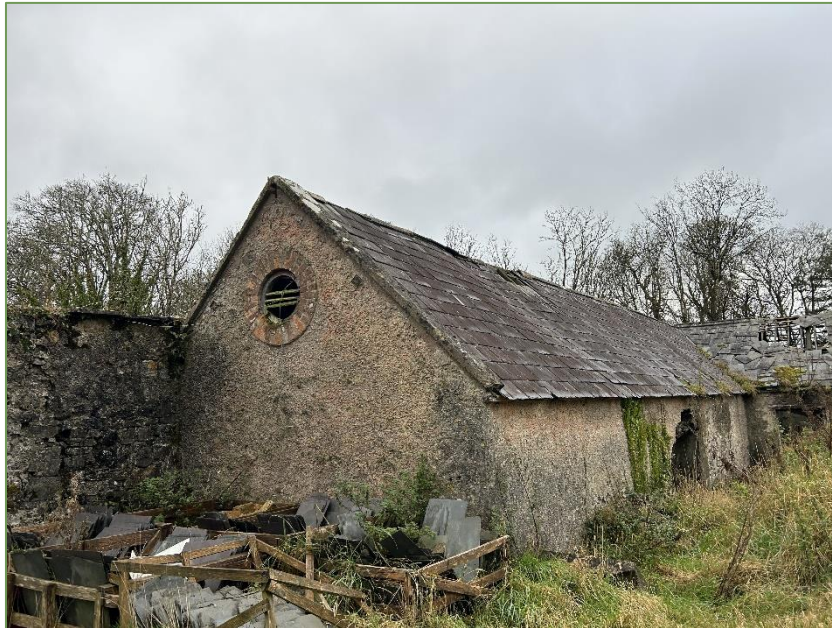
Plate 5.1 – Proposed location of alternative bat roosting location for crevice-dwelling species within the storeroom attic of the former stables complex.

within any areas of attic to which bats may have access (i.e. the areas above the proposed roost) at least must use only traditional bitumen felt (1F)). Any timbers must be pressure treated offsite. Onsite application of wood preservative should be avoided, and if necessary, only products certified to be 'bat safe'³ will be used. A bat-licensed Ecologist will be consulted in relation to any onsite treatment of timber, and details of treatments used will be recorded and included in a post-construction compliance report which will be issued to NPWS.

The bat-licensed Ecologist will carry out a final inspection to confirm that these roosting spaces have been provided as outlined herein. The report will confirm that the dedicated attic roost is appropriately constructed, that bats should not encounter modern roofing membranes in any part of the structures and that bat access points have been appropriately located and installed.

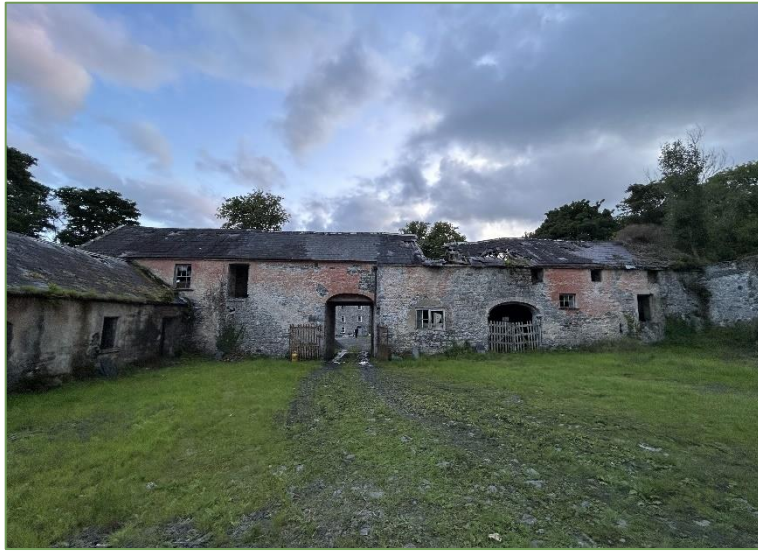
A1. View looking west of the former stables complex and courtyard attached to the Lesser Horseshoe Bat maternity roost (Roost ID: 44).

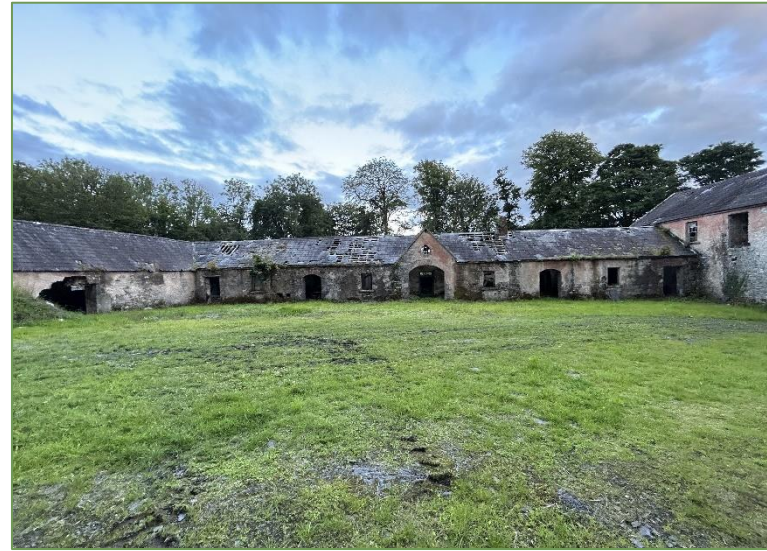
A2. View looking south of the former stables complex and courtyard attached to the Lesser Horseshoe Bat maternity roost (Roost ID: 44).

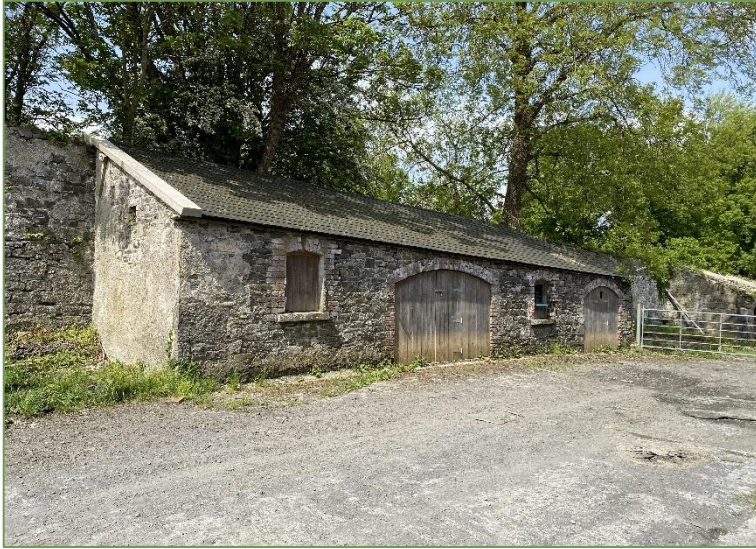
A3. Bespoke NPWS roost constructed approximately 50m east of the original Lesser Horseshoe Bat roosting location within the two-storey outbuilding.

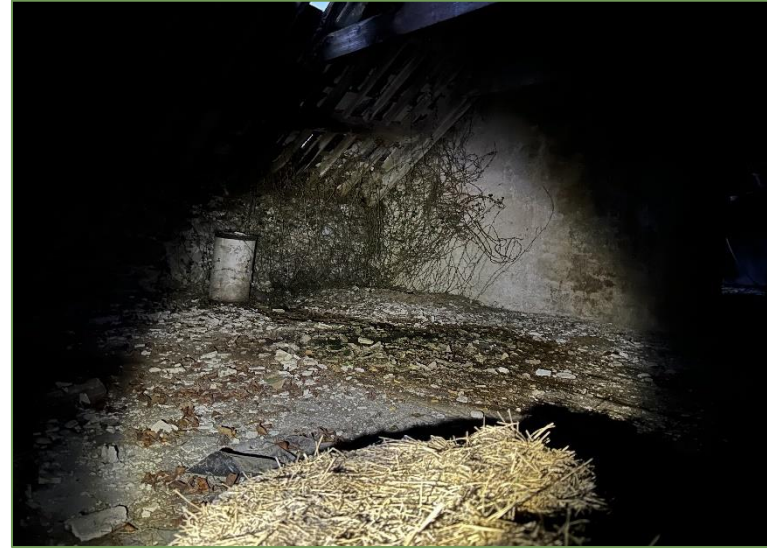
A4. View within the current roosting location for the Lesser Horseshoe Bat maternity colony within Roost ID: 44. Accumulation of droppings and light ingress are clearly visible.

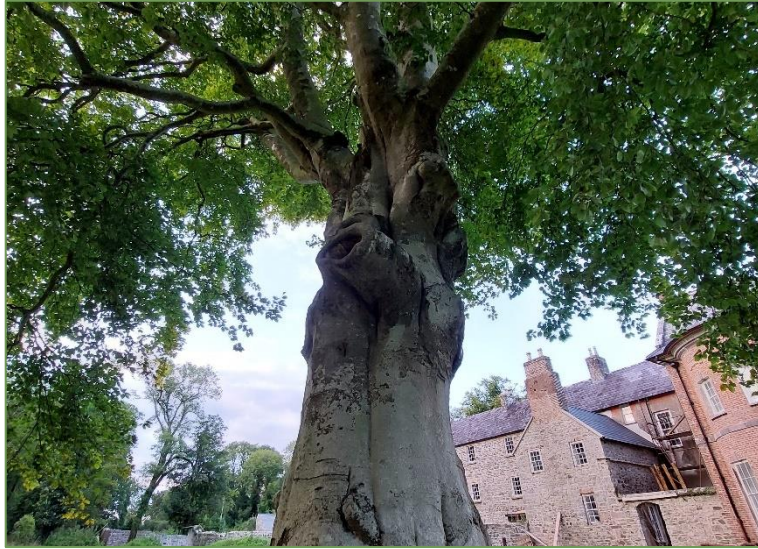
A5. Veteran Beech tree adjacent to Newhall House which houses nesting Barn Owl.

Some survey nights were characterised by high levels of Barn Owl activity, with a confirmed nest within a veteran Beech tree at the front of Newhall House (see **Appendix A5**). Breeding adults were observed flying throughout the site, although none were seen enter any structure housing Lesser Horseshoe Bat roosts. Additionally, Kestrel was identified waiting outside the NPWS roost within the barn buildings (see **Appendix A9**). Considering the advanced state of dereliction of the two-storey outbuildings, the roost remains potentially under threat from access by aerial and non-volant predators.

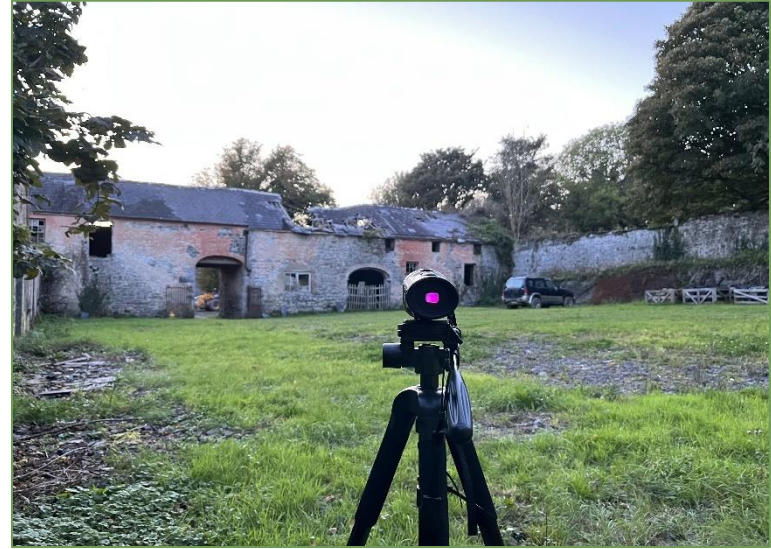
A6. Example view of thermal camera covering the former stables complex.

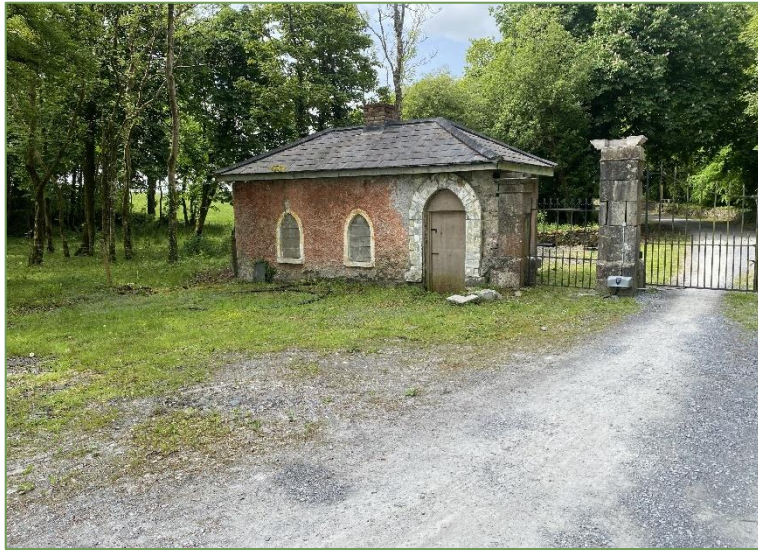
A7. View of the southern gate lodge that does not house the maternity colony of Lesser Horseshoe Bat.

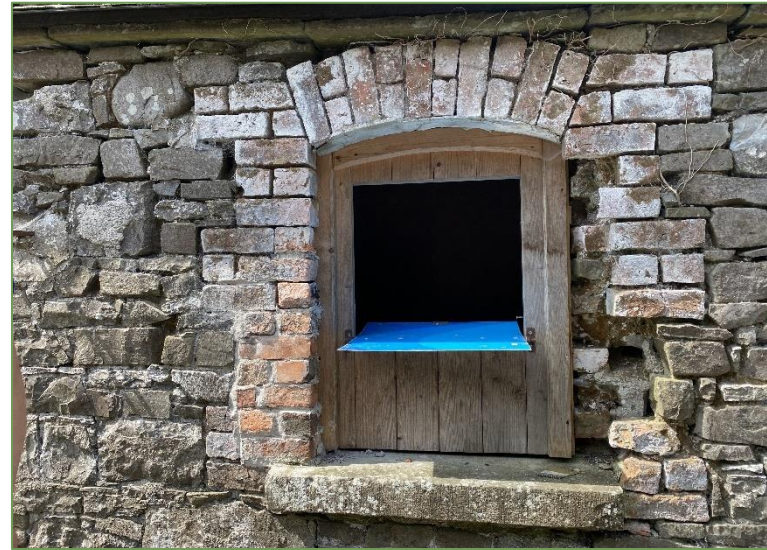
A8. Example of predator exclusion tip tray at the entrance to the NPWS roost.

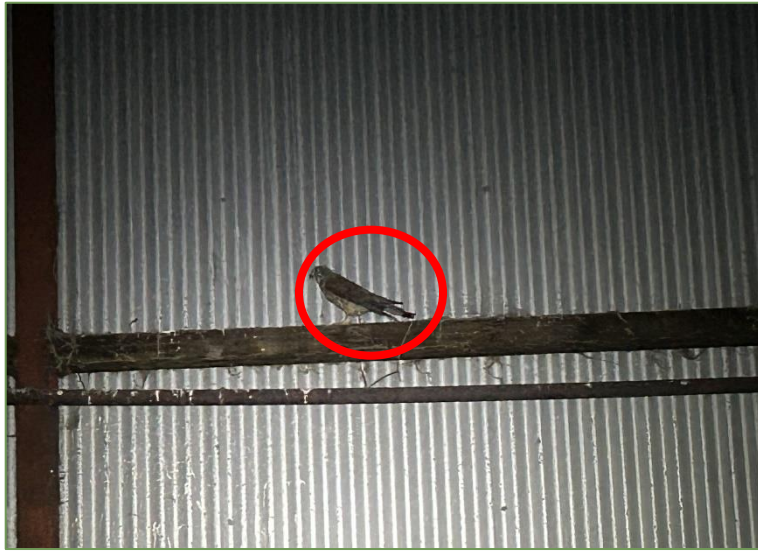
A9. Kestrel (red circle) waiting outside the NPWS Lesser Horseshoe Bat roost during bat emergence.

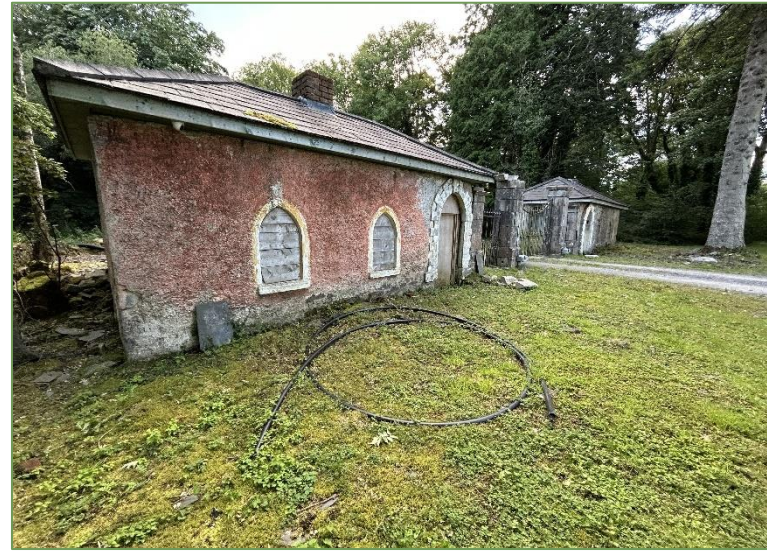
A10. Wide-angle view of both gate lodges, of which the furthest houses a known Lesser Horseshoe Bat maternity colony.

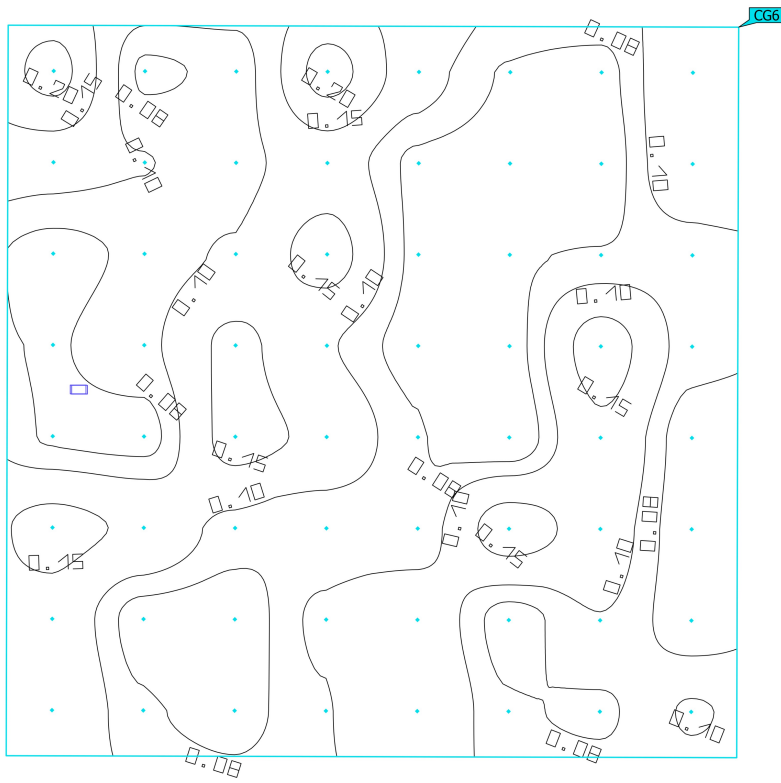
Properties	\bar{E}	E_{min}	E_{max}	$U_0 (g_1)$	g_2	Index
ROOST 2 Perpendicular illuminance Height: 3.000 m	0.10 lx	0.054 lx	0.22 lx	0.54	0.25	CG6

Lighting is proposed on the entrance driveway Horizontal illuminance proximal to roost entrances, commuting habitat etc are less than 0.2 Lux, which is considered to be "complete darkness" (BCT and ILP, 2023)), which is considered sufficient to avoid any significant negative effects due to lighting. No further measures are considered warranted.

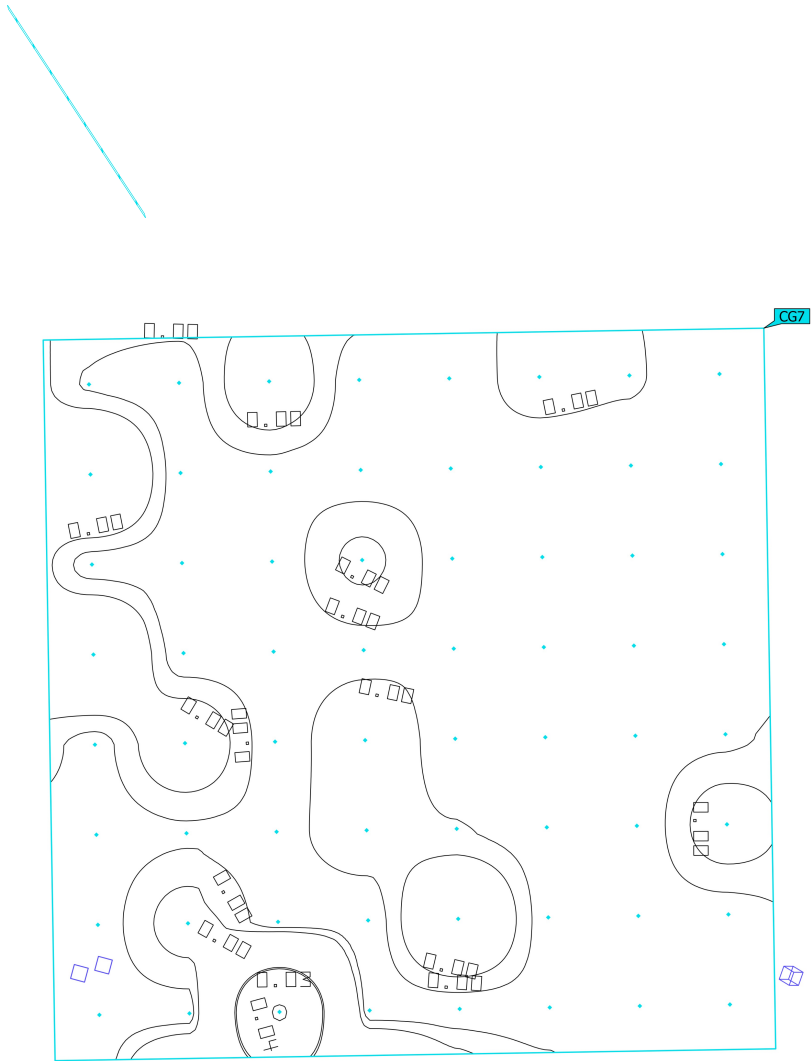
Properties	\bar{E}	E_{min}	E_{max}	$U_o (g_1)$	g_2	Index
ROOST 1 Perpendicular illuminance Height: 3.000 m	0.004 lx	0.002 lx	0.045 lx	-	0.044	CG7

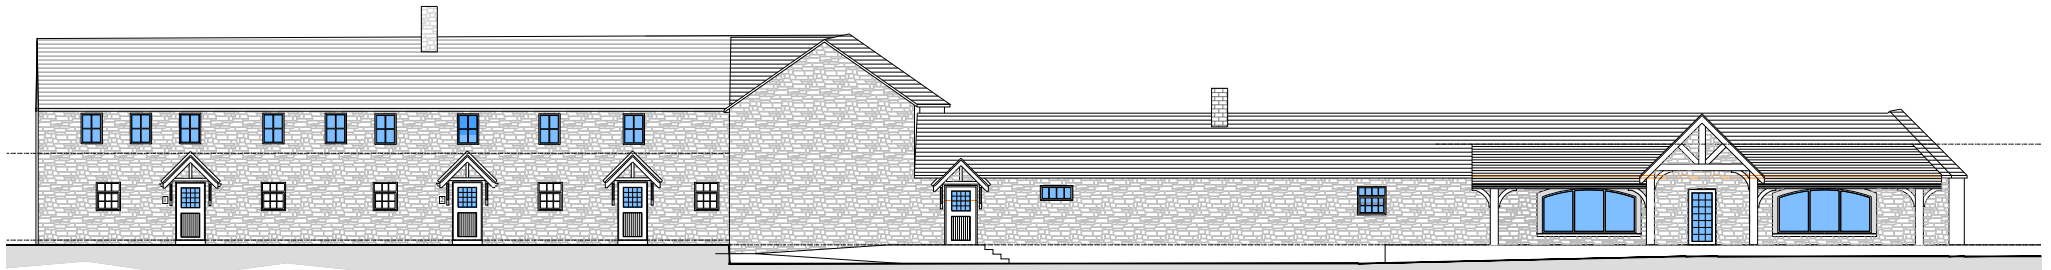
ELEVATION "A"
Scale 1:100

ELEVATION "B"
Scale 1:100

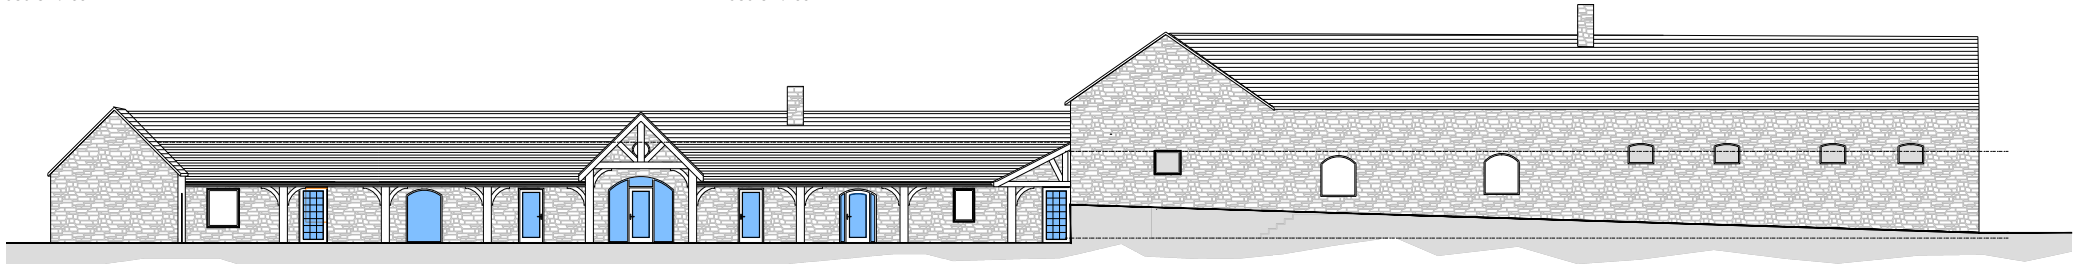
ELEVATION "C"
Scale 1:100

ELEVATION "D"
Scale 1:100
