# Lesser horseshoe bat roost, Transformer Building, Ardnacrusha, Co. Clare

#### Client: ESB

**Project Name & Location:** Lesser horseshoe bat Roost, Transformer Building, Ardnacrusha, Co. Clare

Citation: Bat Eco Services (2024) Lesser horseshoe bat roost, Transformer Building, Ardnacrusha, Co. Clare. Supporting Information for Derogation Licence Application. Unpublished report prepared for ESB.

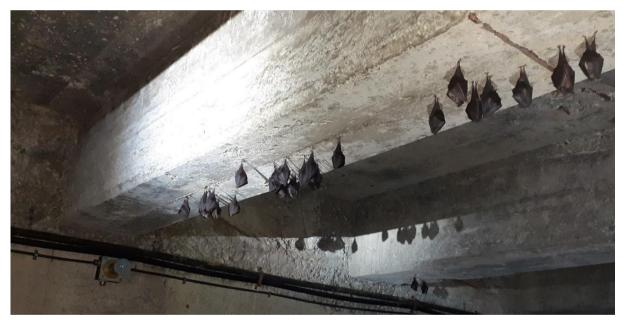
Plate 1: Lesser horseshoe bats in torpor within the basement(4<sup>th</sup> March 2024).

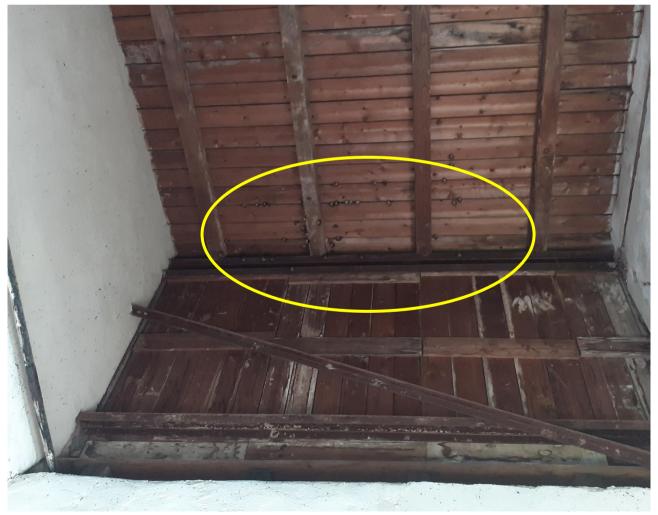
Plate 5: Rafter space in Part C, Substation Room (Lesser horseshoe bats visible – highlighted in yellow).

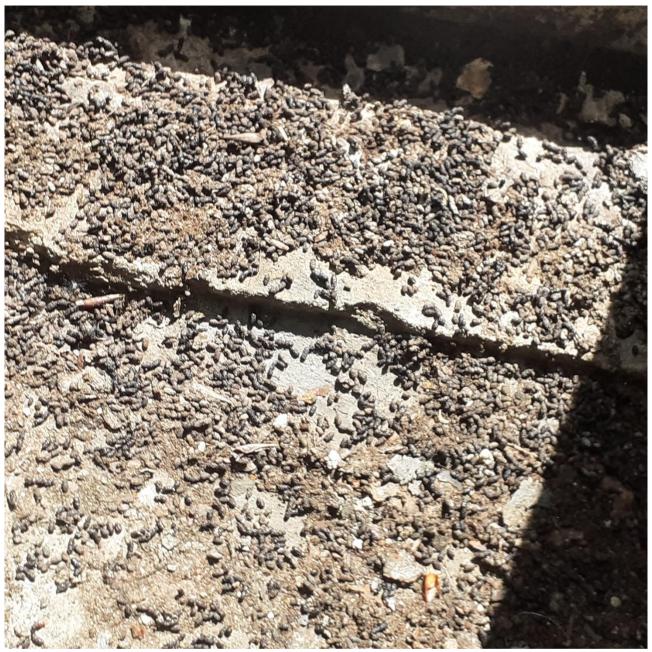
Plate 6: Bat droppings on substation floor (Part D).

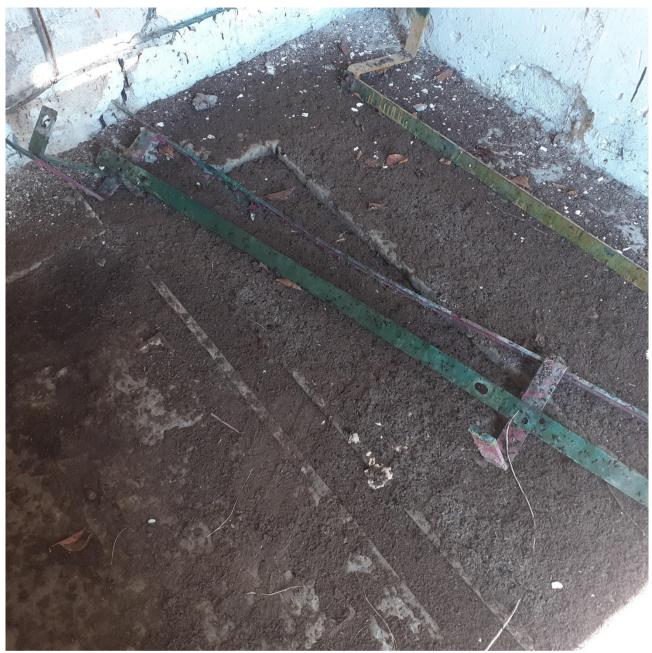
Plate 7: Extent of old bat droppings present on the substation floor (Part C).

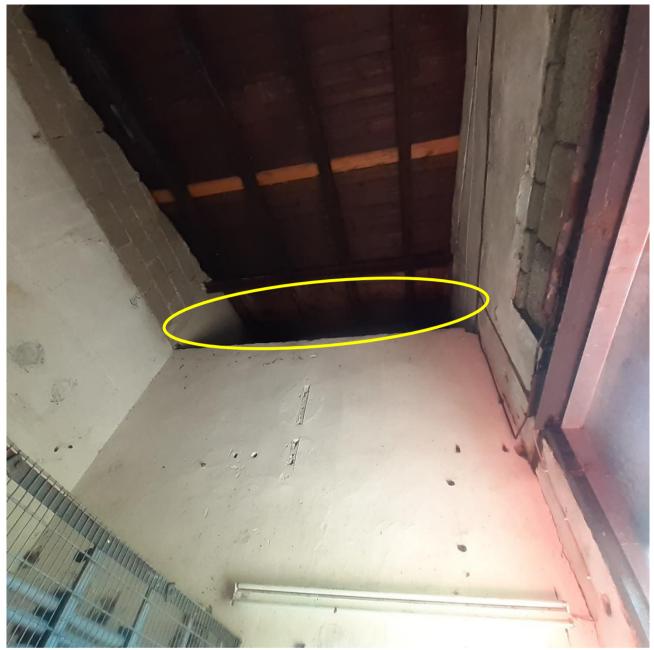
Plate 8: Internal wall in between the two rooms (Part C and Part D) of Substation Room. (Yellow Circle).

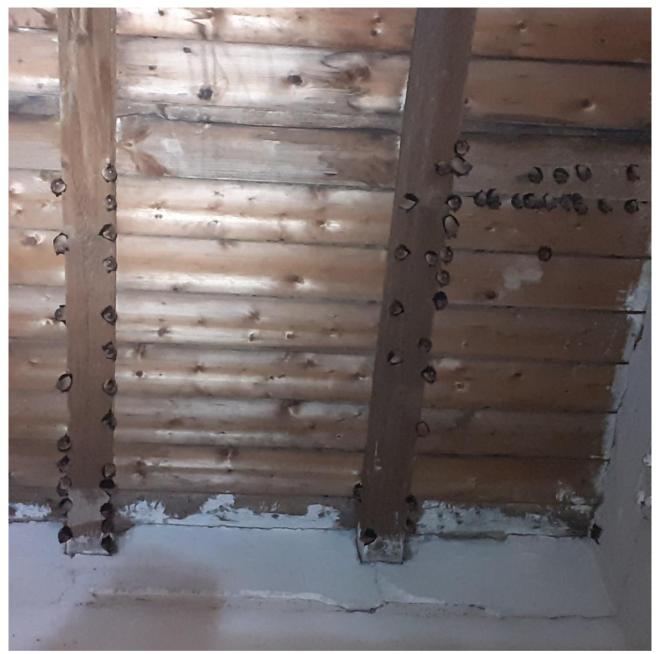
Plate 9: Lesser horseshoe bats in Part B of Transition Room on the 10<sup>th</sup> May 2024.

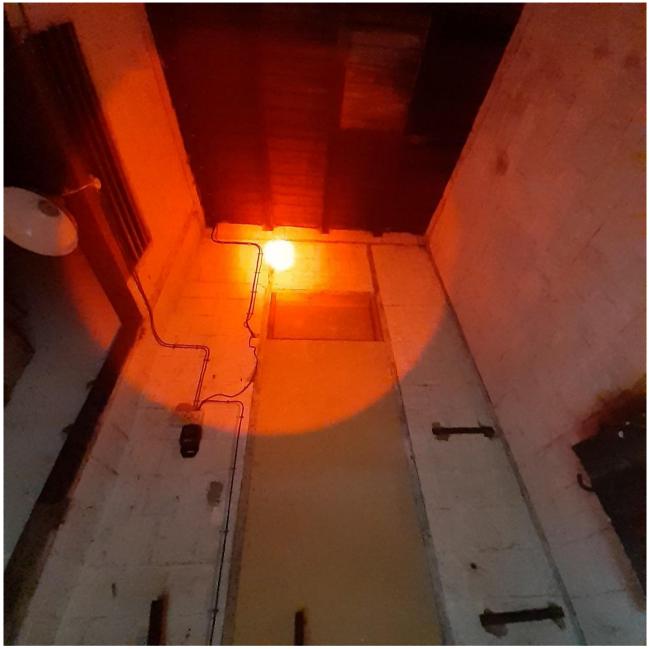
Plate 11: Internal space of Part A, Transition Room (depicting the wall shared with the main space of the Transformer Building. Entrance/Exit into the main space of the Transformer Building is at the rafter level highlighted by the Red Torch.

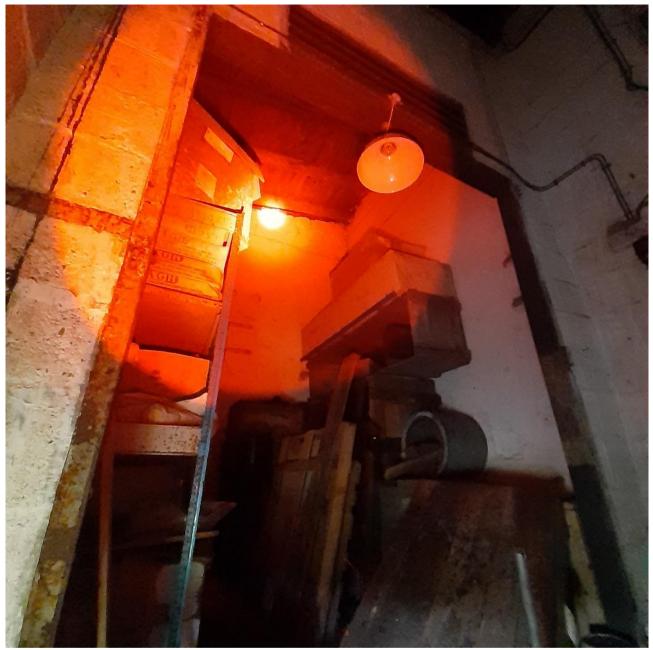
Plate 12: Internal space of Part B, Transition Room – primary space for roosting lesser horseshoe bats roosting in this room.
