Substation, Transformer Building,
Ardnacrusha, Co. Clare – Derogation
Licence Application Letter

Client: ESB Networks

Project Name & Location: Substation, Transformer Building, Ardnacrusha, Co. Clare

RE: Application for a Derogation Licence to undertake works in Substation attached to the Transformer Building, Ardnacrusha, Co. Clare.

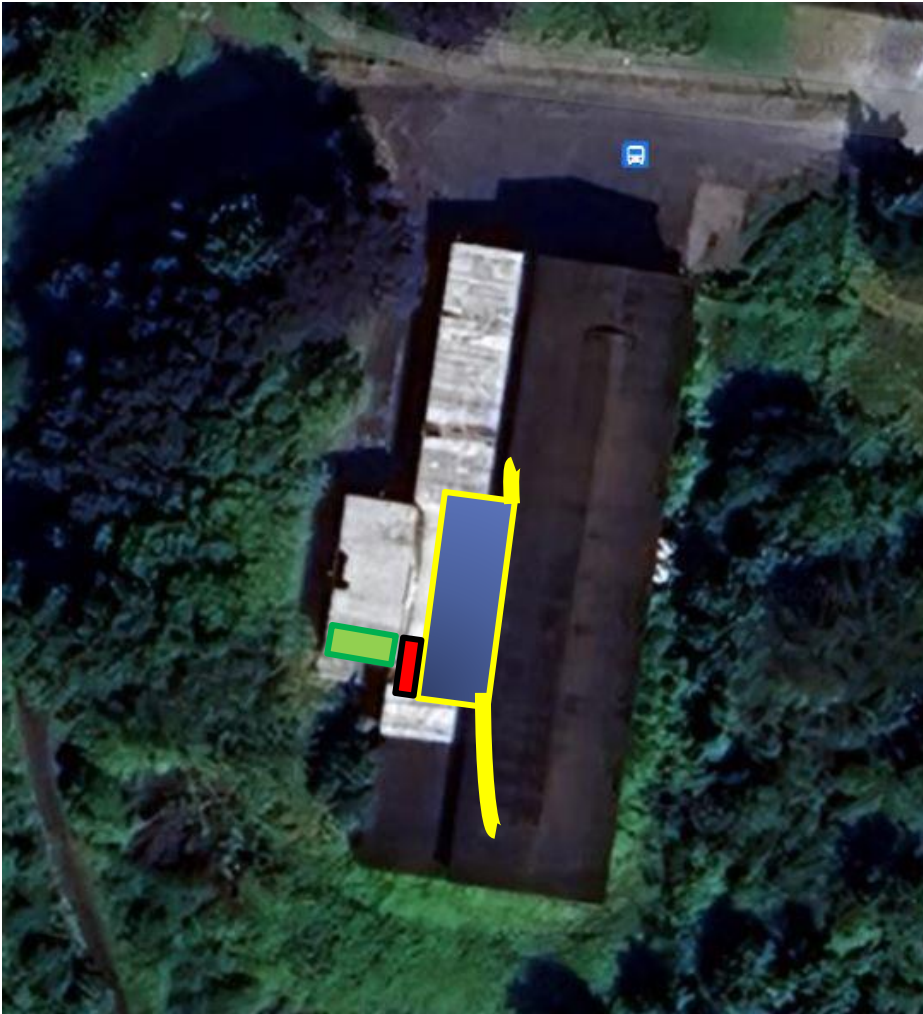
Figure 1: Transformer Building, Ardnacrusha, Co. Clare (approx. located of basement shown in blue and yellow). Transition Room (Red outlined in black) and Substation (Green) represented.

The Substation is a modern extension built onto the existing Transformer Building as shown on the aerial photograph below (Marked by green rectangle).

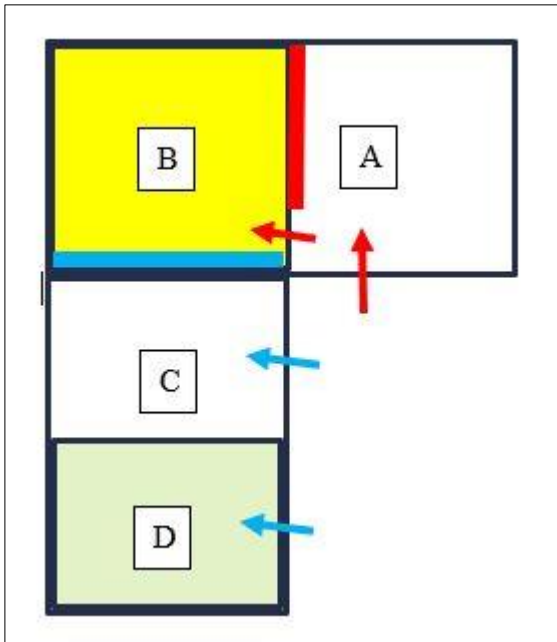
Figure 2a: Drawing of Surveyor access points into Transition Room (Red arrows) and Substation Room (Blue arrows).

The Substation Room is two Rooms (Part C and Part D). External access for surveyors is via a steel doorway for each room (access only permitted under supervision of ESB Networks – Figure 2b, Blue arrows). The height of the room is approximately 5.2m at the point where the substation wall (Part C) is attached to the Transition Room and slopes to approximately 4m to the external wall of Part D of the substation. The majority of the active equipment of the substation is located in Part D (Plate 5).

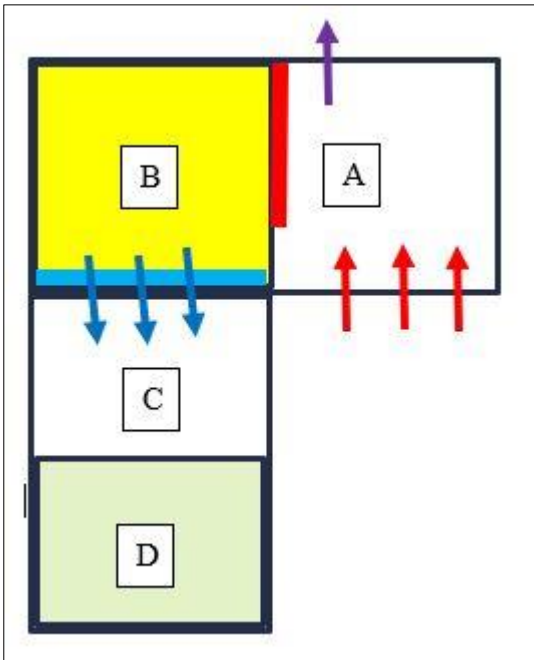
Figure 2b: Drawing of Bat access points into Transition Room (Red arrows), Substation (Blue arrows) and main space of the Transformer Building (Purple arrow).

The pattern of access by lesser horseshoe bats into the Transformer Building, as documented by the series of surveys completed since February 2024, is as follows (please see arrows on Figure 2b and please consult Bat Eco Services (2024) for more information):

- The bats enter the Transformer Building through gaps along the wall plate (facia/soffit area – external wall) of the Transition Room (Part A) via the Red Arrows shown on the figure below (Figure 2b).

- To access the Basement, the bats fly through a “post box” entrance at the rafters/wall plate following the Purple arrows in Part A of Transition Room. This brings the bats into the main space of the transformer building.

- To access the Substation Room, the bats fly from the Transition Room and fly through gaps along the wall plate via the Blue Arrows from Transition Room (Part B) in Substation Room (Part C).

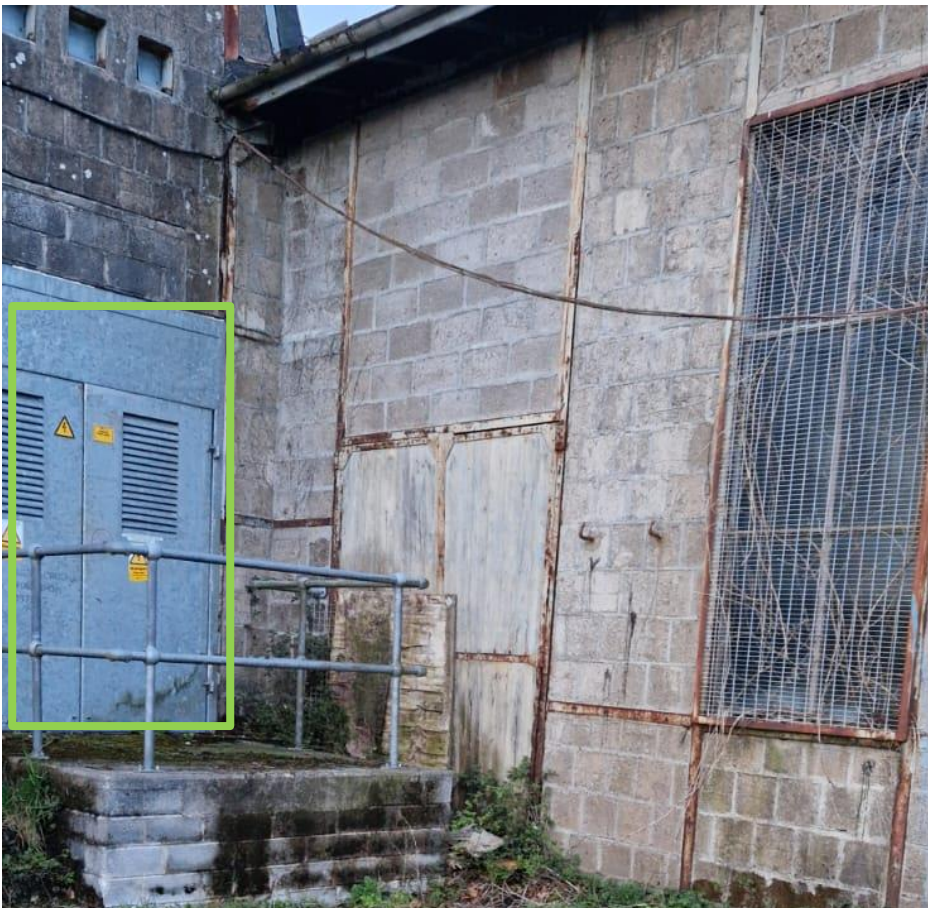
Plate 1: The steel door entrance to Substation Room (Part C – marked by Green box).

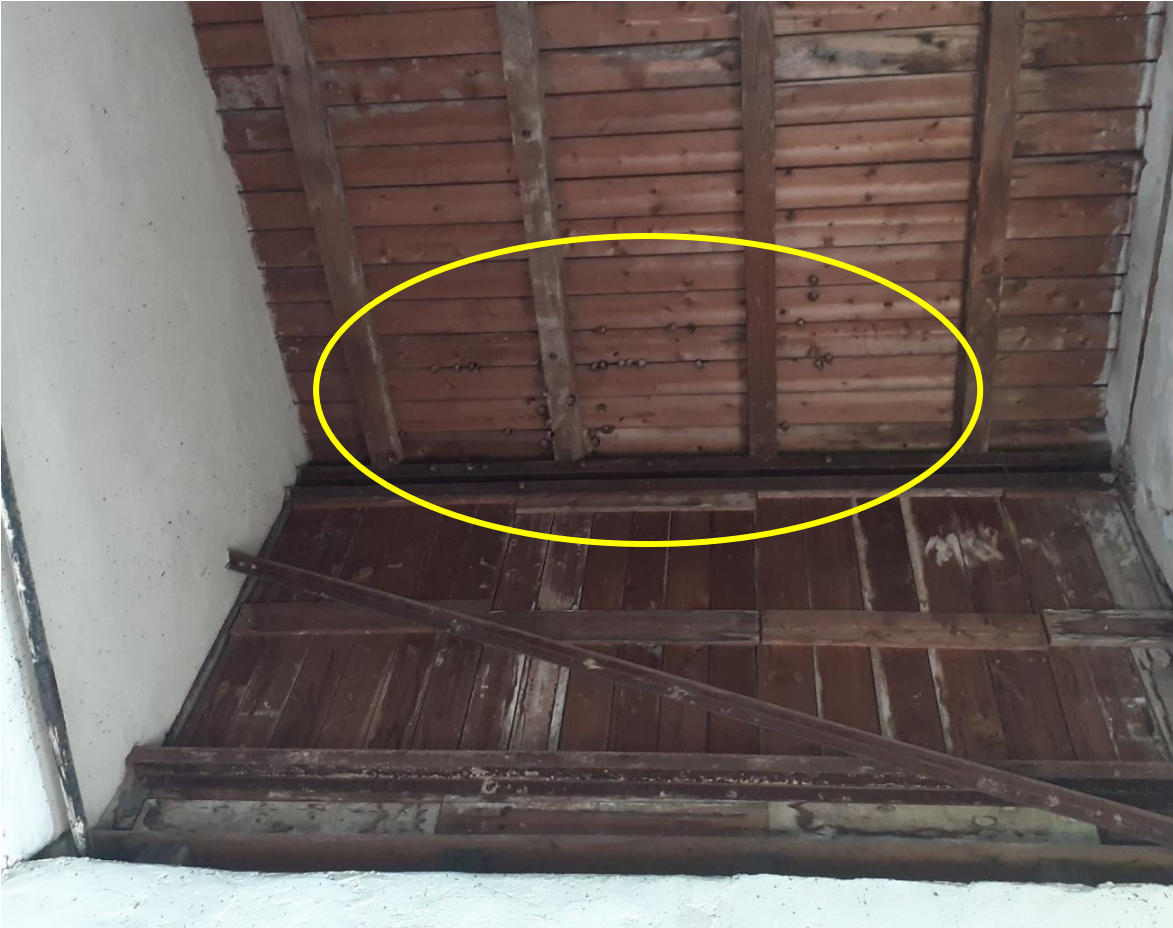
Plate 2: Rafter space in Part C, Substation Room (Lesser horseshoe bats visible – highlighted in yellow). Please note that how high the ceiling space is above the wall plate (i.e. the top of the white painted wall).

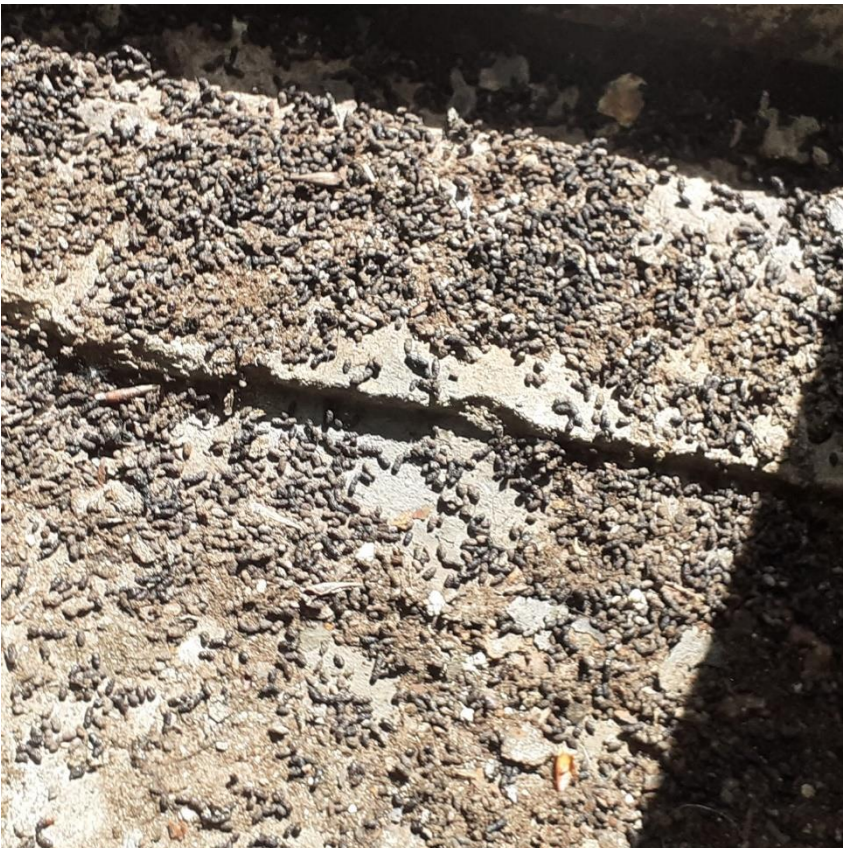
Plate 3: Bat droppings on substation floor (Part D).

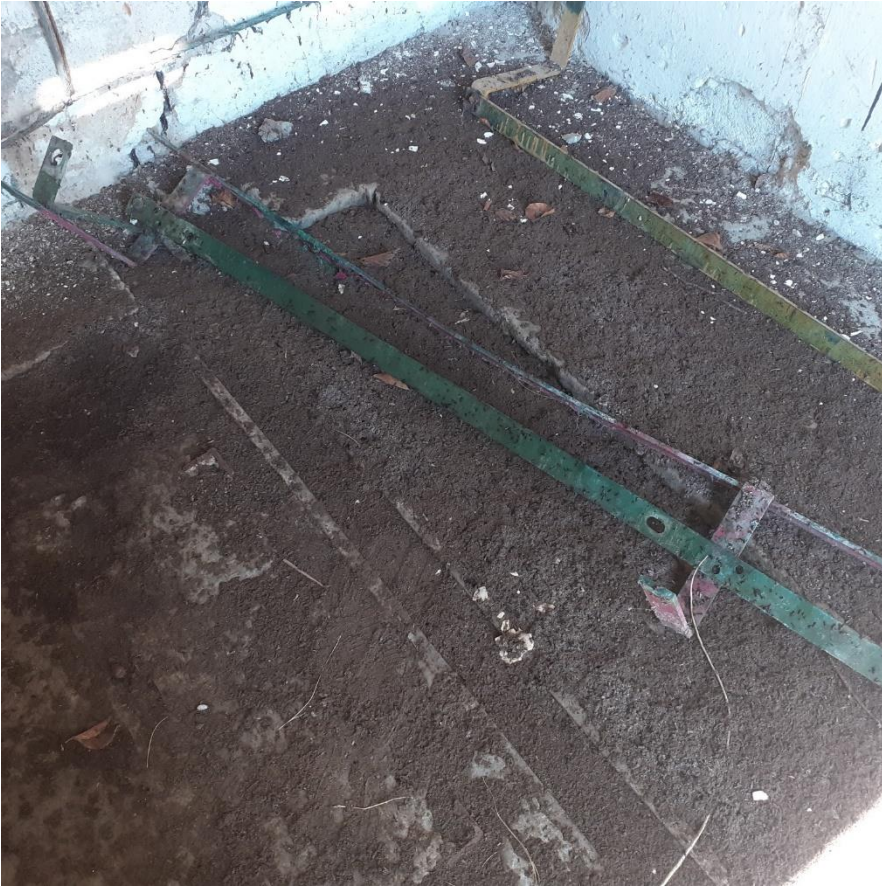
Plate 4: Extent of old bat droppings present on the substation floor (Part C).

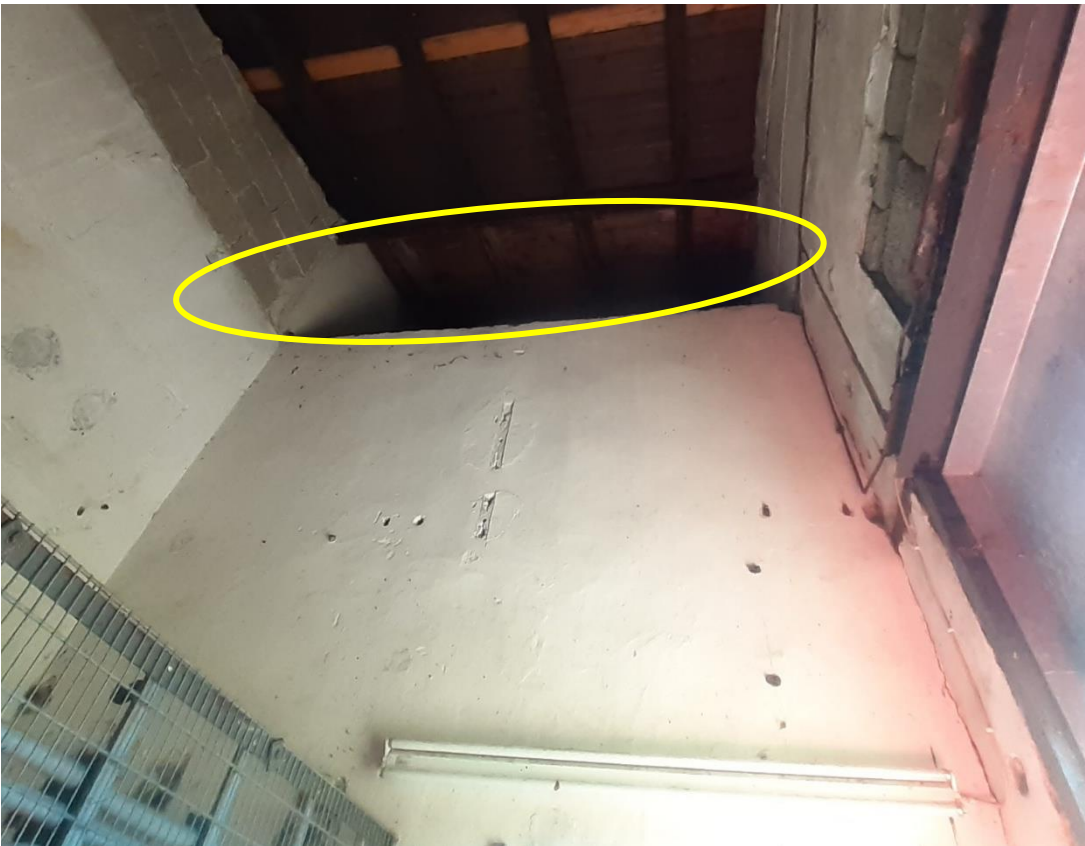
Plate 5: Internal wall in between the two rooms (Part C and Part D) of Substation Room. (Yellow Circle). Please note that how high the ceiling space and the internal white wall (wall between Part C and Part D of the Substation). The steel structure in the right-hand corner is 1.8m high and protects the active equipment of the substation.
