ECOLOGICAL SURVEY OF THE BARROW NAVIGATION

Conservation
Management Plan

PART 2: Conservation Management Plan 1992/93.

**Prepared for:
The Waterways Division
and
The National Parks and Wildlife Service
of The Office of Public Works.**

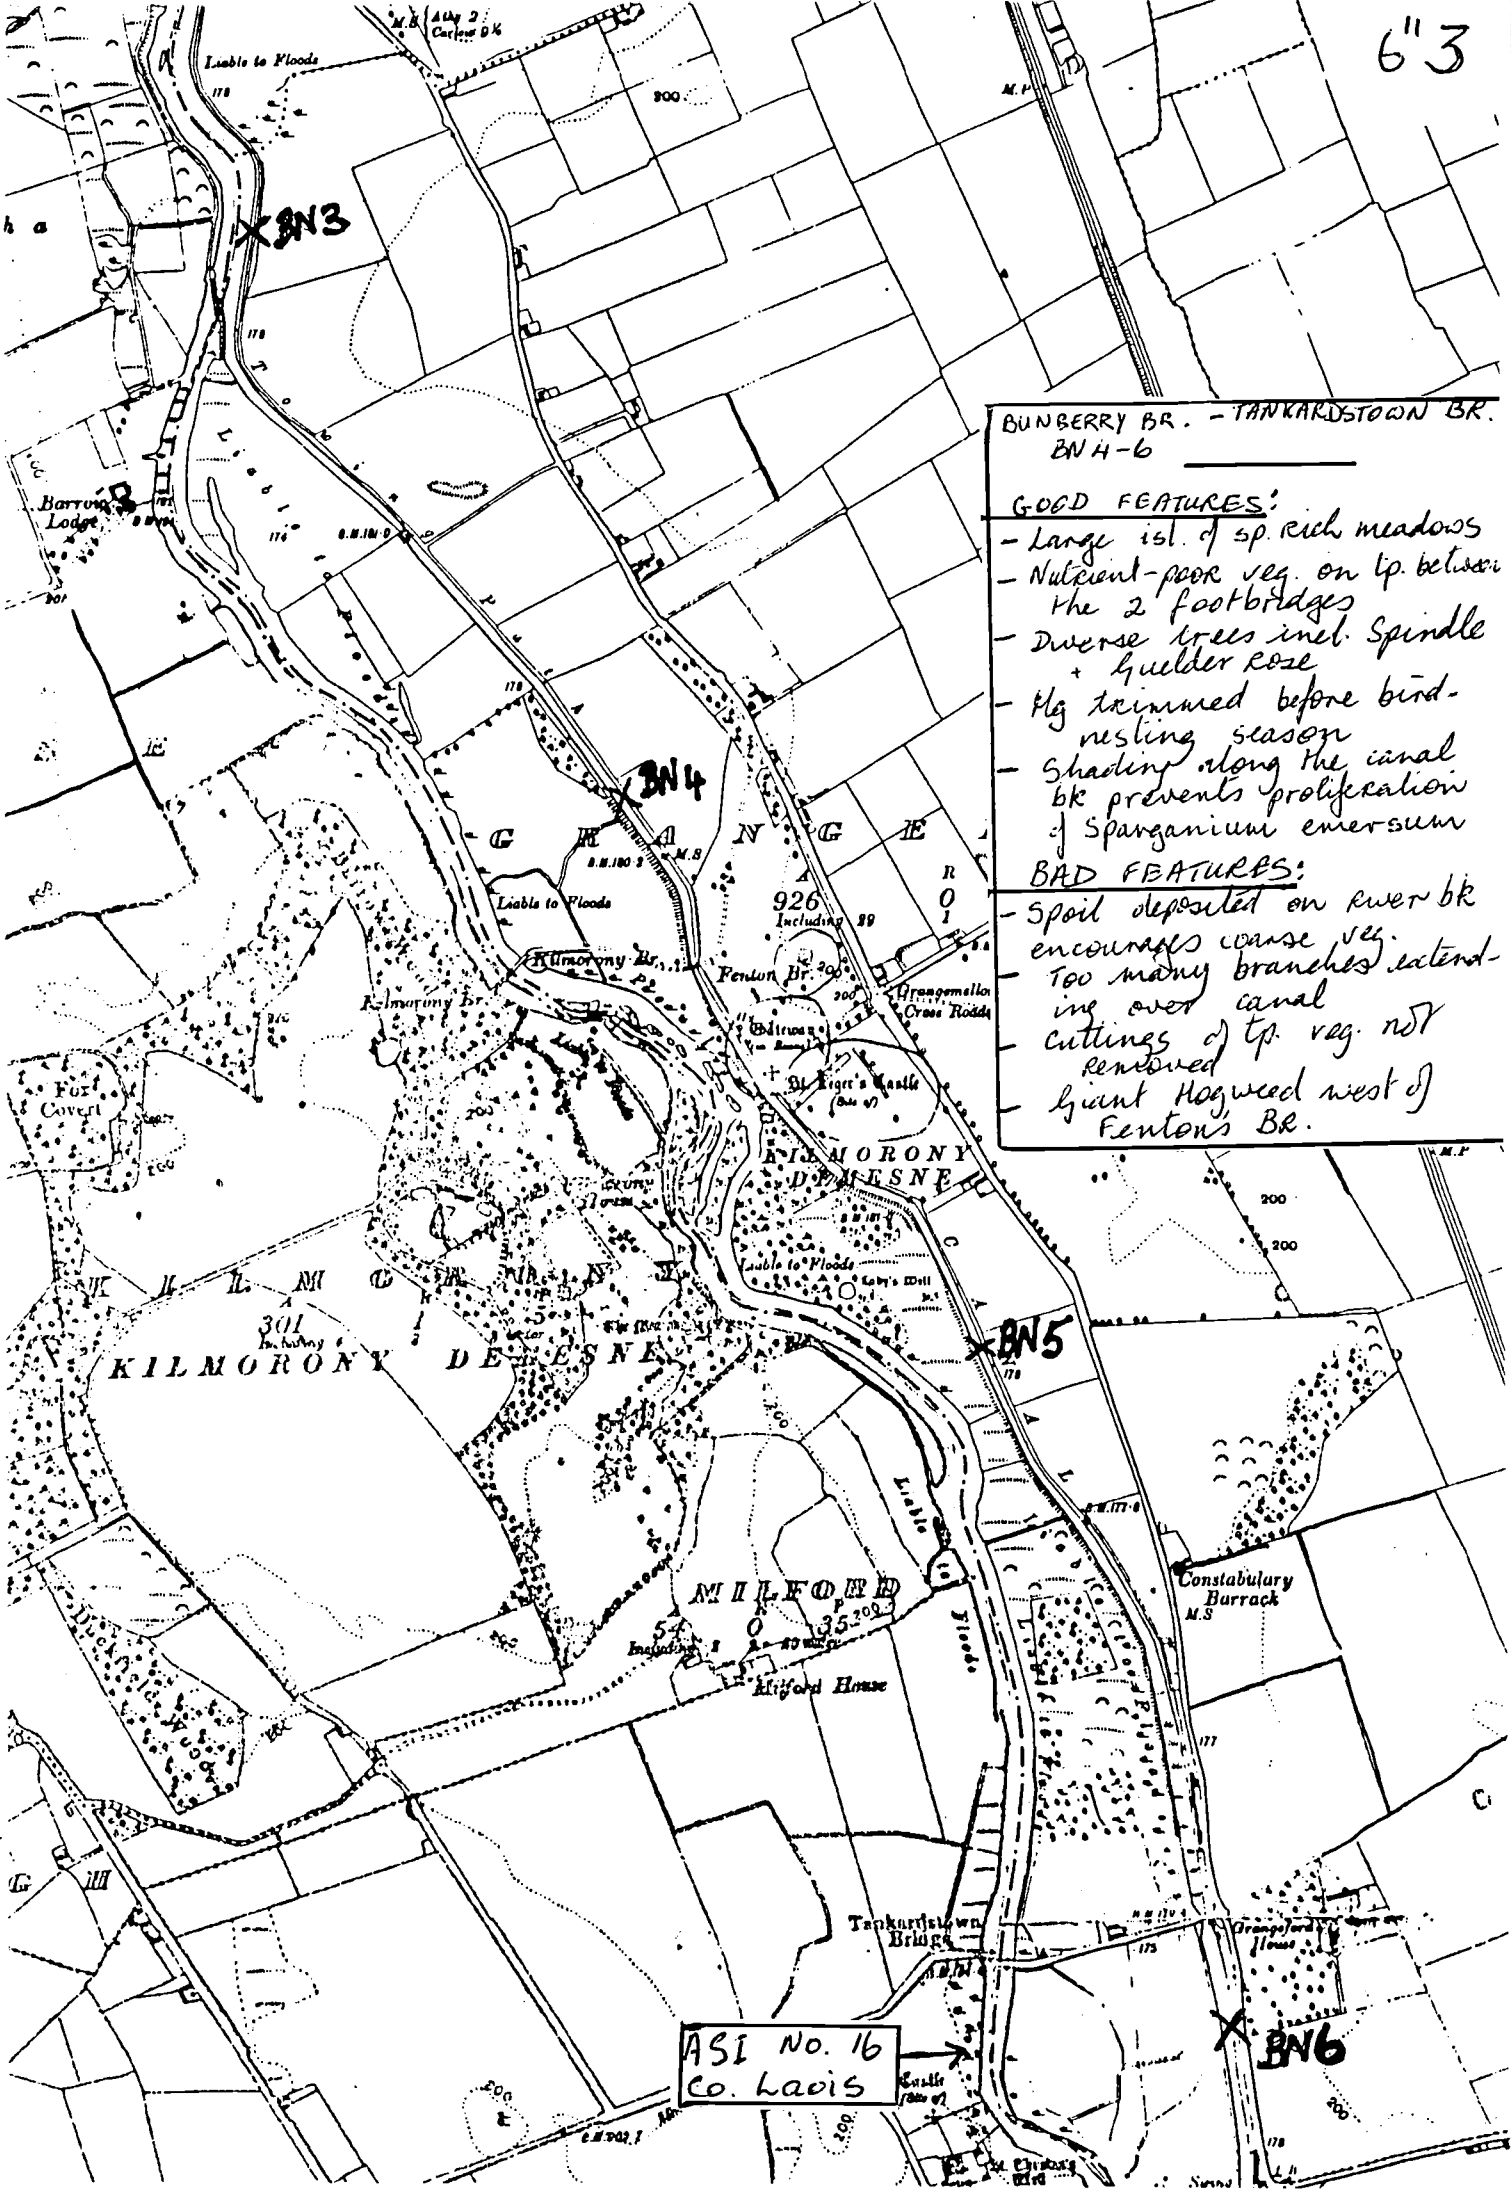
BUNBERRY BR. - TANKARDSTOWN BR.
BN 4-6

- Spoil deposited on river bk encourages coarse veg.
- Too many branches extending over canal
- Cuttings of tp. veg. not removed
- Giant Hogweed west of Fenton's Br.
