Saltmarsh Monitoring Project

2007-2008

Volume 1

Final Report (2009)

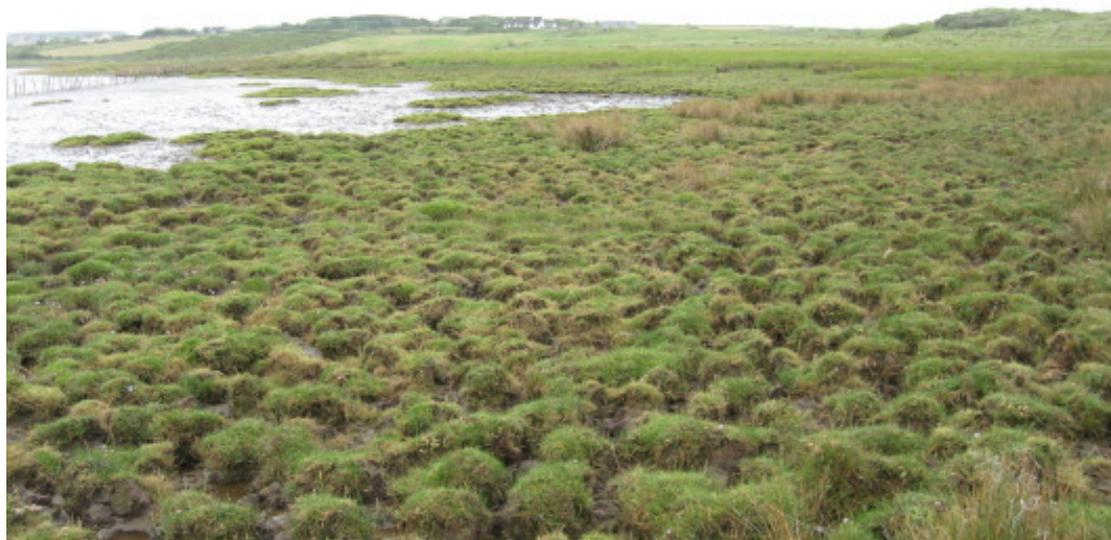
Atlantic salt meadows are commonly used for grazing by livestock, particularly on the south and west coasts. Some saltmarshes are only grazed during the summer, while some sites along the west coast may be grazed all year around. Atlantic salt meadows are vulnerable to damage from heavy grazing levels, which were exacerbated by the unseasonably wet summers during 2007-2008 (Figure 3.6). Both cattle and sheep can create low sward levels within the ASM. In fact, the stocking rate does not need to be too heavy to create a uniform low sward in some sections of the ASM, particularly the middle marsh communities, which have a naturally low sward height. Heavier stocking rates for a more prolonged period of time can also create a uniform sward height in the upper marsh, which is generally dominated by grasses and rushes such as Saltmarsh Rush, Red Fescue and Creeping Bent. However, there were very few sites where overall species diversity was affected by high grazing intensities from either cattle or sheep, so negative impacts were mainly on the physical environment.

Figure 3.6. Heavily poached ASM at Streedagh Point, Co. Sligo (2008).

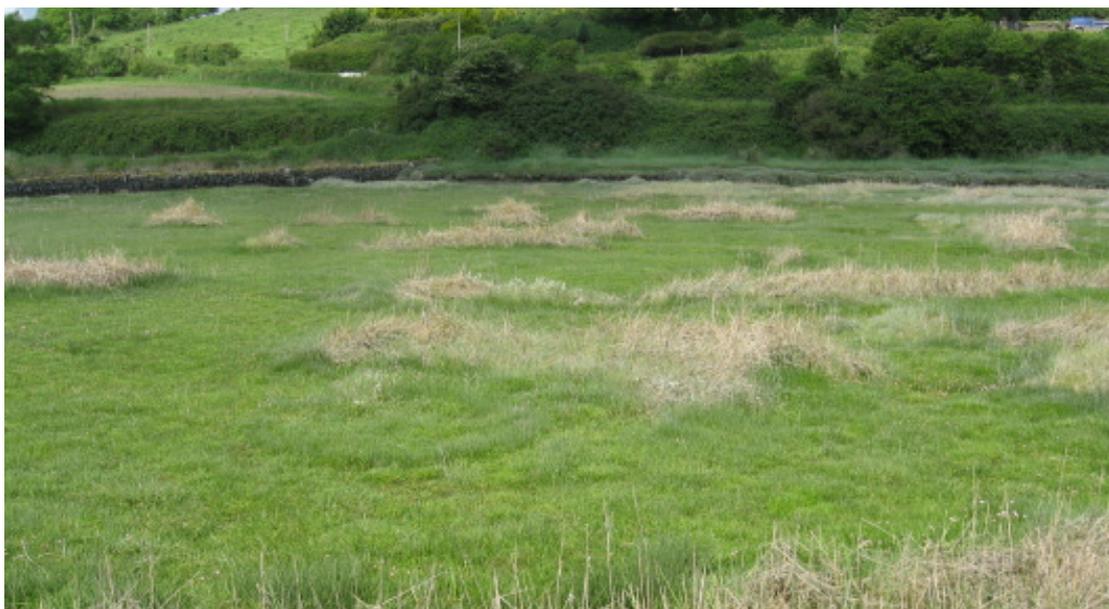
At sites where Common Cordgrass has been established on ASM, it appears most frequently as clumps in the lower-mid saltmarsh zone but is generally not dominant, with cover values most frequently between 1-5%. The cover of Common Cordgrass varies within ASM from site to site and even within sites varied significantly. There were usually small areas with more frequent cover of Common Cordgrass (5-40%) where the species grows through other ASM vegetation but at low stem densities. Patches of saltmarsh with greater than 40% cover of Common Cordgrass were classified as *Spartina* sward and sections of saltmarsh where it was still frequent (20-40%) but there was also substantial ASM vegetation were classified as ASM/*Spartina* sward mosaic. Common Cordgrass had spread into former saltmarsh (ASM) and replaced significant areas of this habitat with *Spartina* sward. At other sites, clumps of Common Cordgrass are scattered over the ASM at densities too low to be mapped as *Spartina* sward or mosaics.

Figure 3.7. Common Cordgrass within ASM at Harbourview, Co. Cork (2008).

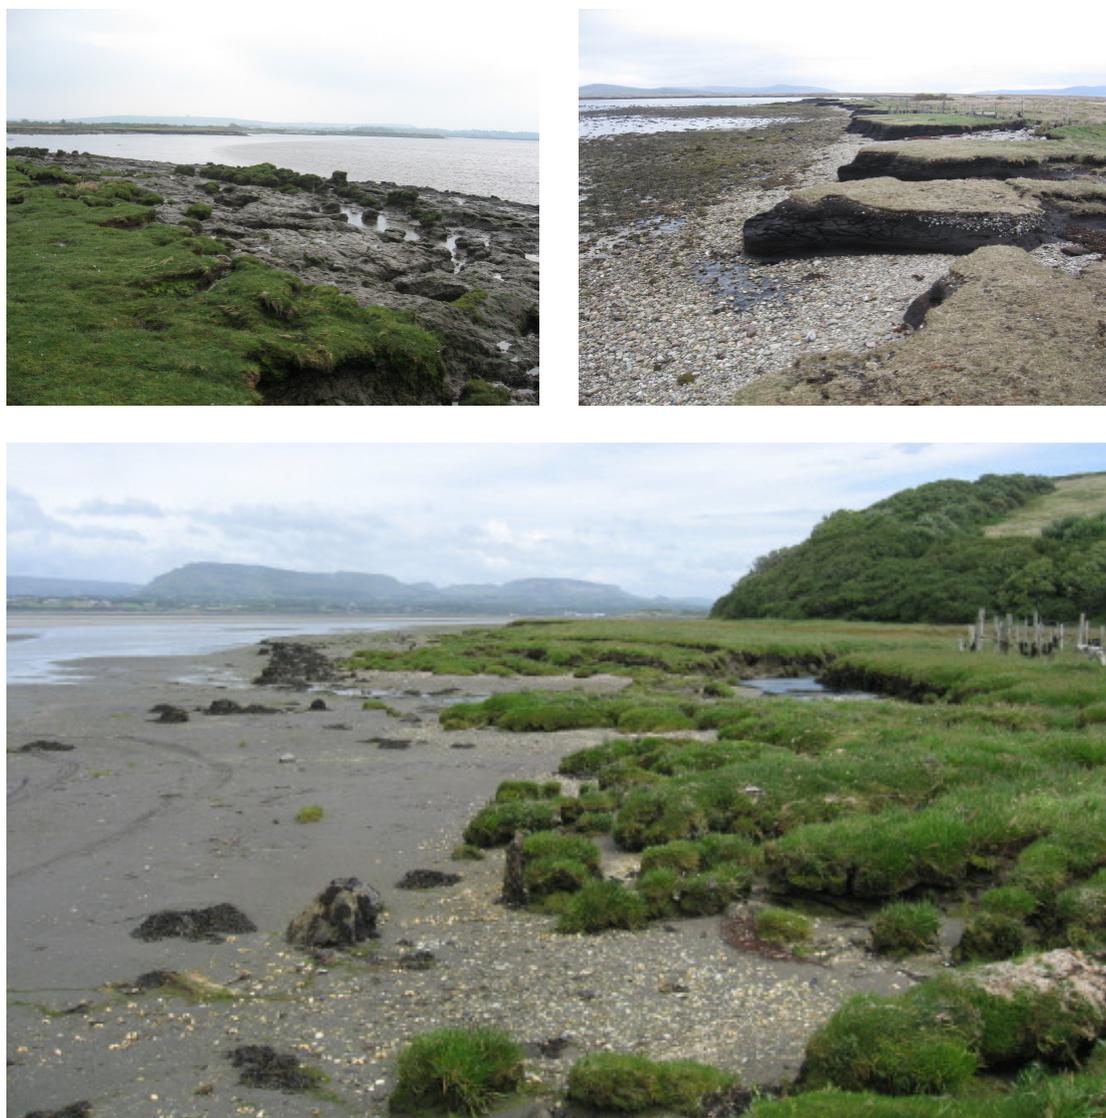
However, these physical signs were not a useful indicator of saltmarsh loss as they were quite common and can be considered as features of natural erosion. In many cases there was no indication the position of these saltmarsh cliffs had moved when comparing their position to the OSI 2nd edition 6 inch maps. While erosion may have occurred in the past, the rate of erosion at present may be neutral or quite low.

Figure 3.8. Indicators of erosion such as eroded mud platforms at Fybagh, Co. Kerry (top left), runnels in the front of the marsh at Aughness Co. Mayo (top right) and fragmented mud at Cummeen Strand (bottom) (2008).

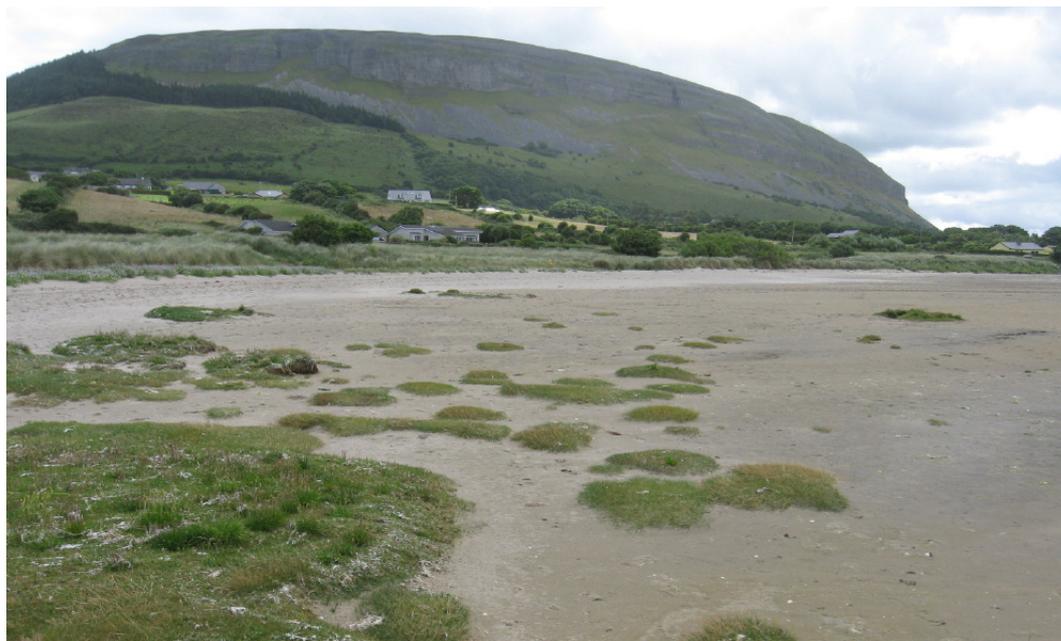
Figure 3.9. Development of accretional mounds at Strandhill, Co. Sligo (2008).

Accretion was generally recorded where new saltmarsh had recently developed (in comparison to the OSI 2nd edition six inch map) or where there physical indications of accretion. The main physical indication was an accretion ridge usually vegetated with pioneer communities along the seaward edge of the saltmarsh (Figure 3.9).

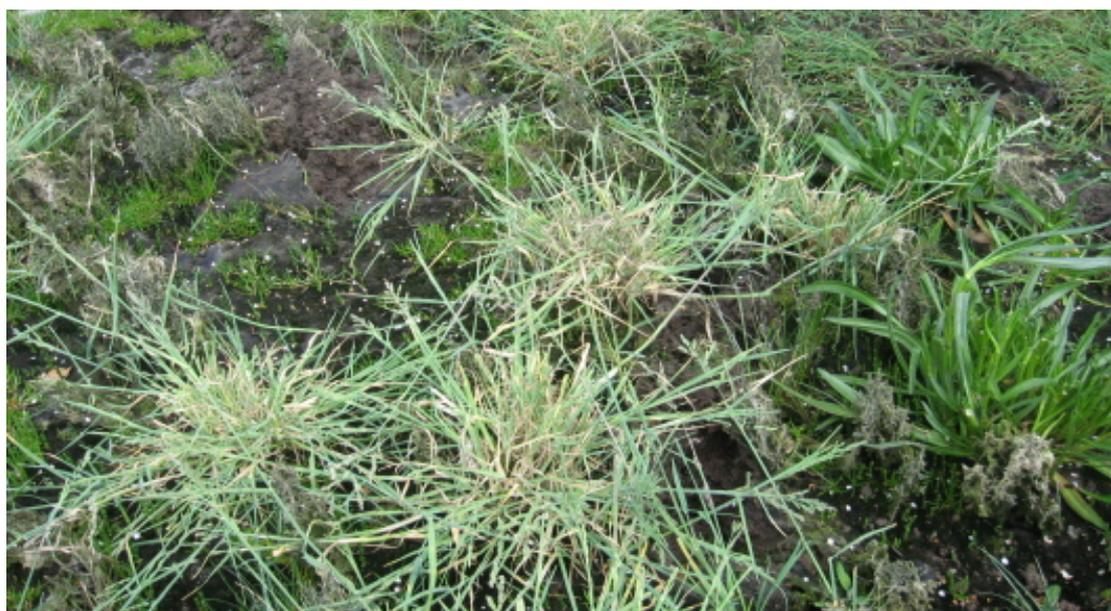
Figure 3.10. Borrer's Saltmarsh-grass at Ballymacoda, Co. Cork (2008).

One of the most notable 'new' records made during the survey was the large population of Borrer's Saltmarsh Grass (*Puccinellia fasciculata*) recorded at Ballymacoda in east Cork (Figure 3.10). This species has only been found from seven 10 km² squares along the Barrow Estuary, Wexford and Dublin shorelines since 1960, with the most westerly record in the past 20 years thought to be the Barrow Estuary (Wexford) (Preston *et al.* 2002) so this population significantly extends the range of this species in Ireland. It has also been recently re-confirmed at another site in east Cork near Kinsale (O'Mahony 2007).

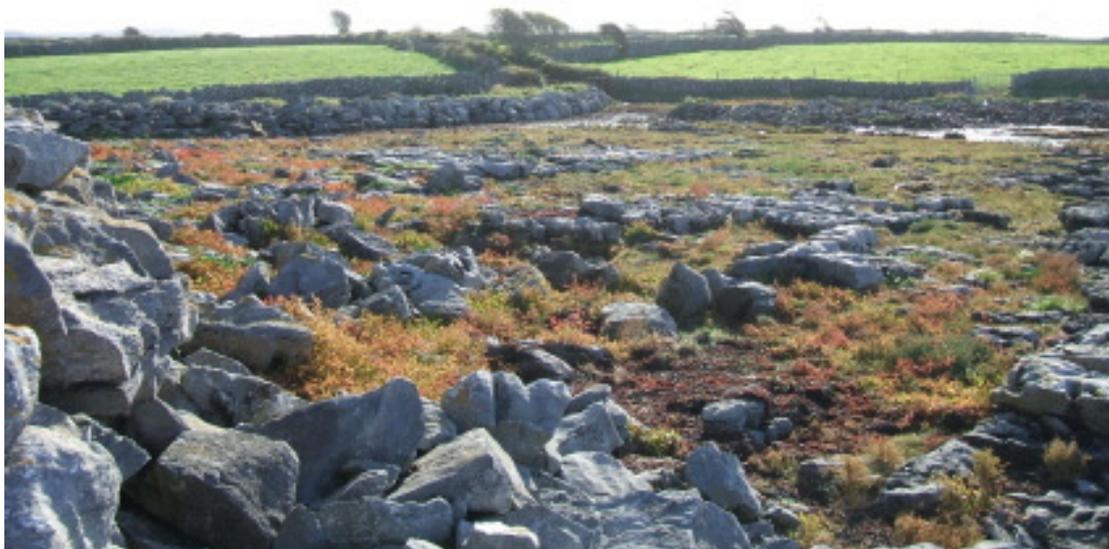
Figure 3.11. Saltmarsh developing over limestone pavement at Scanlan's Island, Co. Clare (2007).

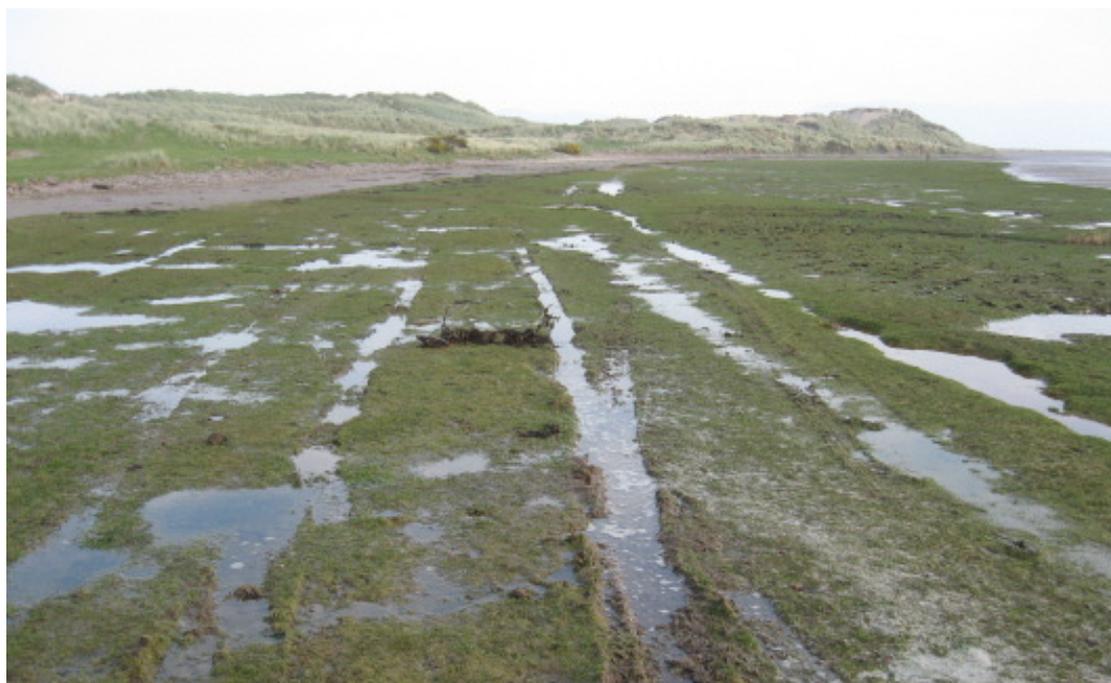
Poaching by cattle was a significant negative impact recorded during this survey. However, Bakker (1985) noted that the patches of bare soil created by cattle poaching created niches for pioneer plants to colonise. This was also mentioned by Boorman (2003) who noted that low trampling intensities provided micro-habitats that allowed pioneer species such as Glasswort and Annual Sea-blite to persist. So even trampling at low intensities can have a positive influence. However, heavy poaching leads to the destruction of the saltmarsh surface. This can be caused by heavy stocking rates of both cattle and sheep and was noted at several sites. Recent recommendations and guidelines to farmers about the implementation of the EU Nitrates Directive also mention that heavy poaching is to be avoided (Anon. 2005).

Figure 4.1. Badly damaged saltmarsh at Rossbehy, Co. Kerry, due to heavy grazing levels and access by vehicles (2008).

- Some badly damaged sites would benefit from significantly reduced stocking rates while other sites would probably benefit from a small reduction in stocking rates or localised management of badly damaged sections. However, care should be taken that grazing is not abandoned altogether, as this may also have negative impacts on conservation status.

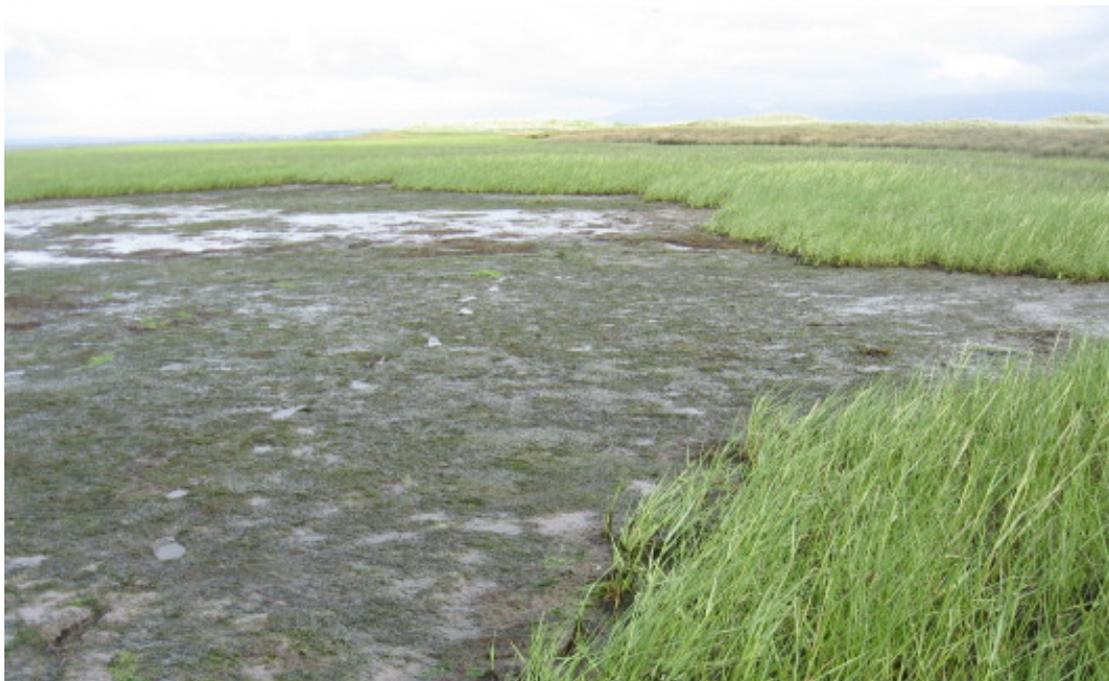
Data from this survey shows that the majority of *Spartina* swards in Ireland have developed on intertidal mudflats and not on saltmarsh. So while impacts on established saltmarsh may not be as significant as previously thought, this species may be having impacts on other Annex I habitats such as mudflats (1140). Anecdotal observations from various sites visited during the project indicate that this species is still spreading on mudflats with numerous seedlings and small clumps spreading along the seaward boundary of the more established stands. This trend is also shown by analysis of various aerial photo series at several sites, which shows that the extent of *Spartina* swards increased measurably during the current assessment period. At other sites the *Spartina* sward seems quite mature and there are no indications of any continued colonisation of mudflats. This species is still in the early stages of colonisation at many sites and has not reached equilibrium yet.

Figure 4.2. *Spartina* swards spreading into Eelgrass beds on adjacent mudflats at Inch, Co. Kerry (2008).

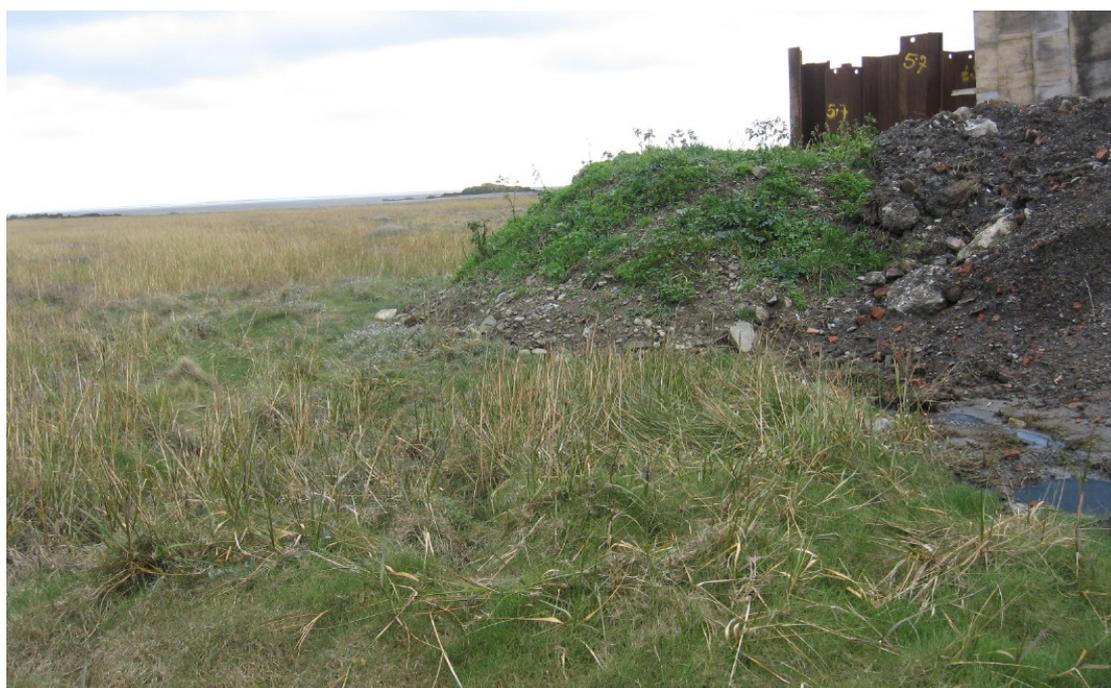
Some of the most significant damaging activities affecting saltmarsh in the past have been agricultural reclamation, flood relief schemes and infilling for industrial use (Curtis 2003). Very large areas of former saltmarsh are now located behind embankments and have been reclaimed for mainly agricultural use. Healy and Hickey (2002) estimated that 6500 ha of land had been reclaimed in the Shannon Estuary and much of this would have been mudflats, saltmarsh and brackish marsh. Devoy (2008) stated that 9000-15,000 ha of land was reclaimed by the 19th century. This gives some indication of the area of potential saltmarsh habitat that has been lost, when considering the current total area of Annex I saltmarsh habitats and *Spartina* swards is estimated to be 5300 ha. However, these activities have not occurred as frequently within the current monitoring period. It was estimated that about 8 ha of Annex I saltmarsh had been destroyed by activities such as reclamation, infilling (Figure 4.3) and other activities such as maintenance work on embankments. Large-scale agricultural reclamation was not a significant impact during this monitoring period although Dunbrody Abbey, an important site in a national context due to the presence of several rare species, has been affected by drainage and re-seeding. Reclamation is generally quite small scale with small areas being infilled. The development of new embankments to exclude the tide during the project was not significant.

Figure 4.3. Infilling from development along landward saltmarsh boundary in Dundalk Bay, Co. Louth (2007).

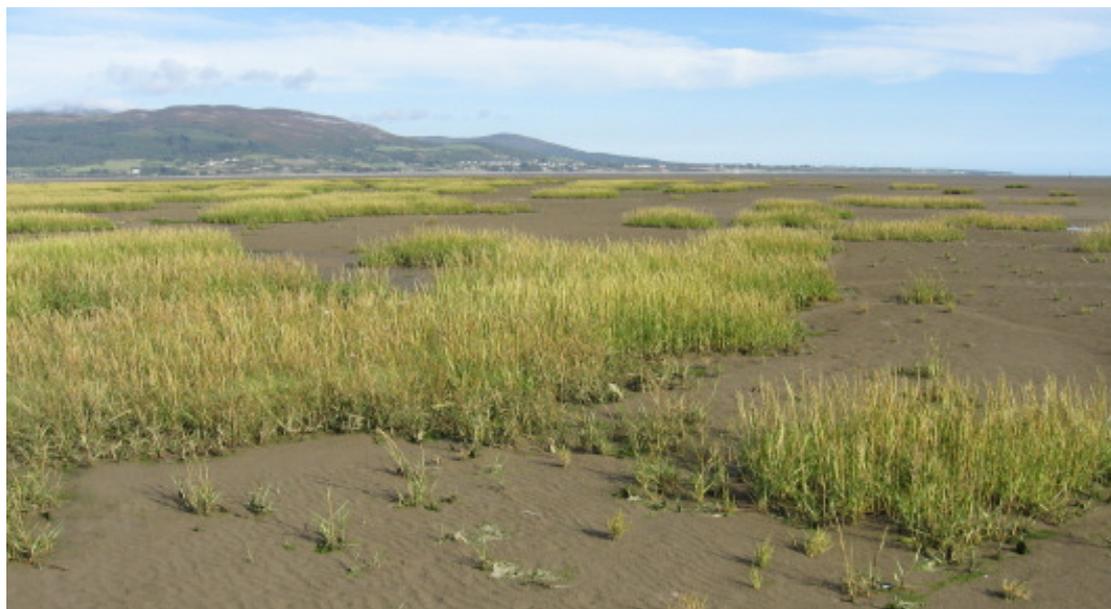
Common Cordgrass still has the capacity to spread to new sites, particularly in the larger estuaries and bays of the west coast, and affect pioneer and low zone saltmarsh communities, particularly *Salicornia* flats and low marsh ASM. Sites such as Donegal Bay, Mulroy Bay, Sligo Bay and Killala Bay are likely to be prone to colonisation by this species, naturally or deliberately in the future. Common Cordgrass is also likely to continue to consolidate at sites where it has only colonised relatively recently (past 50-60 years) with some increases in the extent of *Spartina* swards at the expense of *Salicornia* flats or ASM, and particularly at the expense of mudflats (Figure 4.4). Cooper *et al.* (2006) predict that *Spartina* swards will continue to increase in area on mudflats at their lower boundaries at sites in Northern Ireland. This prediction is based on the fact that *Spartina* swards have not reached their potential niche limit in most of the sites in Northern Ireland. *Spartina* swards in the Republic of Ireland are likely to follow the same trends, particularly swards that have established more recently.

Figure 4.4. Common Cordgrass spreading over sandflats in Dundalk Bay (2007).

- A general policy of active Common Cordgrass control in Irish saltmarshes is not recommended. Any available resources should be used to prevent the spread of this species to new sites, specifically along the west coast of Ireland and to eradication of new populations. There is very little rationale in attempting to control Common Cordgrass at large sites like the Shannon Estuary or Dundalk Bay where there is very limited likelihood of success without considerable outlay of resources. Perhaps *Spartina* swards in Ireland should now be considered as a pioneer saltmarsh community that can take part in the natural ecosystem functioning and succession of Irish saltmarsh communities.

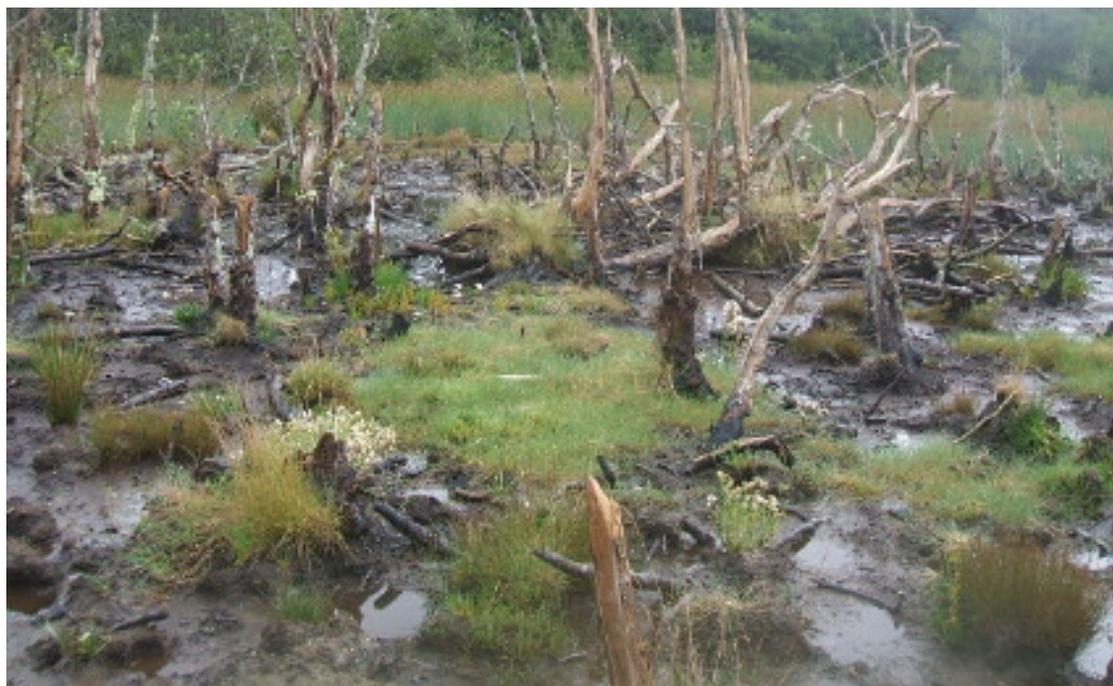
would be a suitable management option, particularly as some of the reclaimed land behind the seawalls is poor in quality, dominated by wet grassland, and has frequently been abandoned (Figure 4.5). The option of managed retreat could be considered within any future Agri-Environment schemes in Ireland with incentives provided for development of new saltmarsh, especially in abandoned reclaimed farmland. A similar scheme has been in operation in England within the Ministry of Agriculture and Food's Habitat Creation Scheme (UK Biodiversity Action Plan for Coastal Saltmarsh - <http://www.ukbap.org.uk/UKPlans.aspx?ID=33>)

Figure 4.5. Newly developing saltmarsh in formerly reclaimed land at Creeslough Co. Donegal (2008)
