GEOHYDROLOGY AND ECOLOGY STUDY

An Additional Study in the Quaternary Geology of Clara Bog.

County Offaly

M.C. Scheffers & J.J.M. van der Meer

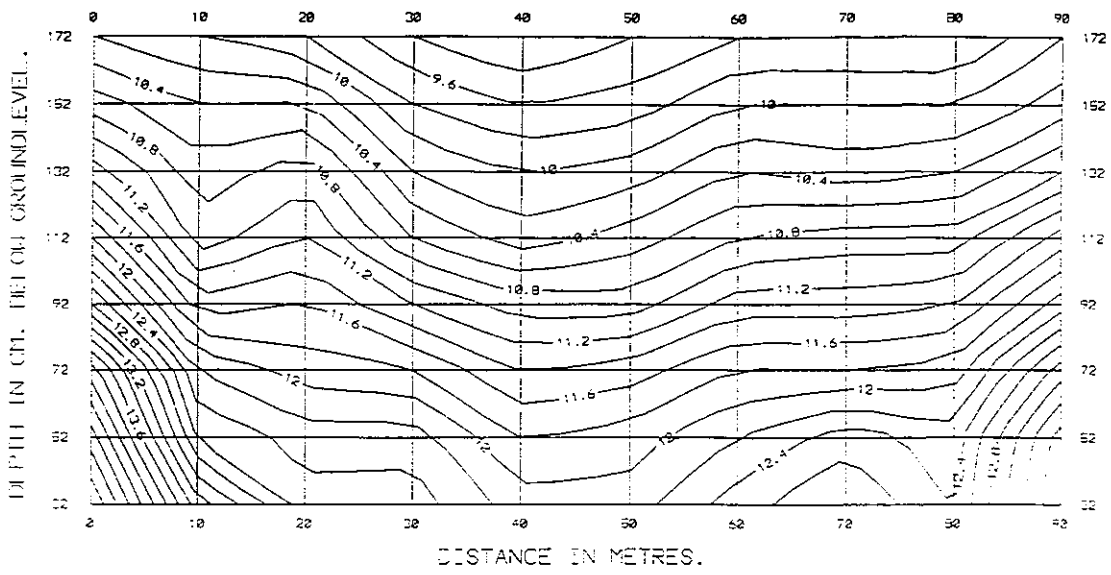
Temperature measurements on Lough Roe on 12-7-'92
along transect E'60 - E'69.
