SECTION THROUGH THE TOP WINDOW

SOUTH ELEVATION EXTERNAL

Drawing Stage: Drawn By: Checked By: Approved By: Date: LE LE 25/01/2024 Information RK Project Details: Menlough Castle Project Name: Scale: Project Number: Menlough Menlough Castle, Galway Site Address: **Castle Galway Phase 4** NTS 20612 Galway City Council Drawing Title: Summary of Proposed Works Originator: Client: 11 Issued for Information 25/01/2024 RK Project: Zone: To The External South Elevation - Sheet 1 Architect: 7L Architects REV. No. REVISION DESCRIPTION DATE ISSUED BY CORA

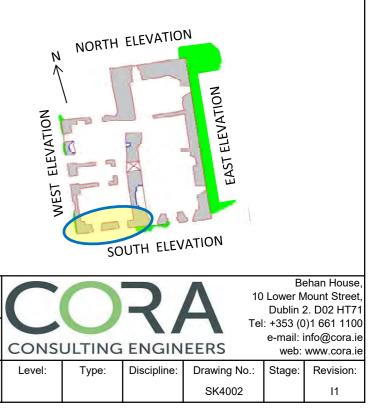
> Existing lintel to be inspected on site. Allow for four number 215mm x 65mm precast lintels with one number 100mm x 100mm limestone lintel on either side, number of lintels per opening. Dry pack between the new lintels and the existing stone. Wall over to be temporary propped during the works. Repair the wall over once the temporary works have been removed.

Note all precast cast concrete lintels to be installed with the rough side facing upwards.

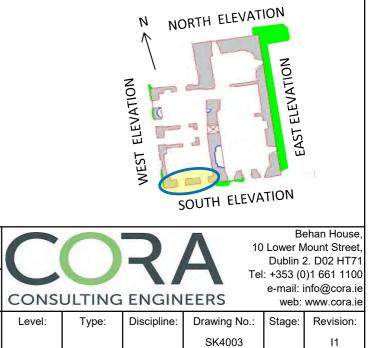
Allow for consolidation of the underside of the stone arch. Note deep repointing may be required with pieces of slate.

Allow for 6 number M8 stainless steel Helibar to between the voussoirs. Helibar to be installed as per manufactures specification.

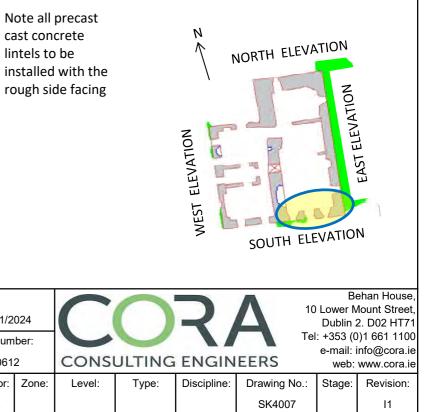
Vegetation to be removed from the base of the window and the stone work to be consolidated. The base of the window to be flaunched to allow rain water to self drain. Note small stone may be required to reduce the width of the mortar joint.

> Note all precast cast concrete lintels to be rough side facing
