Derelict Sites - Initial Inspection

DS Site Address	Unit 1 Newbridge , Athlumney Road, Navan, Co.Meath (House 1 - 101.A & 101.B)		
DS Site Eircode	C15 VH33		
Inspection Type	Re-Inspection		
Inspector	Lorcan Sheenan		
Inspection Date	25/11/2019		
Any representations received from the occupier/owner	No		
Sufficient improvement works carried out/underway	No

Building Type	Dwelling	
Additional Site Information	An old large 3- Storey end of terrace (end of row of 4) situated along the R153 Navan to Kentstown Road, at Andy Brennan Park. The building is of stone construction to the front and has a large extension built onto the rear of modern construction. The front of the dwelling is in very poor condition, with a tree growing out of the side window. The dwelling is pourous and dampness can be seen stained on the external stone face. The rear extension is in reasonable condition and appears to be secured with a combination of timber shutters and steel bars. Of the 4x properties this is easily in the best condition of the 4.

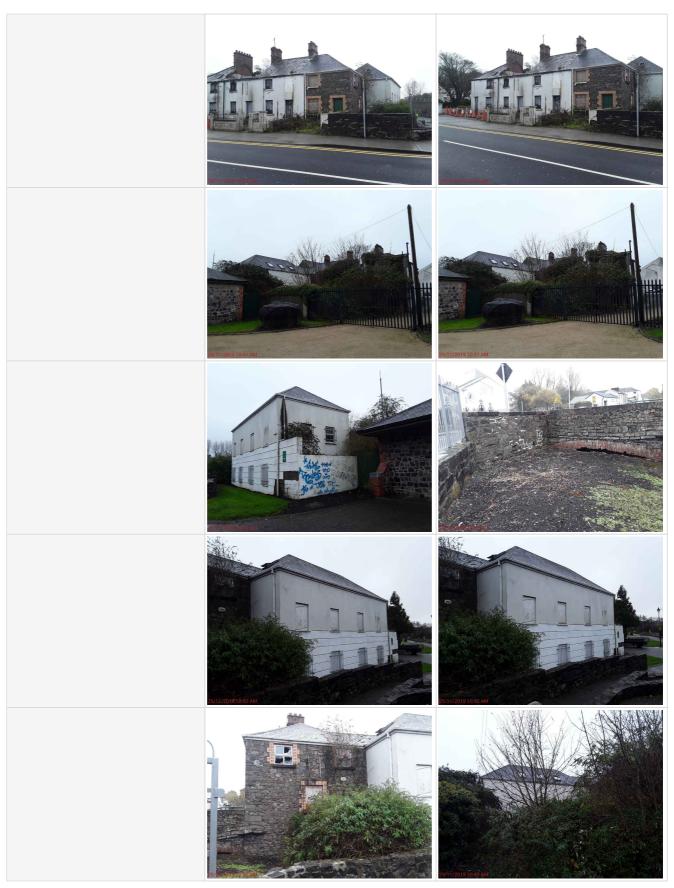
General Site Photos

Additional Comments - Rubbish / Waste	Potential hazardous waste from drug paraphernalia, empty beer bottles/cans, loose rubbish.			
Quantity of waste if applicable (Tonnes / No of Bags)	10			
Tonnes or Bags?	Bags			
Building Appearance Rating	5 - Very Poor			
Building Appearance Issue(s)	Building is in a complete ruinous state, Minor Cracks, Neglected in Appearance, Requires Painting, Significants Cracks			
Roof Condition Rating	3 - Good			
Roof Condition Issue(s)	Moss / Weeds growth, Slates / Tiles loose			
Facia / Soffit Rating	3 - Good			
Facia / Soffit Issue(s)	Partially missing Fascia / Soffit			
Guttering Rating	3 - Good			
Guttering Issue(s)	Weeds In Guttering, Broken Guttering			
Windows / Doors Rating	5 - Very Poor			
Windows / Doors Issue(s)	Boarded Up, Broken Window (s), Missing Window (s), Damaged Door(s)			
Additional Comments - Windows / Doors	Majority are boarded up with a combination of timber shutters, steel bars. 2x windows are smashed on side elevation.

Structure Rating	4 - Poor			
Structure Issue(s)	Along Public Road / Footpath, Structure is in a state of ruin and dereliction, Trees, Bushes growing inside building			
End of Life Vehicles on site?	No			
Site Signage	No			
Total Area of Land (Ha)	0.0169			
Planning Notice?	No

Recommendations	Please see below
Issue Non Statutory Notices / Statutory Notices	Issue a Section 8(2) Notice
