# TO 334 Munster Bridges Term Maintenance 4

Natura Impact Statement for Munster Bridges  
(2023, Year 1)

Transport Infrastructure Ireland (TII)

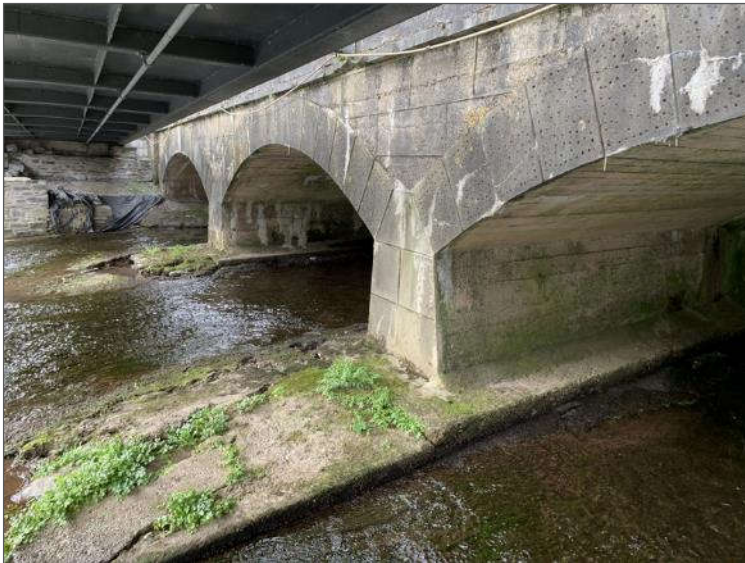
**Plate 2.1** Killeagh River Bridge.

Killeagh River Bridge is a 3-span masonry arch bridge over the Dissour River. Each span is 4.8m of arch barrel which comprises concrete, the remainder is stone masonry. Plate 2.1 shows Killeagh Bridge. A recently constructed metal pedestrian bridge can be seen to the left. Killeagh River Bridge is hydrologically connected to Ballymacoda (Clonpriest and Pillmore) SAC and Ballymacoda Bay SPA. A Japanese knotweed sign is located at the bridge.

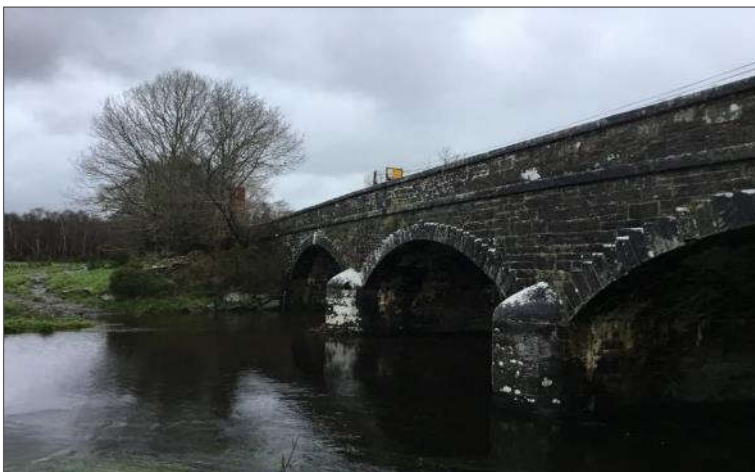
**Plate 2.2** Duncannon Bridge.

The Duncannon Bridge is a 3-span masonry arch bridge with masonry parapets carrying N72 over the River Blackwater. Each span is 9.1m and the rise of arch barrel at crown is 1.77m. The bridge is within the Blackwater River (Cork/Waterford) SAC. It is hydrologically connected to Blackwater Callows SPA. Plate 2.2 shows the north elevation. NPWS noted pearl mussel to be present at and downstream of the bridge. However, 2023 targeted survey work found no mussels present within 100m upstream and downstream of the bridge. A single pair of old empty shells was noted c. 90m downstream. Pearl mussel is a QI of the Blackwater River (Cork/Waterford) SAC.

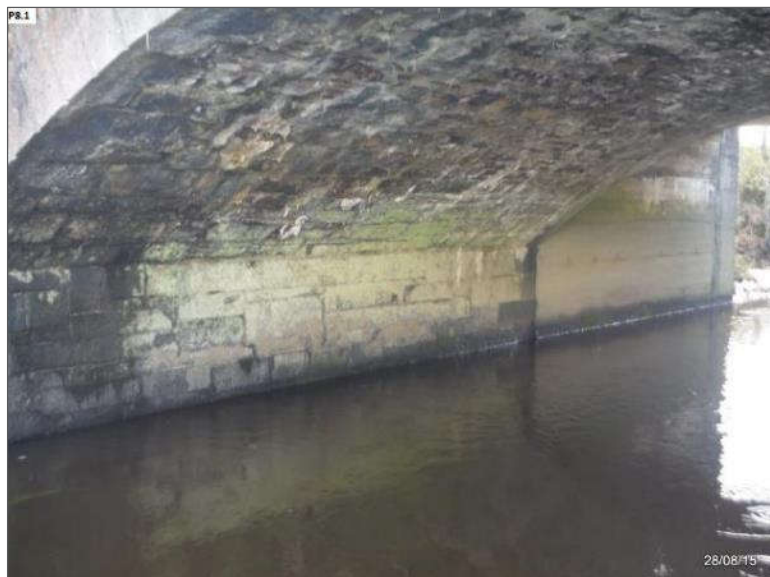
**Plate 2.3 Ahane Bridge.**

Ahane Bridge is a double span masonry arch bridge with a concrete slab secondary structure with an overall length of 19.5m. There are spalled concrete parapet walls along the carriageway. The bridge carries the N72 over the Owentaraglin River within the Blackwater River (Cork/Waterford) SAC. Plate 2.3 displays the north elevation. NPWS noted pearl mussel to be present at and downstream of the bridge. However, 2023 survey work only located pearl mussel ca. 40m downstream of the bridge. Pearl mussel is a QI of the Blackwater River (Cork/Waterford) SAC.

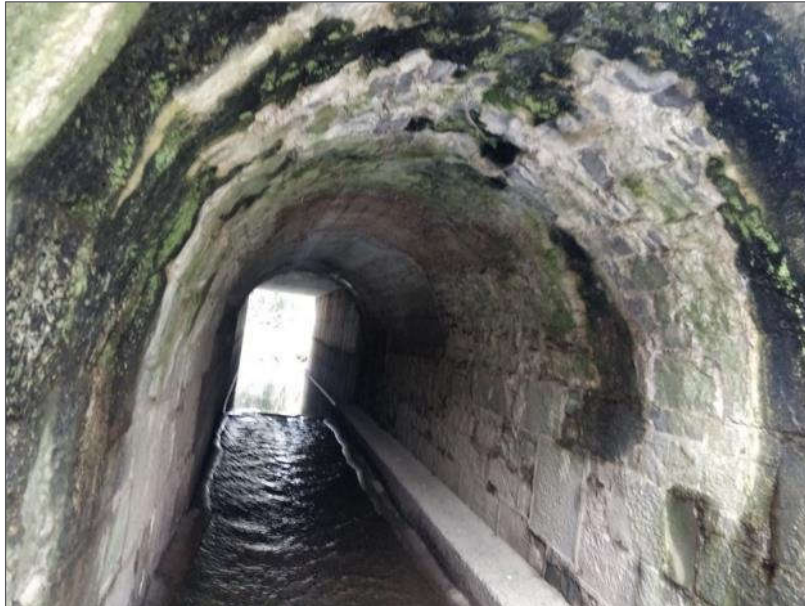
**Plate 2.5 Lombardstown Bridge under the arch.**

Lombardstown Bridge consists of a masonry arch structure with a large concrete deck extension to the upstream elevation. There are low concrete parapet walls on both sides behind crash barriers. Plate 2-5 shows Lombardstown Bridge. The structure is not within the Blackwater River (Cork/Waterford) SAC. It carries water under the N72 just over 35m from the River Blackwater. There are no records of pearl mussel from Lombardstown Bridge. NPWS has, however, recorded pearl mussel ca. 0.6km downstream of bridge on main channel of River Blackwater. Pearl mussel is a QI of the Blackwater River (Cork/Waterford) SAC.

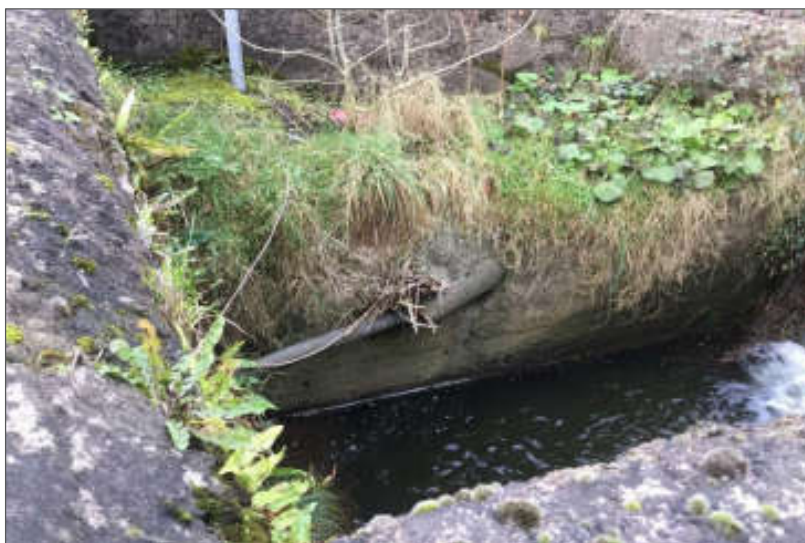
**Plate 2.6 Firville Culvert.**

The structure is a 2-span masonry structure with masonry parapets. The maximum span is 1.17m and the minimum span is 0.67m. The structure is located 600m upstream of the Blackwater River (Cork/Waterford) SAC on the N72. Plate 2.6 shows the north side of this structure. There are no records of pearl mussel from Firville Bridge. NPWS has, however, recorded pearl mussel ca. 0.7km downstream of bridge on main channel of River Blackwater. Pearl mussel is a QI of the Blackwater River (Cork/Waterford) SAC.

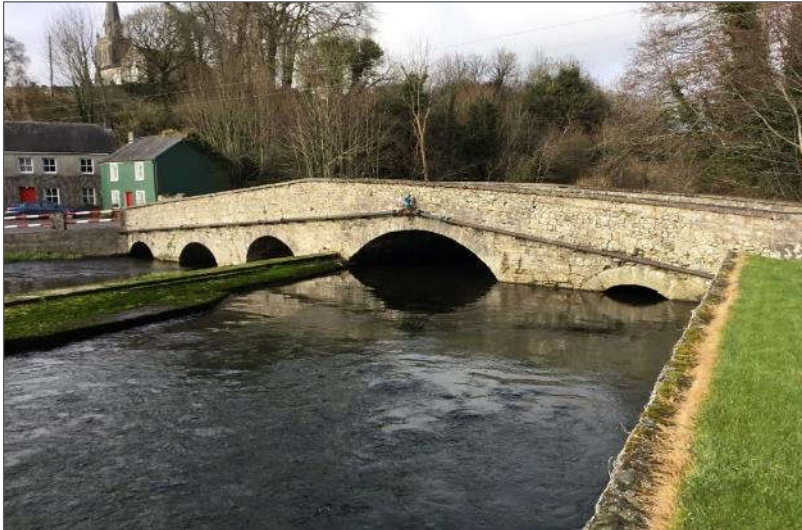
**Plate 2.7** Castletownroche Bridge.

The Castletownroche Bridge is a 5-span masonry arch bridge with masonry parapets. The maximum span is 5.6m and the minimum span is 2.33m. The rise of arch barrel for the maximum span at crown is 1.56m. There is water pipe strapped to the south of the bridge. The structure is within the Blackwater River (Cork/Waterford) SAC. Plate 2.7 shows the south elevation. There are no records of pearl mussel from Castletownroche Bridge. NPWS has, however, recorded pearl mussel ca. 8.4km downstream of bridge on main channel of River Blackwater. Pearl mussel is a QI of the Blackwater River (Cork/Waterford) SAC.

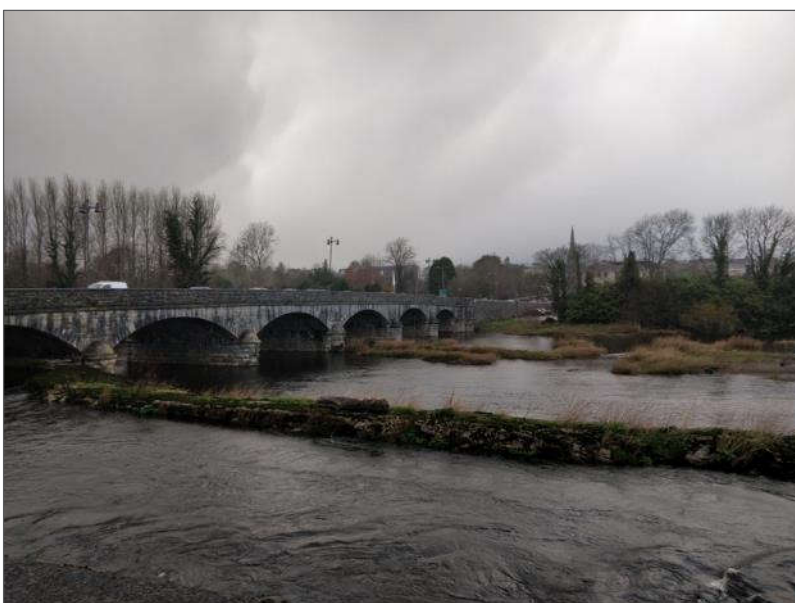
**Plate 2.8** Fermoy Bridge.

The Fermoy Bridge is a 7-span masonry arch bridge with masonry parapets which carries N72 over the River Blackwater. The maximum span is 14.6m and the minimum span is 11.52m. The river is accessible by using a bridge inspection unit. The structure is within Blackwater River (Cork/Waterford) SAC and located 1.6km upstream of the Blackwater Callows SPA. Plate 2.8 shows the west elevation. There are no records of pearl mussel from Fermoy Bridge. NPWS has, however, recorded pearl mussel ca. 2km downstream of bridge on main channel of River Blackwater. Pearl mussel is a QI of the Blackwater River (Cork/Waterford) SAC.

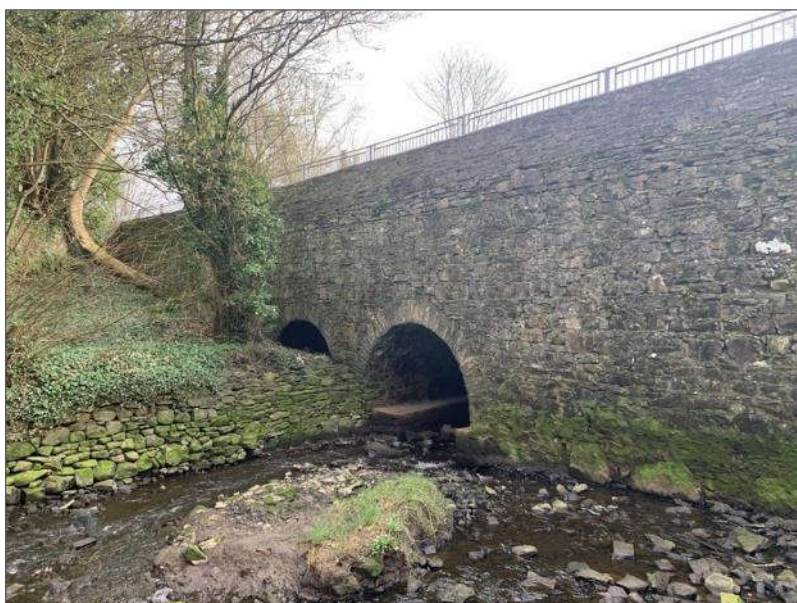
**Plate 2.9 Burrane Bridge.**

The Burrane Bridge is a 2-span bridge comprised by corrugated steel arch on the south side and masonry arch on the north side. The span is 3.1m each and rise of arch barrel at crown is 1.34m. There is steel safety barrier on the south side and steel parapet on the north side. The structure is located on the Shannon estuary and is on the upstream boundary of both the Lower River Shannon SAC and River Shannon and River Fergus Estuaries SPA. Plate 2.9 shows the north elevation.

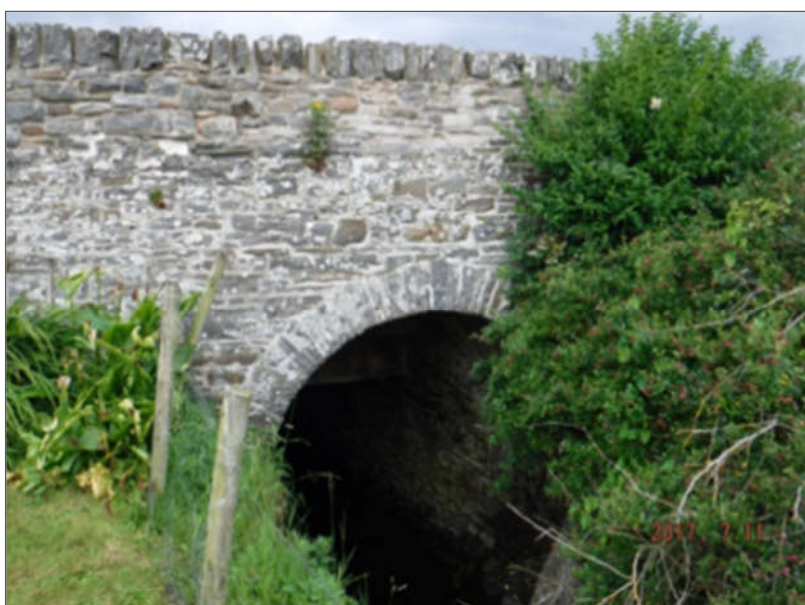
**Plate 2.10 Kilkee Bridge.**

The Kilkee Bridge is a single span bridge. It is a masonry arch in the south side, and it has been widened using a reinforced concrete slab in the north side. The span is 2.53m. The substructure consists of 2 masonry abutments. There are masonry parapets on both sides of the carriageway. The structure is located 200m upstream of Kilkee Reefs SAC. Plate 2.10 shows the south elevation.

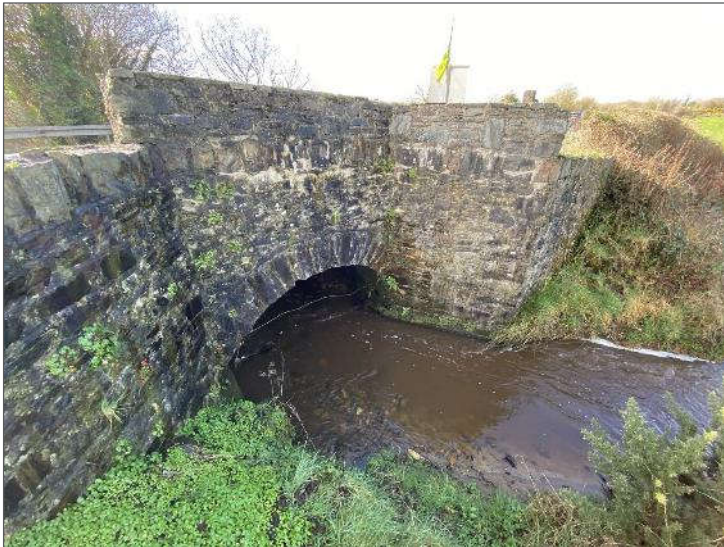
**Plate 2.11 Kilneedan Bridge.**

The Kilkneedan Bridge is a 2.94m single span masonry arch bridge with in-situ reinforced concrete extension. The structure carries N22 over the Leamnaguila 22 which is a tributary of the Gweestin River. The bridge is within the Castlemaine Harbour SAC. Castlemaine Harbour SPA is ca. 30km downstream of the bridge. Plate 2.11 shows the masonry arch at east side, with a concrete slab at west side.

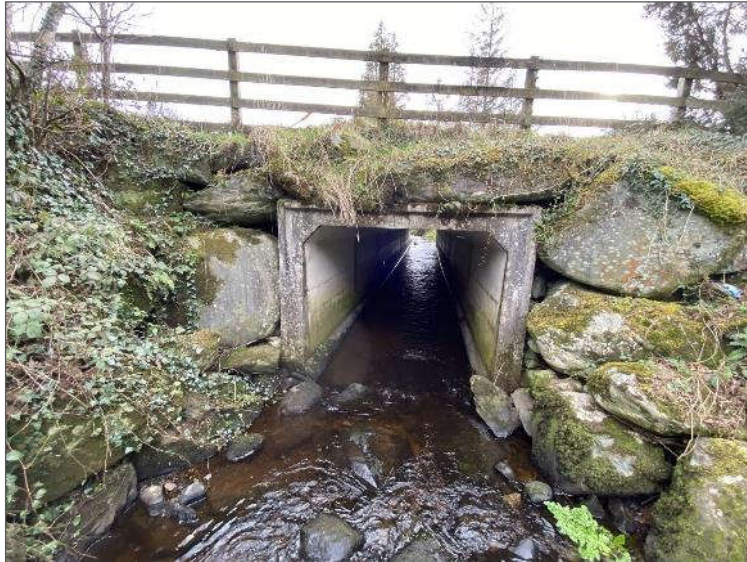
**Plate 2.13 Cloghane Culvert.**

Cloghane Culvert is a concrete culvert over the Ardeegalvan 22 watercourse. It crosses under the N22 on the eastern side of Killarney. It is located within Killarney National Park, Macgillycuddy's Reeks and Caragh River Catchment SAC and is located 11.8km upstream of the Killarney National Park SPA. Plate 2.13 shows Cloghane Culvert. There are no records of pearl mussel from Cloghane Bridge. NPWS has, however, recorded pearl mussel ca. 0.2km downstream of the bridge on main channel of River Flesk (Kerry). Pearl mussel is a QI of Killarney National Park, Macgillycuddy's Reeks and Caragh River catchment SAC.

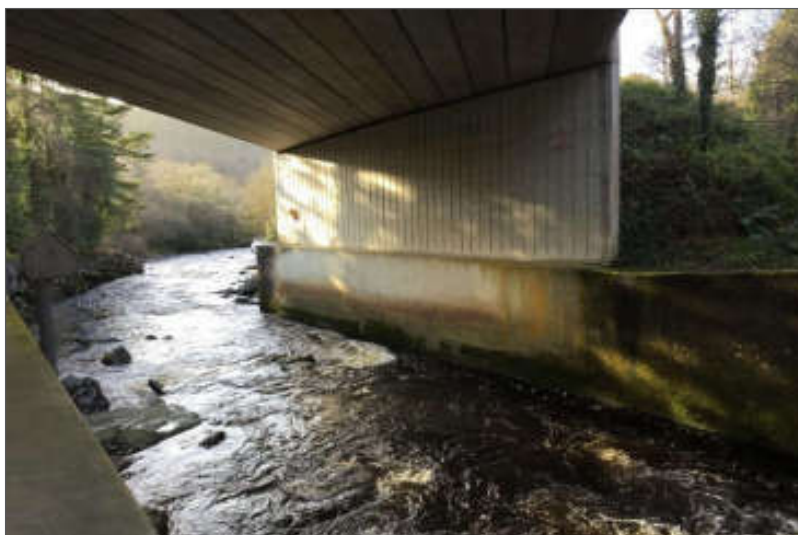
**Plate 2.15 Poulgorm Bridge.**

The Poulgorm Bridge is a 23.90m single span concrete bridge which carries the N22 over the River Flesk in Co. Kerry. The parapets comprise heavy steel rails over the deck with a masonry parapet at top of the wing walls. The bridge is within the Killarney National Park, Macgillycuddy's Reeks and Caragh River catchment SAC. It is located 24.2km upstream of the Killarney National Park SPA. Plate 2.15 shows the south elevation. There are no records of pearl mussel from Poulgorm Bridge. NPWS has, however, recorded pearl mussel ca. 2.1km downstream of the bridge on main channel of River Flesk (Kerry). Pearl mussel is a QI of Killarney National Park, Macgillycuddy's Reeks and Caragh River catchment SAC.

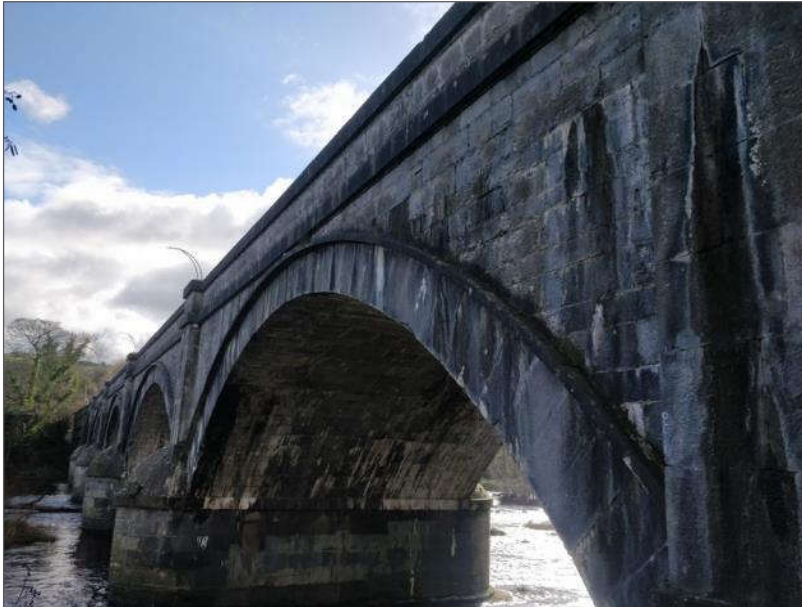
**Plate 2.17 Listowel Bridge.**

The Listowel Bridge is a 5-span stone masonry arch bridge. The span lengths are 15.2m each. The substructure consists of 2 masonry abutments and 4 masonry piers. There are masonry parapets on both sides of the carriageway. The structure is within the Lower River Shannon SAC. Plate 2.17 shows the west elevation. There are no pearl mussel at Listowel Bridge; mussel have been recorded ca. 48m upstream of the bridge. Pearl mussel is a QI of Lower River Shannon SAC.

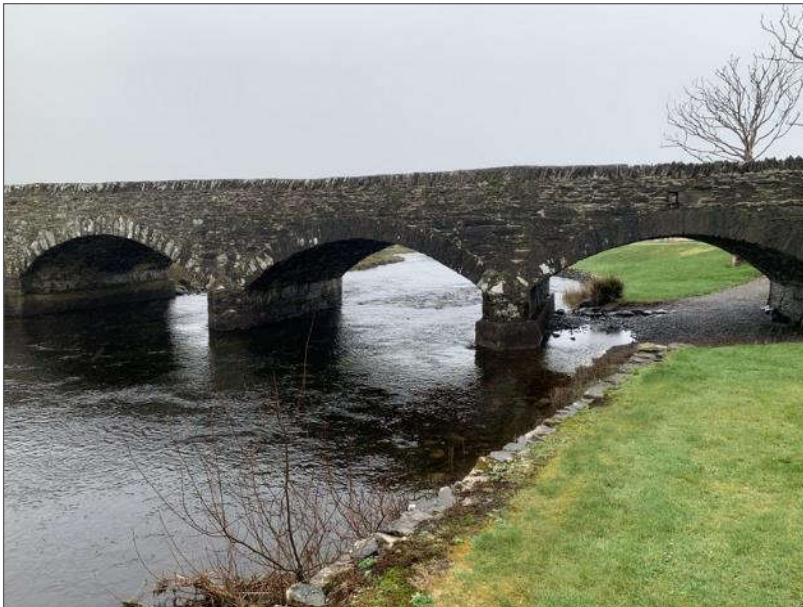
**Plate 2.19** Waterville Bridge.

The Waterville Bridge is a 3-span stone masonry arch bridge. The spans are of similar around 7.13m. The substructure consists of 2 masonry abutments and 2 masonry piers. There are masonry parapets on both sides of the carriageway. The structure is within the Ballinskelligs Bay and Inny Estuary SAC. Killarney National Park SAC is located immediately upstream of the bridge. Plate 2.19 shows the east elevation.

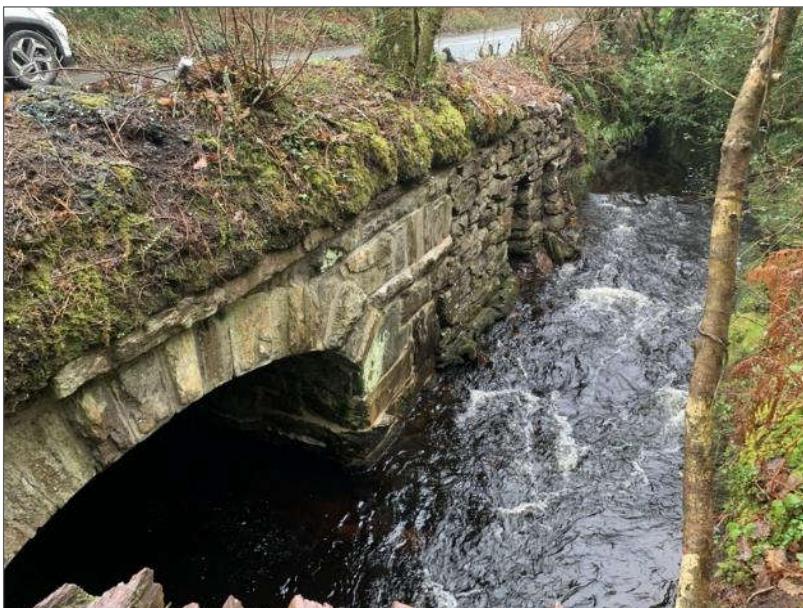
**Plate 2.20** Derreenamacken Bridge.

The Derreenamacken Bridge is a single span stone masonry arch bridge. The span is 3.04m. Two box culverts are located close to the arch. There are no parapets on the structure. The structure is located 150m upstream of the Kenmare River SAC and 1.2km west of Blackwater River (Kerry) SAC. Plate 2.20 shows the north elevation.

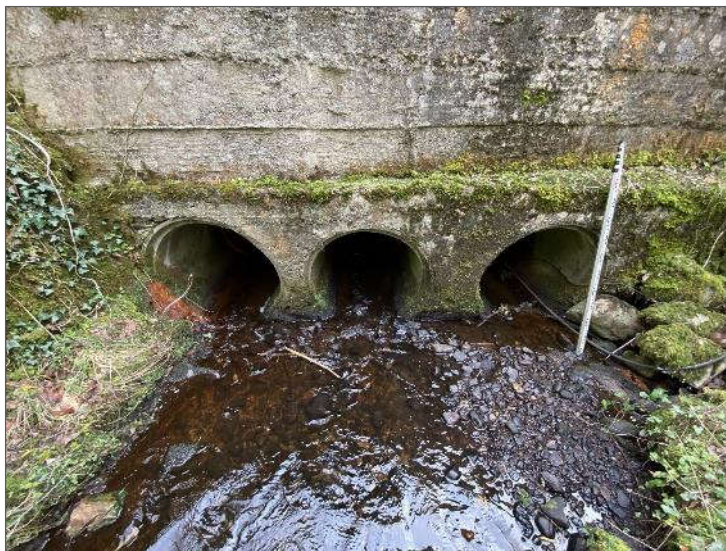
**Plate 2.21** Ardteegalvan Bridge.

The Ardteegalvan Bridge is three arch masonry bridge. There are adjacent to the bridge three precast reinforced concrete pipes in the north side. The span is 2.94m. The substructure consists of 2 masonry abutments. There are masonry parapets on both sides of the carriageway. The structure is located 2km upstream of the Killarney National Park, Macgillycuddy's Reeks and Caragh River Catchment SAC and 15km upstream of Killarney National Park SPA. Plate 2.21 shows the north elevation. There are no records of pearl mussel from Ardteegalvan Bridge. NPWS has, however, recorded pearl mussel ca. 3.1km downstream of the bridge on main channel of River Flesk (Kerry). Pearl mussel is a QI of Killarney National Park, Macgillycuddy's Reeks and Caragh River catchment SAC.

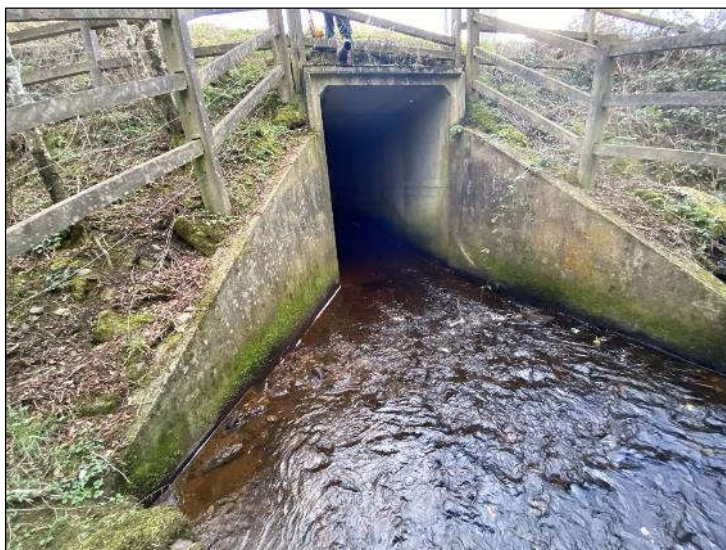
**Plate 2.22** Knockeennagowan Bridge.

Knockeennagowan Bridge is a concrete culvert over the Knockanaroor watercourse. It is not located with a Natura 2000 site. The structure is located 2.8km upstream of the Killarney National Park, Macgillycuddy's Reeks and Caragh River Catchment SAC and 17km upstream of Killarney National Park SPA. Plate 2.22 shows Knockeennagowan Bridge. There are no records of pearl mussel from Knockeennagowan Bridge. NPWS has, however, recorded pearl mussel ca. 4.9km downstream of the bridge on main channel of River Flesk (Kerry). Pearl mussel is a QI of Killarney National Park, Macgillycuddy's Reeks and Caragh River catchment SAC.

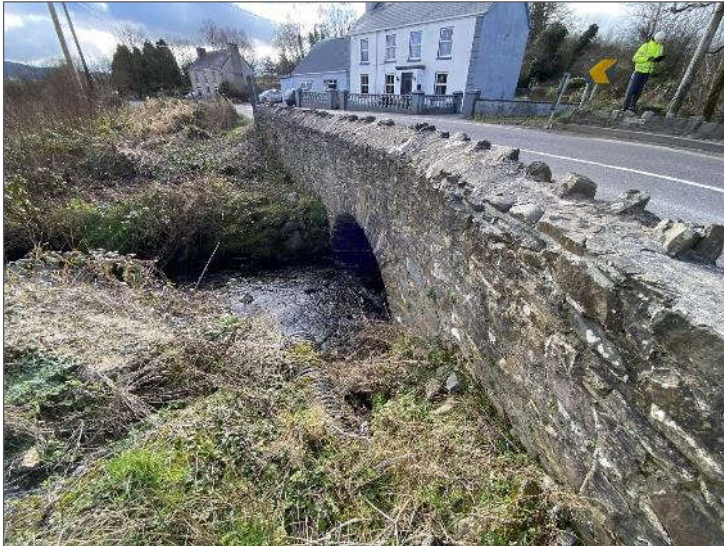
**Plate 2.23 Gortanahaneboy Bridge.**

The Gortanahaneboy West Bridge is a 2.95m single span masonry arch bridge with masonry parapets on both sides of the carriageway. The rise of arch barrel at crown is 1.40m. The structure is within the Killarney National Park, Macgillycuddy's Reeks and Caragh River Catchment SAC. Killarney National Park SPA is over 20km downstream of the bridge. Plate 2.23 shows the deck, abutments, and riverbed of the bridge. There are no records of pearl mussel from Poulgorm Bridge. NPWS has, however, recorded pearl mussel ca. 8.4km downstream of the bridge on main channel of River Blackwater. Pearl mussel is a QI of Killarney National Park, Macgillycuddy's Reeks and Caragh River catchment SAC.

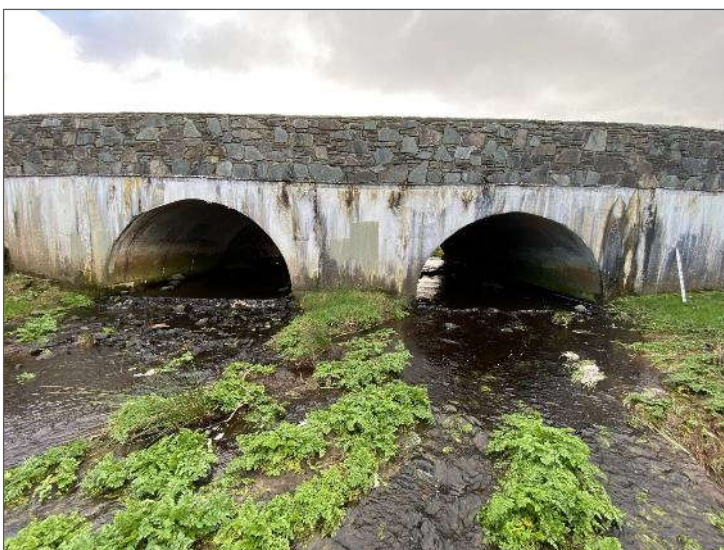
**Plate 2.24 Cullavaw Bridge.**

The Cullavaw Bridge is a 2-span masonry arch bridge with reinforced concrete arch extension to the north end. The maximum span is 4.14m and the minimum span is 3.60m. The structure carries N72 over the Cullavaw stream which is a tributary of the River Blackwater. The bridge is located 1.5km upstream of the Blackwater River (Cork/Waterford) SAC. Plate 2.24 shows the north elevation.

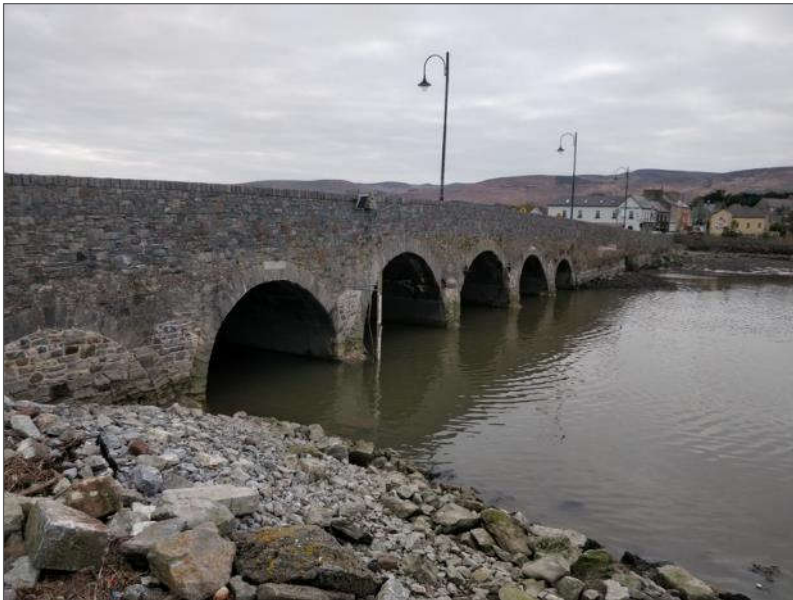
**Plate 2.25 Blennerville Bridge.**

The Blennerville Bridge is a 5-span stone masonry arch bridge. The span lengths vary between 7.4m and 4.8m. The substructure consists of 2 masonry and concrete abutments and 4 masonry and concrete piers. There are masonry parapets on both sides of the carriageway. The structure is within Tralee Bay and Magharees Peninsula, West to Cloghane SAC and within Tralee Bay Complex SPA. Plate 2.25 shows the west elevation.

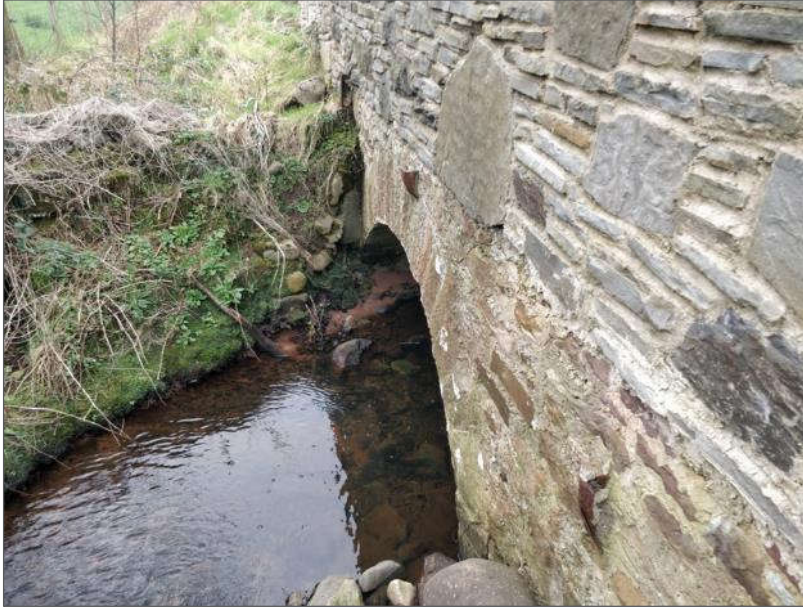
**Plate 2.27** Enrights Bridge.

Enrights Bridge is a single span stone masonry structure on the N86 west of Blennerville. The stream discharges to Tralee Bay and Magharees Peninsula, West to Cloghane SAC immediately at the downstream face of the structure and Tralee Bay Complex SPA c. 0.1km downstream. Plate 2.27 shows Enrights Bridge.

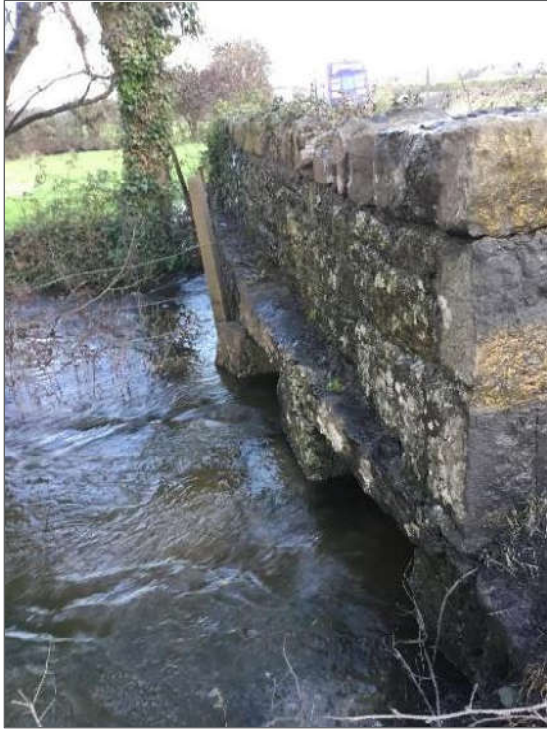
**Plate 2.28** Rincullia Bridge.

Rincullia Bridge is a three-span masonry and concrete bridge with a span of 6.2m. Masonry parapets line the carriageway above the structure. The bridge carries the N69 over the Ahacronane River within the Lower River Shannon SAC and 300m upstream of the River Shannon and River Fergus Estuaries SPA. Plate 2.28 shows the face of the bridge.

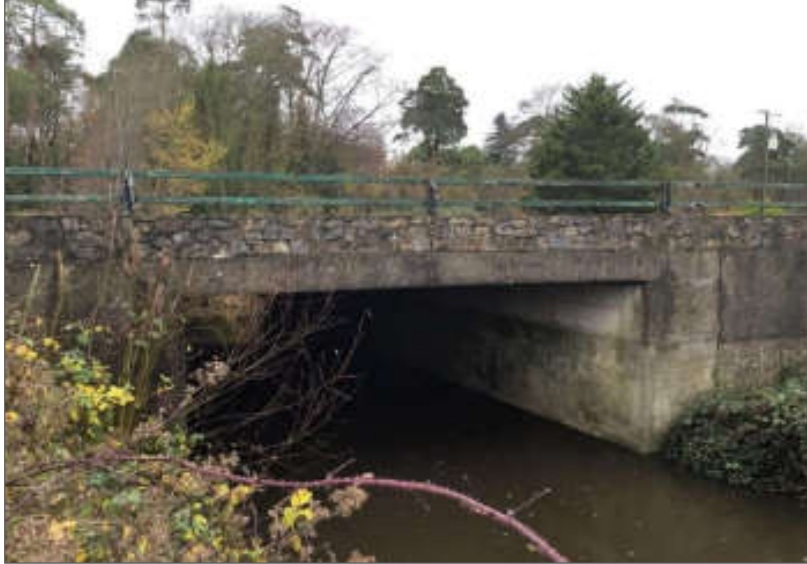
**Plate 2.29** Canal Bridge.

The Canal Bridge is a 6.1m single span concrete slab. The parapets are masonry with steel railing. The structure is within the Lower River Suir SAC. Plate 2.29 shows the south elevation.

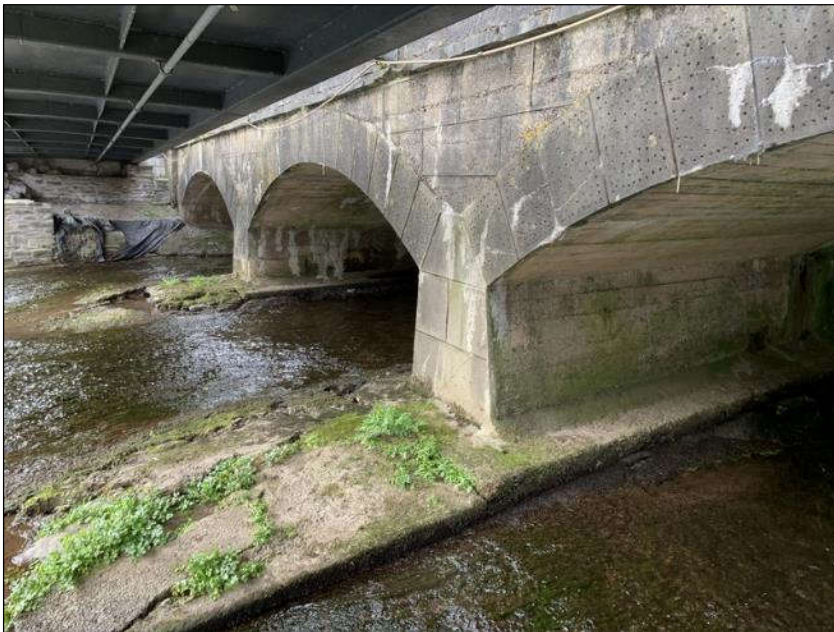
**Plate 5.1 Killeagh River Bridge.**

Killeagh River Bridge is a 3-span masonry arch bridge over the Dissour River. Each span is 4.8m of arch barrel which comprises concrete, the rest is stone masonry. Ballymacoda (Clonpriest and Pillmore) SAC is ca. 7.2km downstream of bridge. Ballymacoda Bay SPA ca. 6.5km downstream of bridge. Plate 5.1 shows Killeagh Bridge.

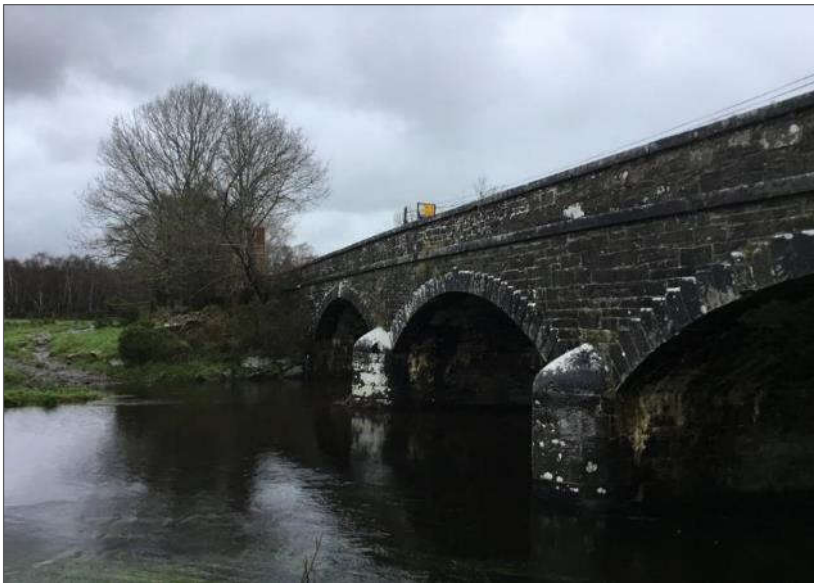
**Plate 5.2 Duncannon Bridge.**

The Duncannon Bridge is a 3-span masonry arch bridge with masonry parapets carrying N72 over the River Blackwater. Each span is 9.1m and the rise of arch barrel at crown is 1.77m. The bridge is within the Blackwater River (Cork/Waterford) SAC. Plate 5.2 shows the north elevation.

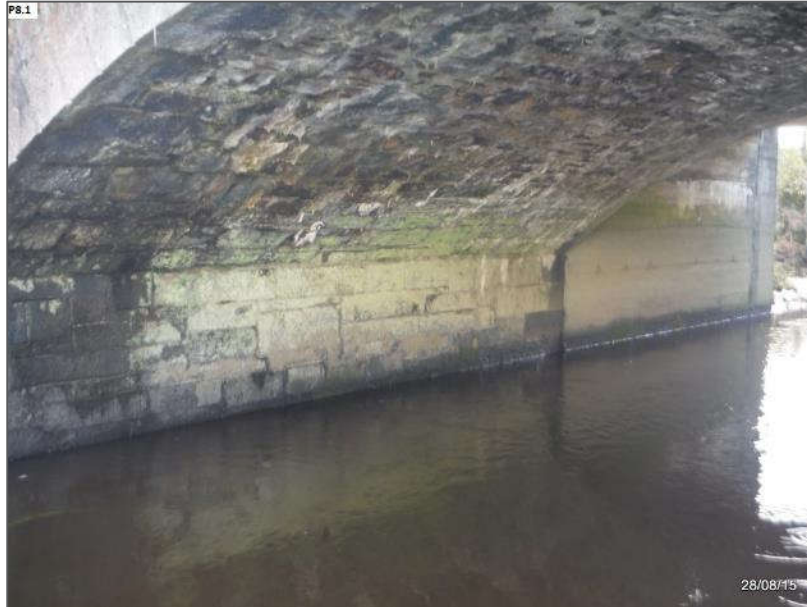
**Plate 5.3 Ahane Bridge**

Ahane Bridge is a double span masonry arch bridge with a concrete slab secondary structure with an overall length of 19.5m. There are spalled concrete parapet walls along the carriageway. The bridge carries the N72 over the Owentaraglin River within the Blackwater River (Cork/Waterford) SAC. Plate 5.3 displays the north elevation.

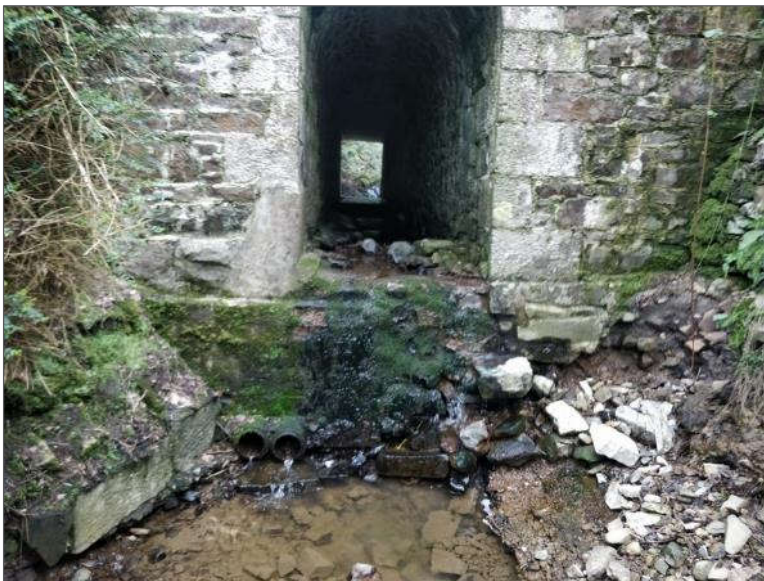
**Plate 5.4 Boland's Bridge.**

The Boland's Bridge is a single span masonry arch bridge with in-situ reinforced concrete extension. The original arch barrel has a span of 1.2m. The concrete slab extension has a clear span of 1.258m and measures 2.25m to the barrel of the slab. The bridge is within the Blackwater River (Cork/Waterford) SAC. Plate 5.4 shows the concrete section at north side. As can be seen in Plate 5.4 the stream is small in scale with limited flow. Works will be undertaken during the summer months when river flows are at their lowest.

All scour protection works will be done in the dry by placing and compacting mass concrete in any scour void less than 300mm depth and 300mm width provided immediately in front of the affected area over a length and width specified in the Work Order for that bridge. As can be seen in Plate 5.4, the stream is small in scale and supports low flows. Furthermore, works will be undertaken during the summer months when river flows will be low. It will be necessary to divert the river around the works are in order that the scour void can be filled in the dry. This in turn will prevent any concrete or cementitious product from entering the watercourse.

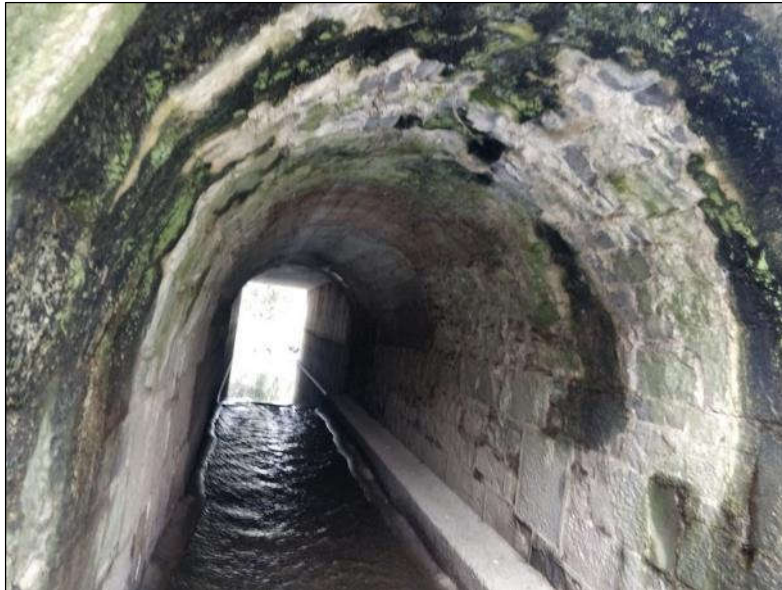
**Plate 5.5 Lombardstown Bridge under the arch.**

Lombardstown Bridge consists of a masonry arch structure with a large concrete deck extension to the upstream elevation. There are low concrete parapet walls on both sides behind crash barriers. Plate 5.5 shows Lombardstown Bridge. Blackwater River (Cork/Waterford) SAC located ca. 35m downstream of bridge.

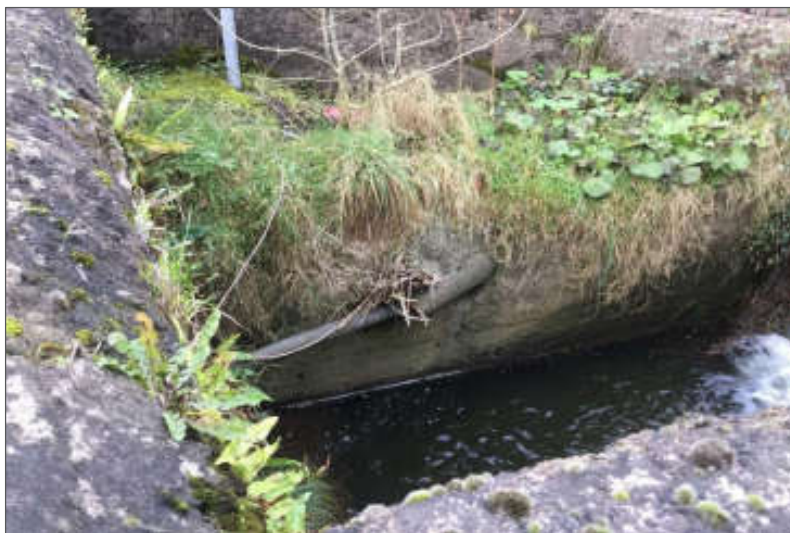
**Plate 5.6**      **Firville Culvert.**

The structure is a 2-span masonry structure with masonry parapets. The maximum span is 1.17m and the minimum span is 0.67m. The structure is located over the Scarteen watercourse ca. 600m upstream of the Blackwater River (Cork/Waterford) SAC. Plate 5.6 shows the north side.

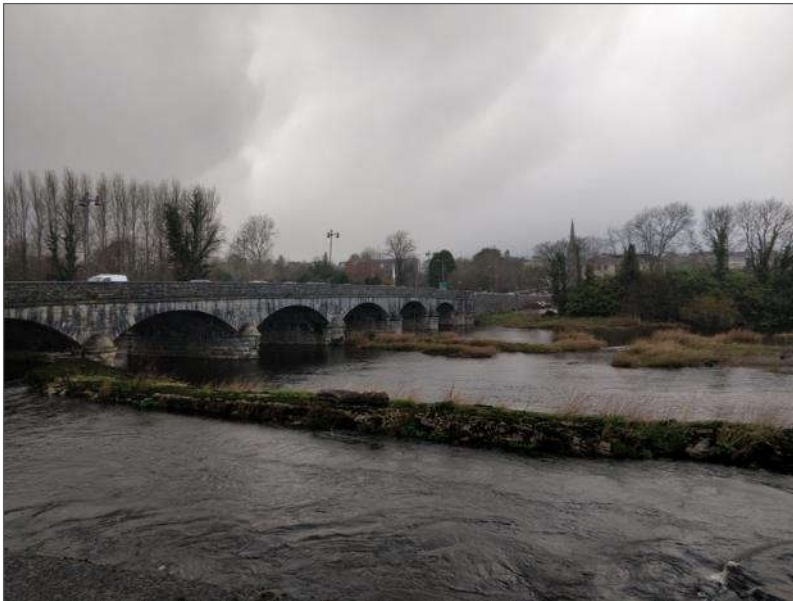
**Plate 5.8 Fermoy Bridge.**

The Fermoy Bridge is a 7-span masonry arch bridge with masonry parapets which carries N72 over the River Blackwater. The maximum span is 14.6m and the minimum span is 11.52m. The river is accessible by using a bridge inspection unit. The structure is within Blackwater River (Cork/Waterford) SAC and located 1.6km upstream of the Blackwater Callows SPA. Plate 5.8 shows the west elevation.

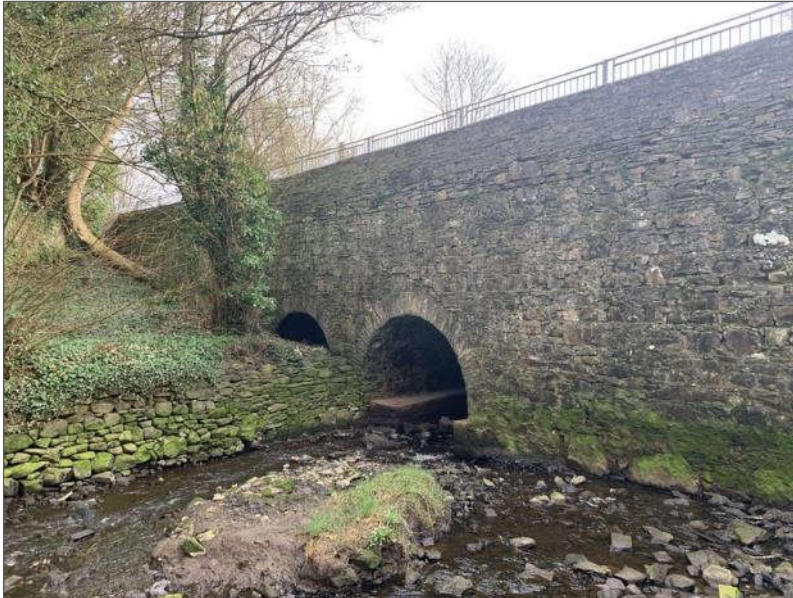
**Plate 5.9 Bunrane Bridge.**

The Bunrane Bridge is a 2-span bridge comprised by corrugated steel arch on the south side and masonry arch on the north side. The span is 3.1m each and rise of arch barrel at crown is 1.34m. There is steel safety barrier on the south side and steel parapet on the north side. The structure is within the Lower River Shannon SAC and is located ca. 80m upstream of the River Fergus Estuaries SPA. Plate 5.9 shows the north elevation.

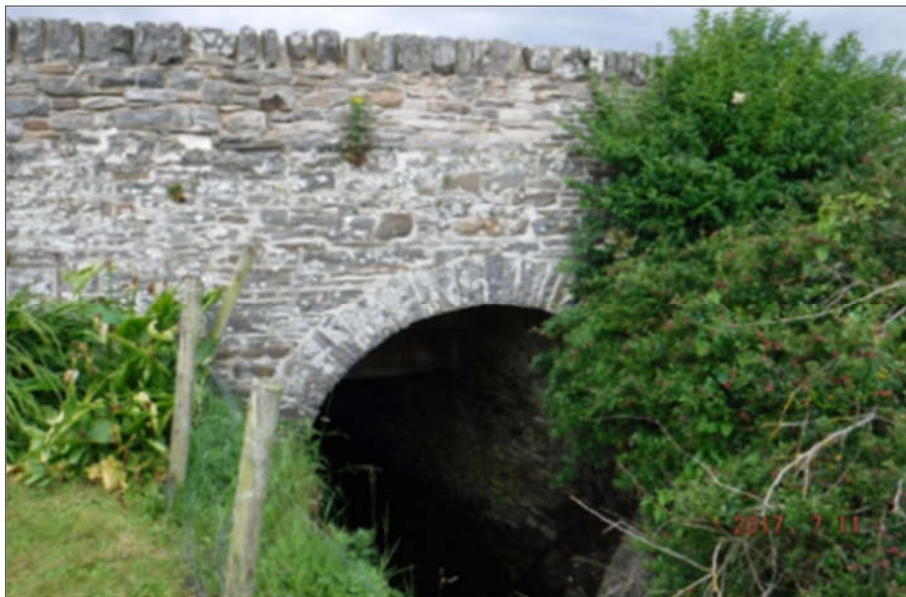
**Plate 5.10 Kilkee Bridge.**

The Kilkee Bridge is a single span bridge. It is a masonry arch in the south side, and it has been widened using a reinforced concrete slab in the north side. The span is 2.53m. The substructure consists of 2 masonry abutments. There are masonry parapets on both sides of the carriageway. The structure is located 200m upstream of Kilkee Reefs SAC. Plate 5.10 shows the south elevation.

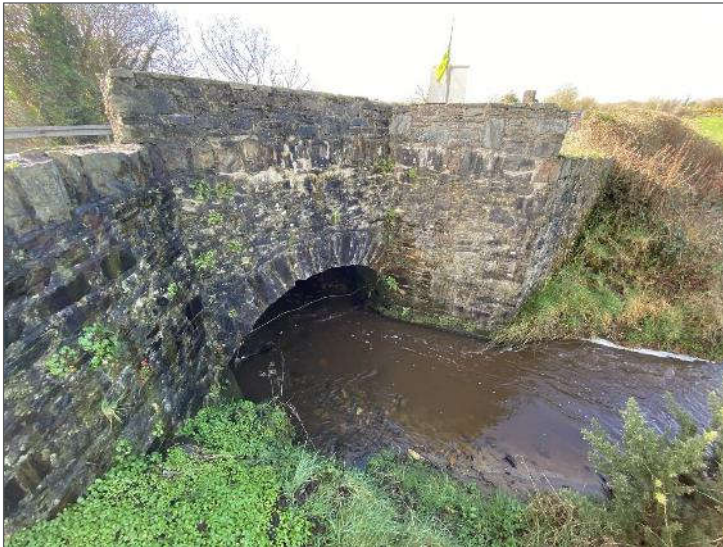
**Plate 5.11 Kilneedan Bridge.**

The Kilneedan Bridge is a 2.94m single span masonry arch bridge with in-situ reinforced concrete extension. The structure carries N22 over the Leamnaguila 22 which is a tributary of the Gweestin River. The bridge is within the Castlemaine Harbour SAC. Plate 5.11 shows the masonry arch at east side; a concrete slab is located at the west side.

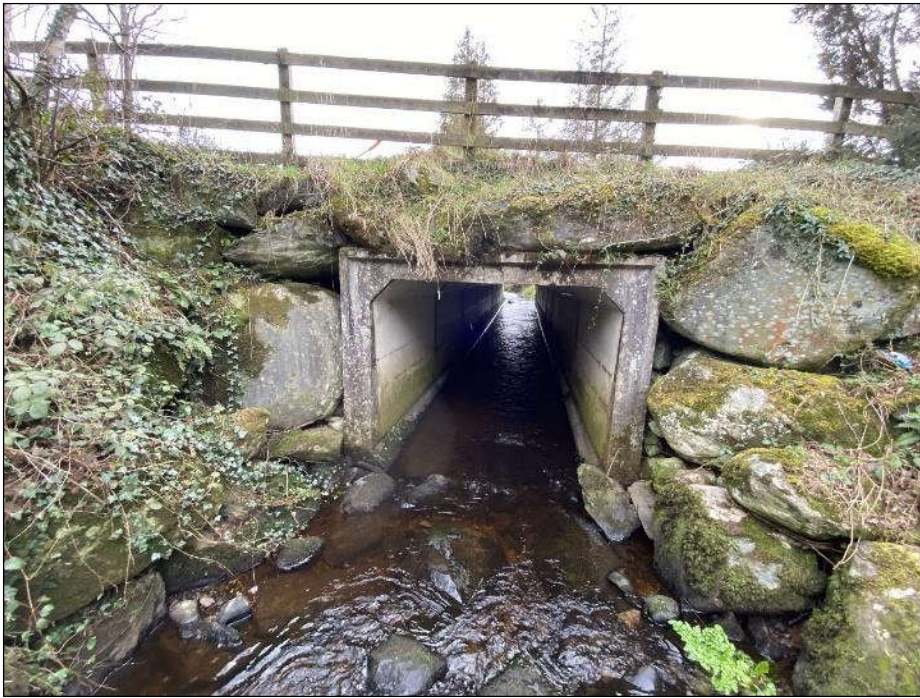
**Plate 5.13 Cloghane Culvert.**

Cloghane Culvert is a concrete culvert over the Ardteegalvan 22 watercourse. Plate 5.13 shows Cloghane Culvert. Cloghane Culvert is located within Killarney National Park, Macgillycuddy's Reeks and Caragh River Catchment SAC and Killarney National Park SPA is located ca. 11.km downstream of the bridge.

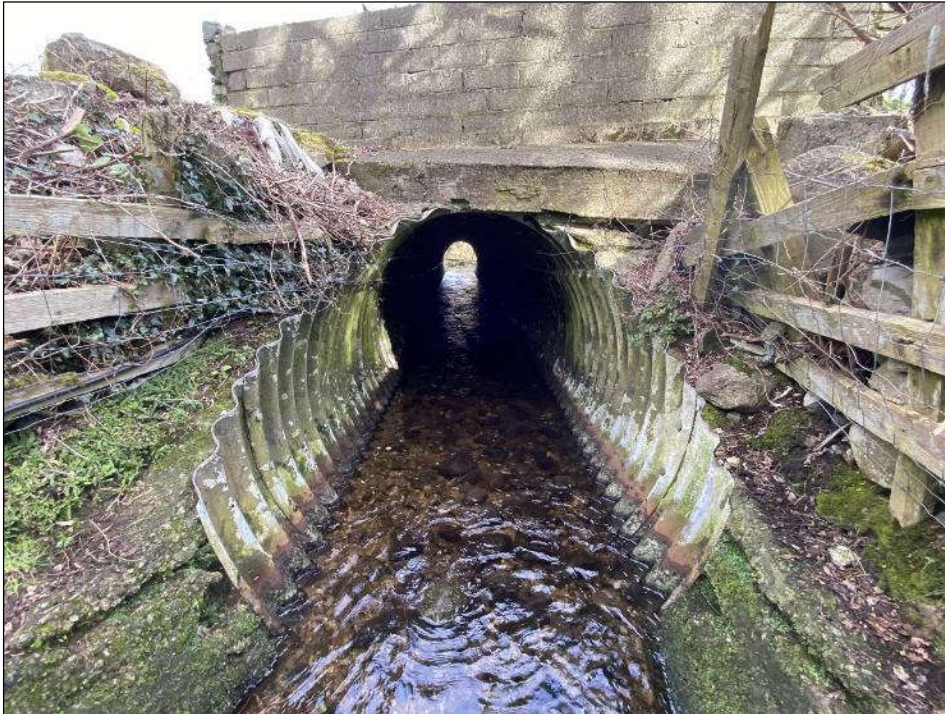
**Plate 5.14 Curraglass Culvert.**

Curraglass Culvert is a corrugated steel culvert with a concrete invert over a stream which flows to Rusheen\_Beg. Plate 5.14 shows Curaglass Culvert. Killarney National Park, Macgillycuddy's Reeks and Caragh River Catchment SAC is located ca. 250m downstream of the bridge. Killarney National Park SPA is located ca. 16km d/s of bridge.

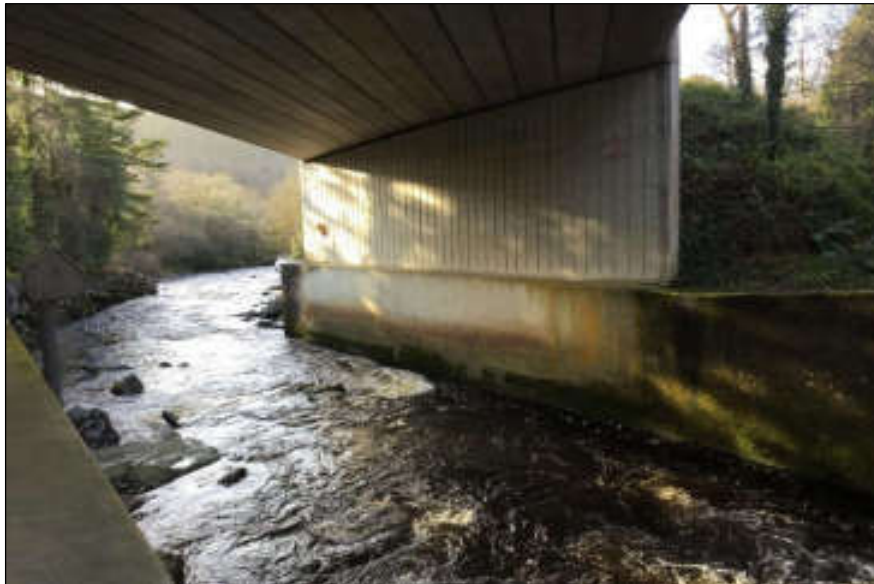
**Plate 5.15 Poulgorm Bridge.**

The Poulgorm Bridge is a 23.90m single span concrete bridge which carries the N22 over the River Flesk in Co. Kerry. The parapets comprise heavy steel rails over the deck with a masonry parapet at top of the wing walls. The bridge is within the Killarney National Park, Macgillycuddy’s Reeks and Caragh River catchment SAC. Killarney National Park SPA is located ca. 24.2km downstream of the bridge. Plate 5.15 shows the south elevation.

Poulgorm Bridge is constructed from a mix of materials, include masonry parapet walls and metal railings; the bridge proper is made of large precast concrete sections sitting on concrete abutments; as well as areas of rock armour. Apart from some areas of moss, there is no evidence of saxicolous (see Table 5.4; Plate 5.15).

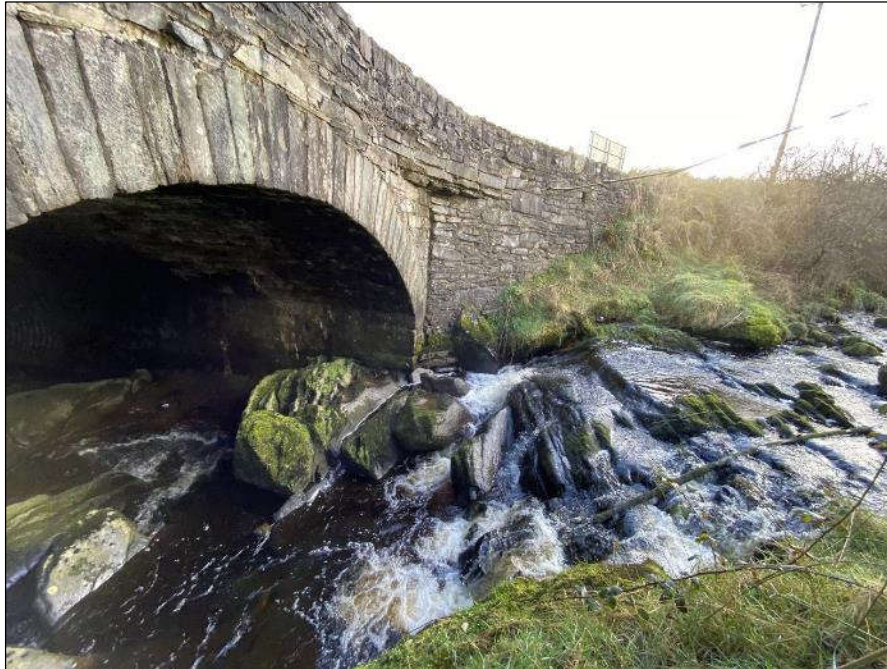
**Plate 5.16 Corranmore Bridge.**

Corranmore Bridge is a single span masonry arch bridge over the Ford Currimeenavrick. Plate 5.16 shows Corranmaree Bridge. The bridge located ca. 400m upstream of Killarney National Park, Macgillycuddy’s Reeks and Caragh River catchment SAC and ca. 30km upstream of Killarney National Park SPA.
