# TO 334 Munster Bridges Term Maintenance 4

Natura Impact Statement for Munster Bridges  
(2023, Year 1)

Transport Infrastructure Ireland (TII)

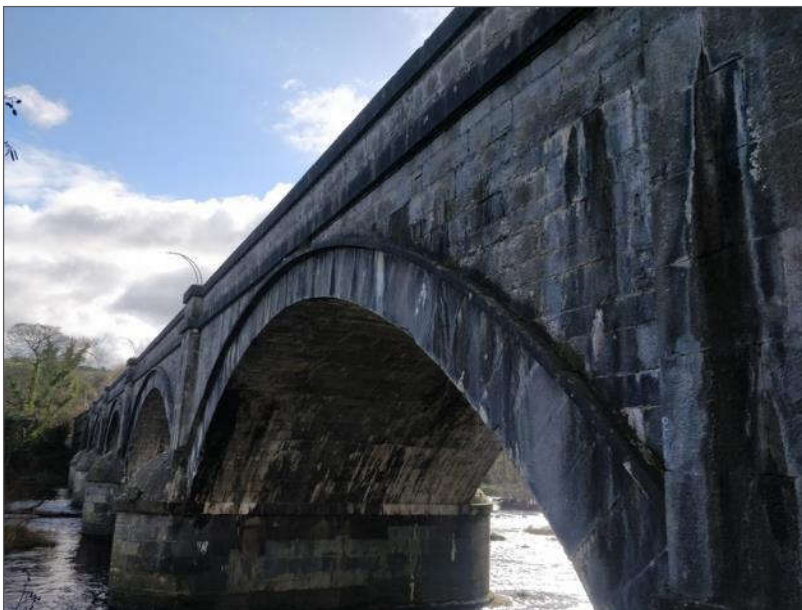
**Plate 5.17 Listowel Bridge.**

The Listowel Bridge is a 5-span stone masonry arch bridge. The span lengths are 15.2m each. The substructure consists of 2 masonry abutments and 4 masonry piers. There are masonry parapets on both sides of the carriageway. The structure is within the Lower River Shannon SAC. Plate 5.17 shows the west elevation.

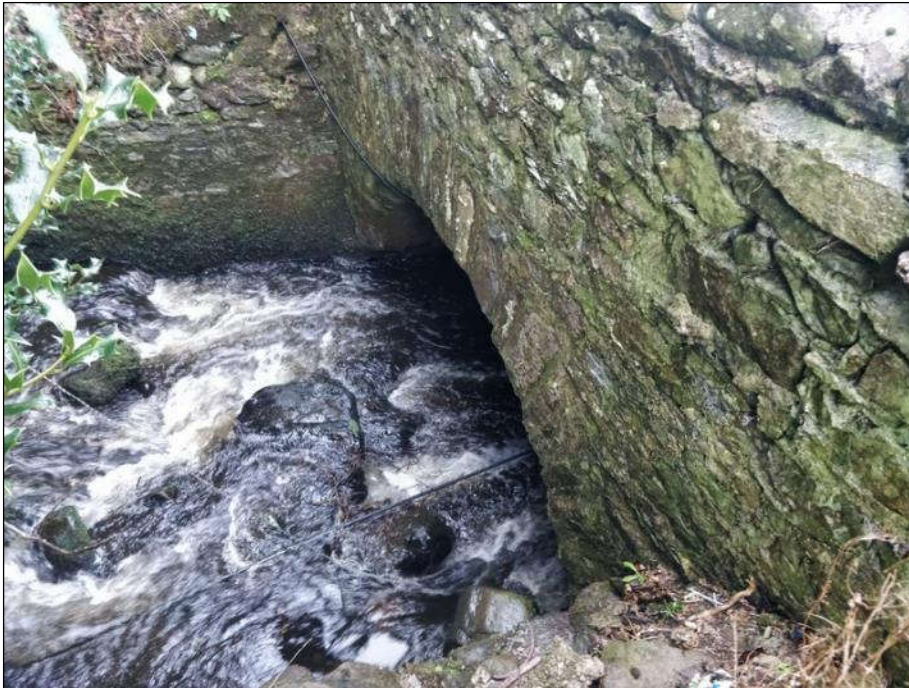
**Plate 5.18 Glenbeigh National School Bridge.**

Glenbeigh National School Bridge is a single span masonry arch bridge over the Coolroe\_Lower watercourse. Plate 2-18 shows Glenbeigh National School Bridge. Plate 5.18 shows Glenbeigh National School. Glenbeigh National School Bridge is located ca. 4km upstream of Castlemaine Harbour SAC and ca. 4km upstream of Castlemaine Harbour SPA.

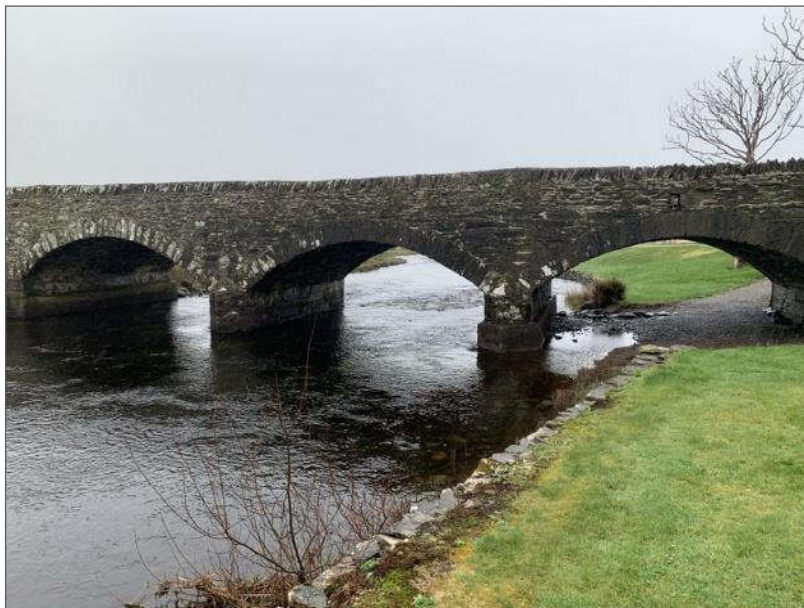
**Plate 5.19 Waterville Bridge.**

The Waterville Bridge is a 3-span stone masonry arch bridge. The spans are of similar around 7.13m. The substructure consists of 2 masonry abutments and 2 masonry piers. There are masonry parapets on both sides of the carriageway. The structure is within the Ballinskelligs Bay and Inny Estuary SAC. Plate 5.19 shows the east elevation.

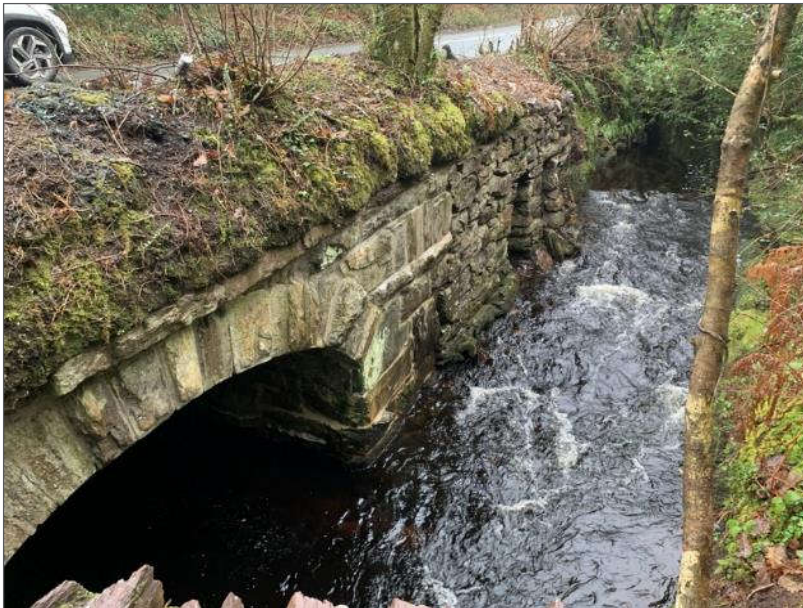
**Plate 5.20 Derreenamacken Bridge.**

The Derreenamacken Bridge is a single span stone masonry arch bridge with two stone culverts just west of the arch. The span is 3.04m. The substructure consists of 2 masonry abutments. There are no parapets on the structure. The structure is located 150m upstream of the Kenmare River SAC. Plate 5.20 shows the north elevation. The Blackwater River (Kerry) SAC is also located ca. 1.2km to the east of the bridge via straight line distance.

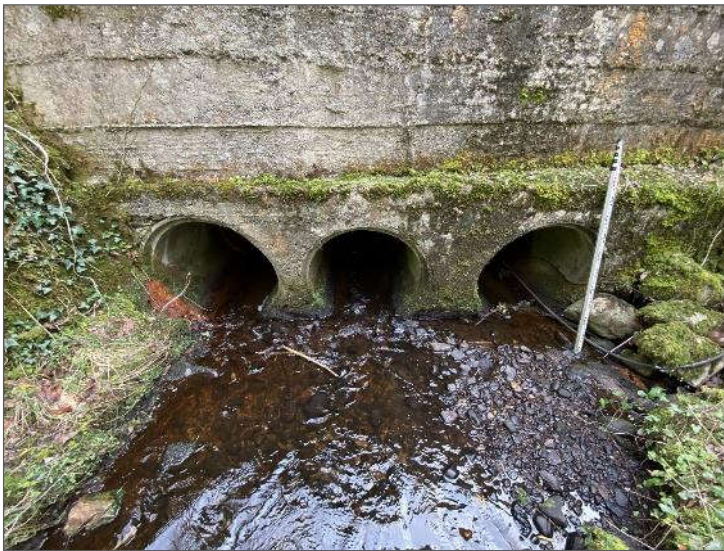
**Plate 5.21 Ardteegalvan Bridge.**

The Ardteegalvan Bridge is three arch masonry bridge. There are adjacent to the bridge three precast reinforced concrete pipes in the north side. The span is 2.94m. The substructure consists of 2 masonry abutments. There are masonry parapets on both sides of the carriageway. The structure is located 2km upstream of the Killarney National Park, Macgillycuddy's Reeks and Caragh River Catchment SAC and ca. 15km upstream of Killarney National Park SPA. Plate 5.21 shows the north elevation.

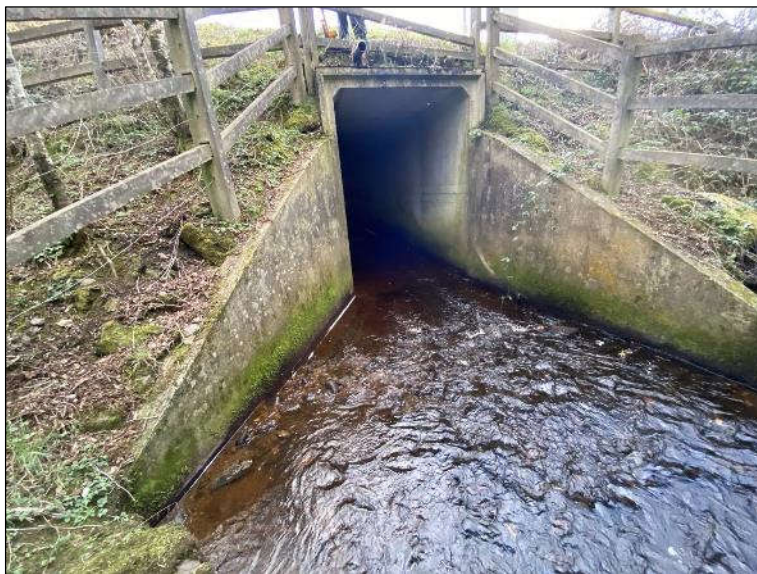
**Plate 5.22 Knockeennagowan Bridge.**

Knockeennagowan Bridge is a concrete culvert over the Knockanaroor watercourse. Plate 5.22 shows Knockeennagowan Bridge. This structure is located ca. 2.km upstream of Killarney National Park, Macgillycuddy's Reeks and Caragh River Catchment SAC and ca.17km upstream of Killarney National Park SPA.

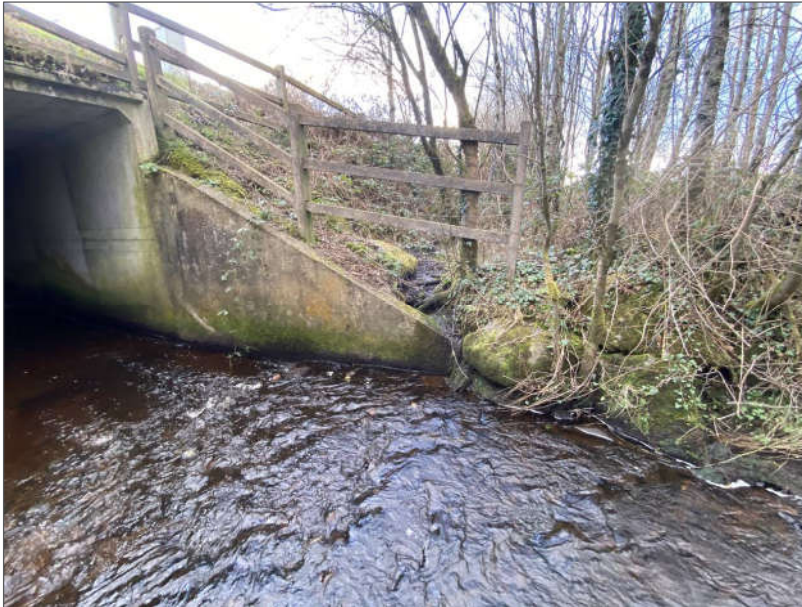
**Plate 5.22b** Small stream flowing over northern wingwall at Knockeennagowan Bridge.

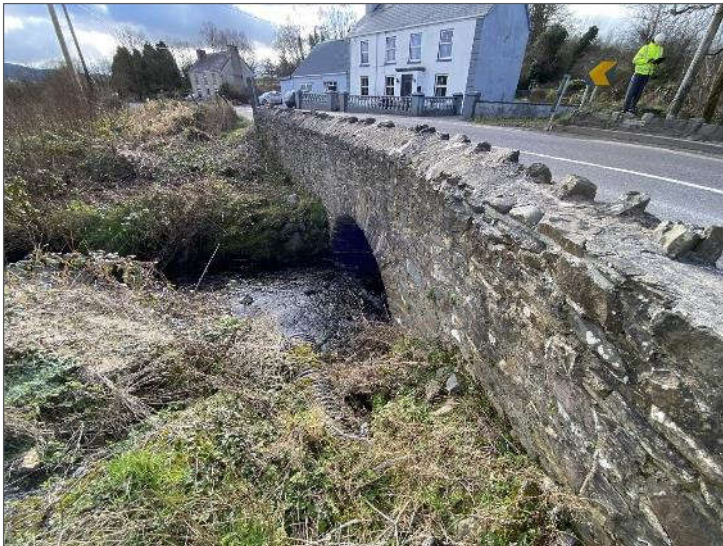
**Plate 5.23 Gortanahaneboy Bridge.**

The Gortanahaneboy West Bridge is a 2.95m single span masonry arch bridge with masonry parapets on both sides of the carriageway. The rise of arch barrel at crown is 1.40m. The structure is within the Killarney National Park, Macgillycuddy's Reeks And Caragh River Catchment SAC and Killarney National Park SPA is located over 20km downstream of the bridge. Plate 5.23 shows the deck, abutments and riverbed of the bridge.

Gortanahaneboy West Bridge is a small single span masonry bridge. Bridge photos show no evidence of saxicolous vegetation growing on the structure (see Plate 5.23).

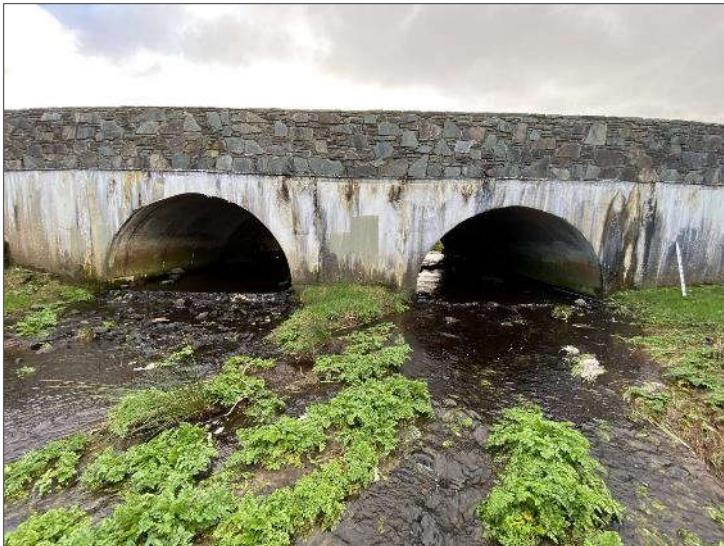
**Plate 5.24 Cullavaw Bridge.**

The Cullavaw Bridge is a 2-span masonry arch bridge with reinforced concrete arch extension to the north end. The maximum span is 4.14m and the minimum span is 3.60m. The structure carries N72 over the Cullavaw stream which is a tributary of the River Blackwater. The bridge is located 1.5km upstream of the Blackwater River (Cork/Waterford) SAC. Plate 5.24 shows the north elevation.

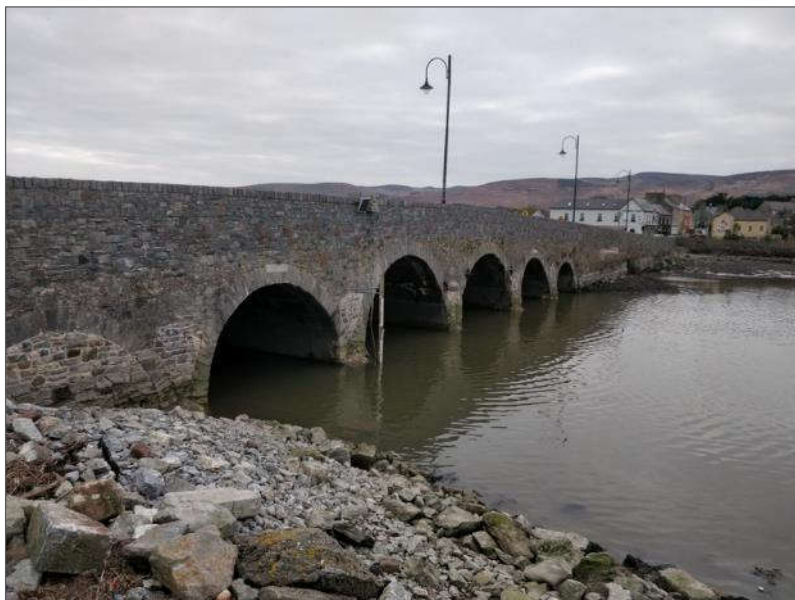
**Plate 5.25 Blennerville Bridge.**

The Blennerville Bridge is a 5-span stone masonry arch bridge. The span lengths vary between 7.4m and 4.8m. The substructure consists of 2 masonry and concrete abutments and 4 masonry and concrete piers. There are masonry parapets on both sides of the carriageway. The structure is within Tralee Bay and Magharees Peninsula, West to Cloghane SAC and Tralee Bay Complex SPA. Plate 5.25 shows the west elevation.

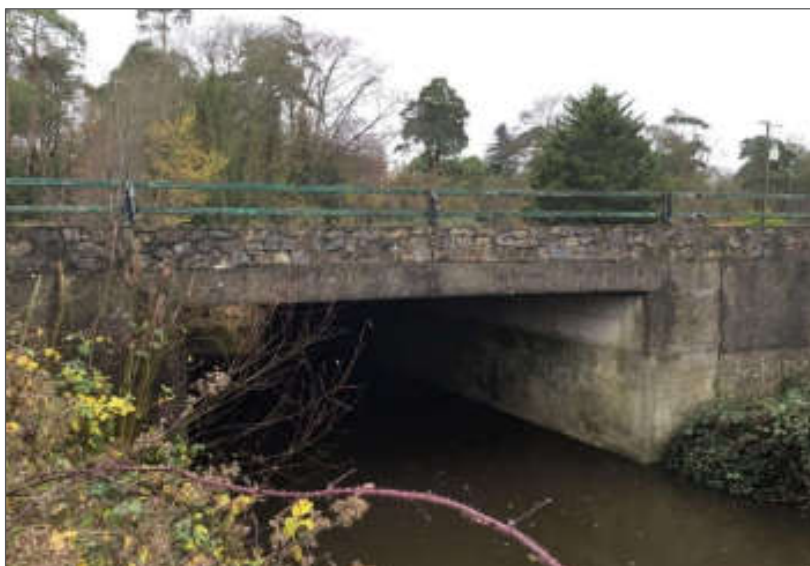
**Plate 5.29 Canal Bridge.**

The Canal Bridge is a 6.1m single span concrete slab. The parapets are masonry with steel railing. The structure is within the Lower River Suir SAC. Canal Bridge is located over a canal which flows to the River Suir. Plate 5.29 shows the south elevation.
